JAMES RIVER BASIN

Name of Dam: Sugar Hollow

Location: Albemarle County, State of Virginia

# PHASE I INSPECTION REPORT NATIONAL DAM SAFETY PROGRAM

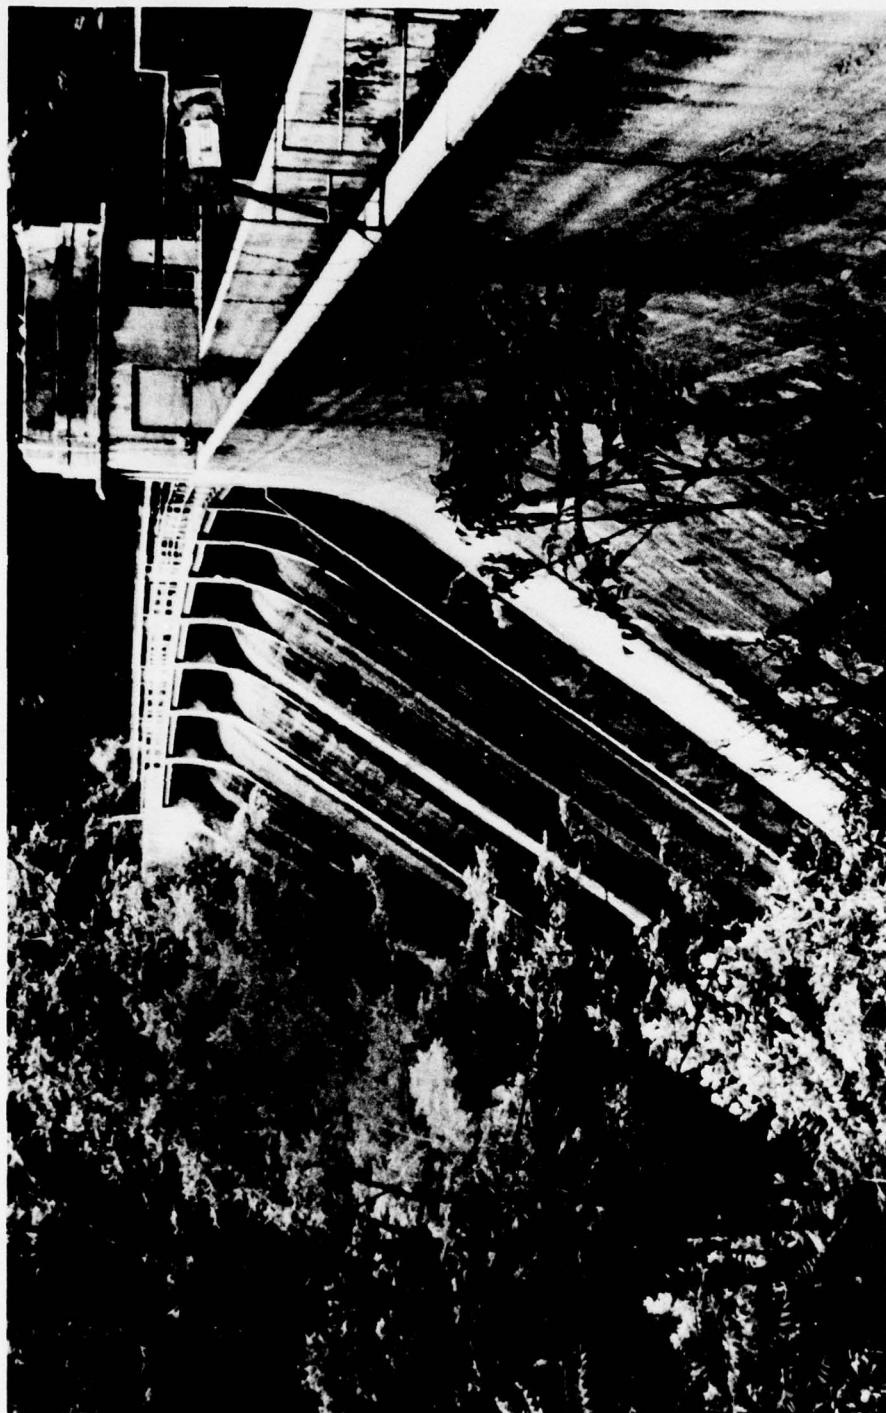
OVERALL VIEW OF DAM

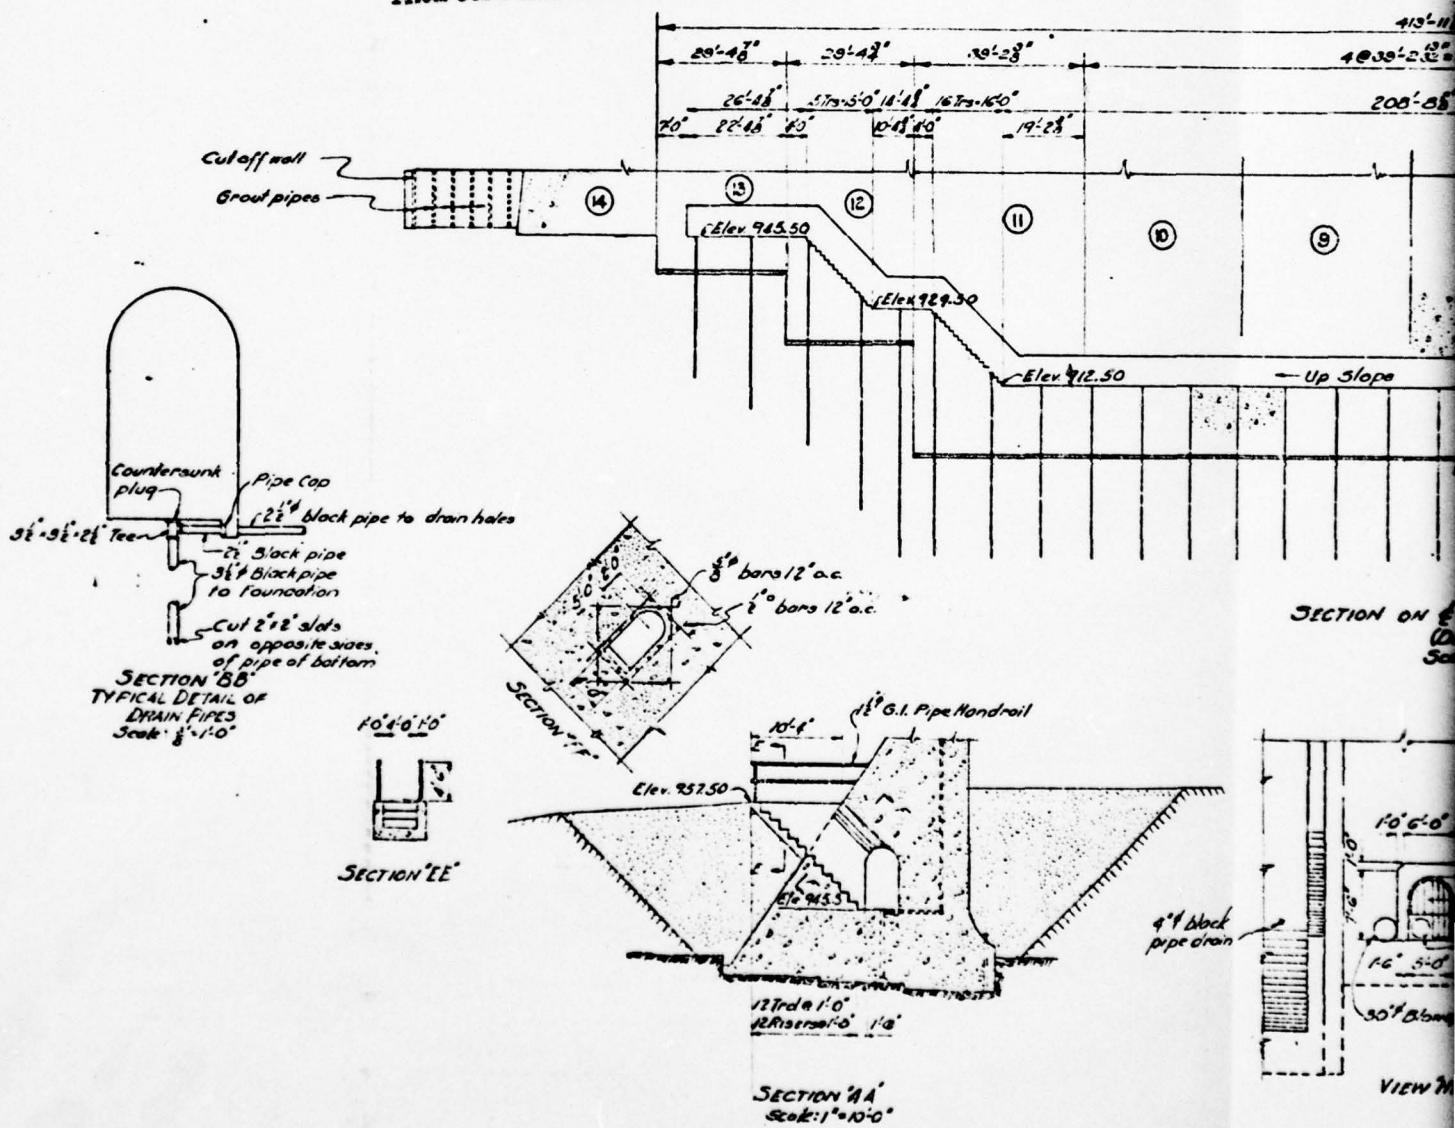
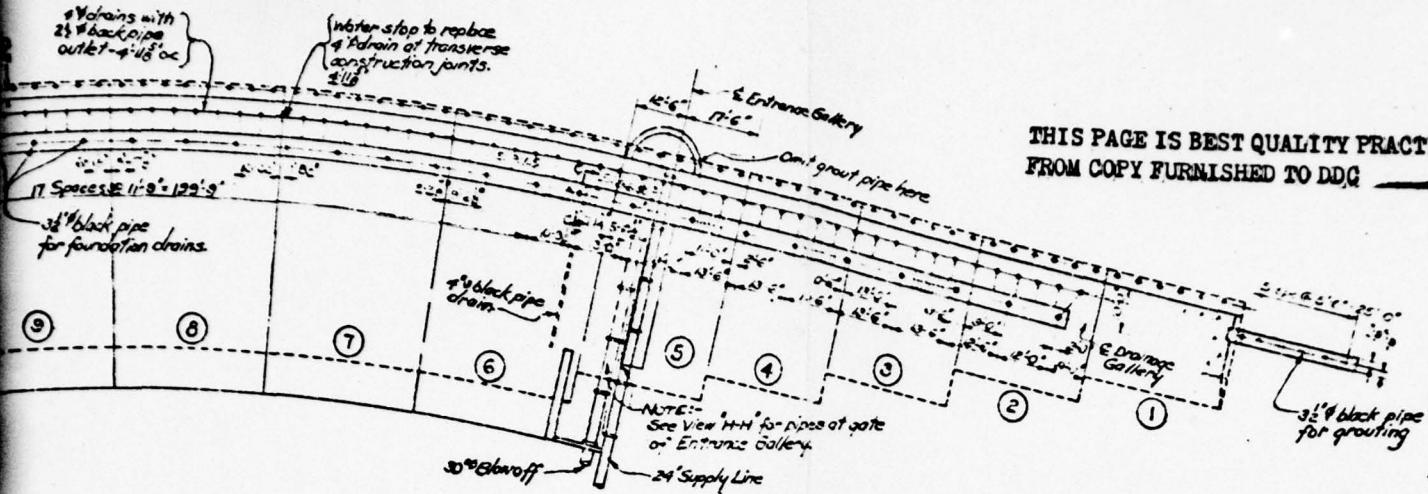
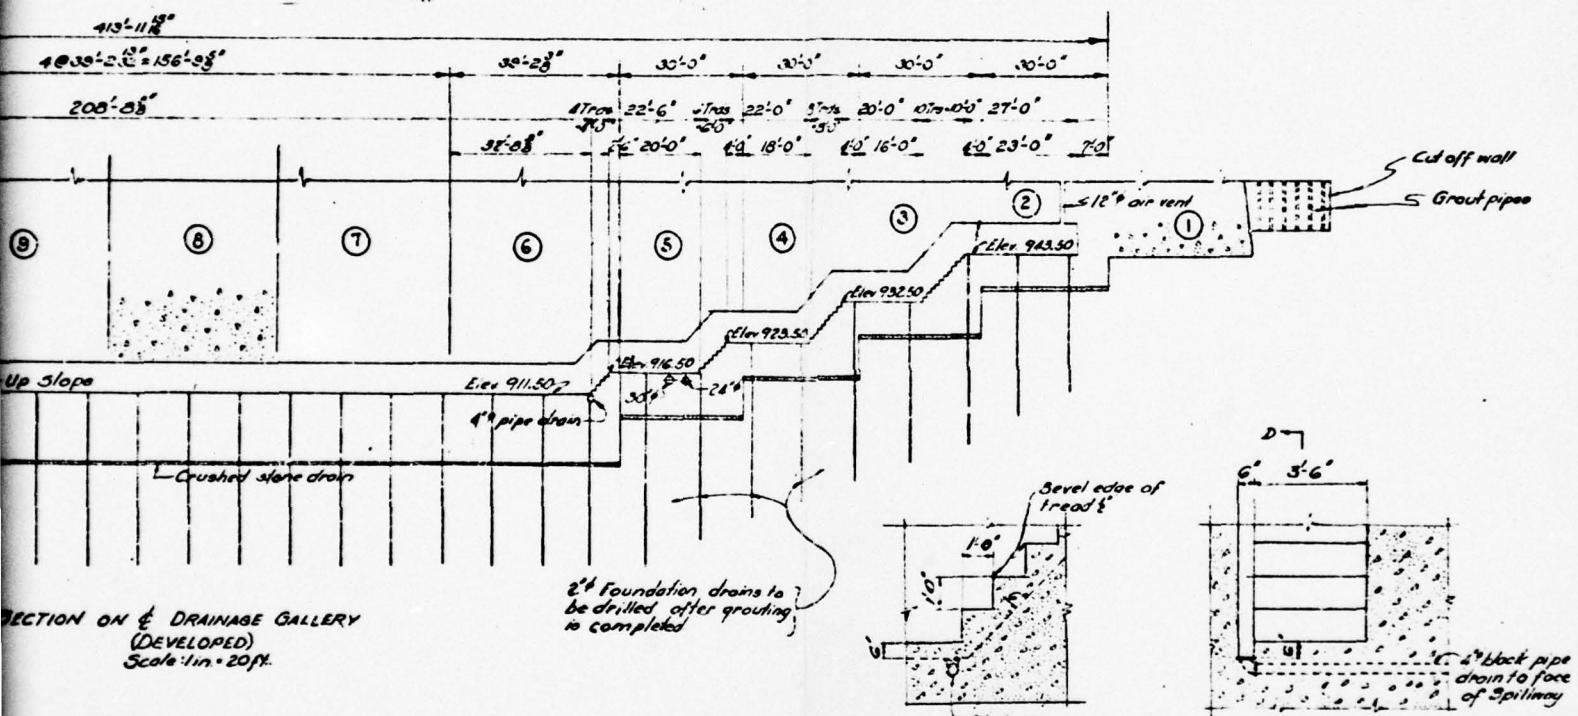
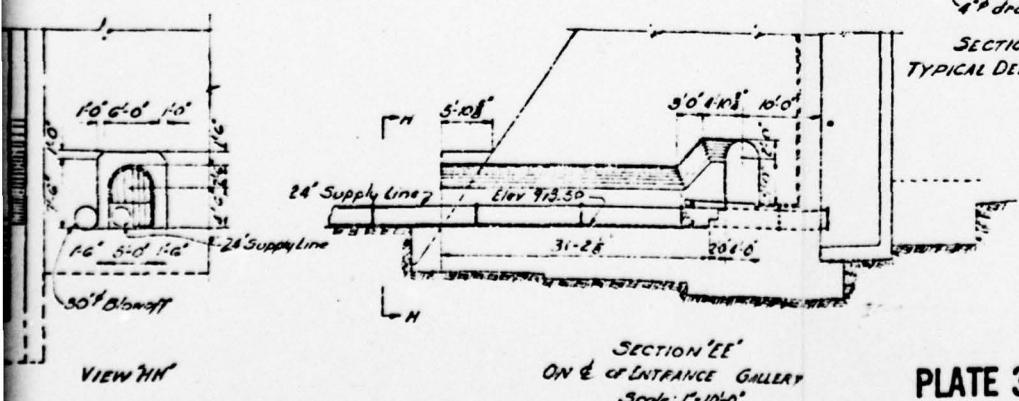
PLATE 3

gallery. Water was present in the overflow trough (see Plate 3). Part of the drainage system appeared to be functioning properly. Some of the drains in the right end of the gallery were covered with mud and debris, and were not functioning.
