Name Of Dam: DOUTHAT DAM

Location: BATH COUNTY, VIRGINIA.

(Inventory Number: VA-01701).

PHASE I INSPECTION REPORT

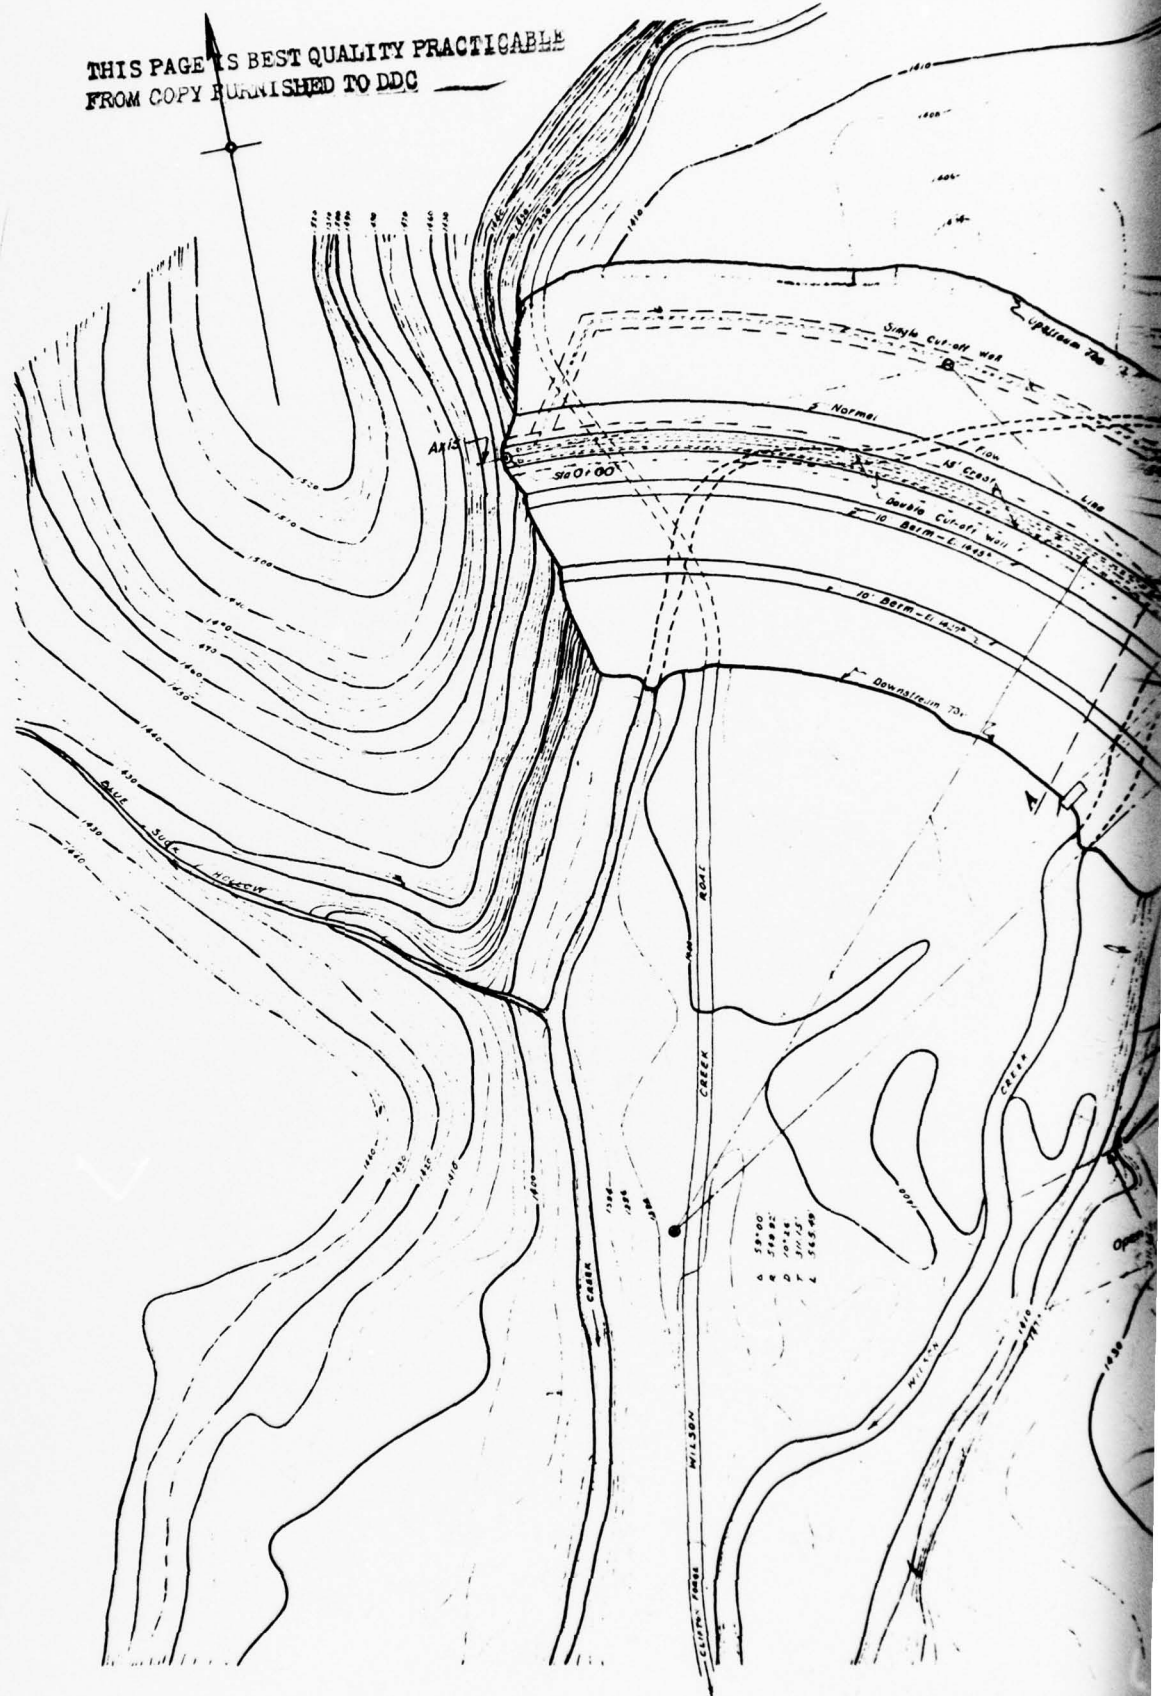
FIGURE 3

The drawings show that the impervious earth core and the concrete cutoff walls were designed to be founded on bedrock. The site under fill east of line A-B (see Figure 3, Appendix I) was to be stripped to rock. West of line A-B the site was to be stripped of loam only. Line A-B was to be located in the field where soil ceases to show reworked alluvial deposits, such as loam, silt, and sand deposits. The foundation for earthfill at the cliff near the east end of the dam was to be stepped to provide a more stable base for the fill.
