Carvin Cove Dam (~~Inventory Number~~ VA 02301). Roanoke River Basin.  
Botetourt County, Virginia. Phase I Inspection Report.

REPORT DOCUMENTATION PAGE		READ INSTRUCTIONS BEFORE COMPLETING FORM
1. REPORT NUMBER VA 02301	2. GOVT ACCESSION NO.	3. RECIPIENT'S CATALOG NUMBER
4. TITLE (and Subtitle) Phase I Inspection Report National Dam Safety Program Carvin Cove Dam Botetourt County		5. TYPE OF REPORT & PERIOD COVERED Final

REVISION NO. 1 TO PHASE I INSPECTION REPORT  
NATIONAL DAM SAFETY PROGRAM

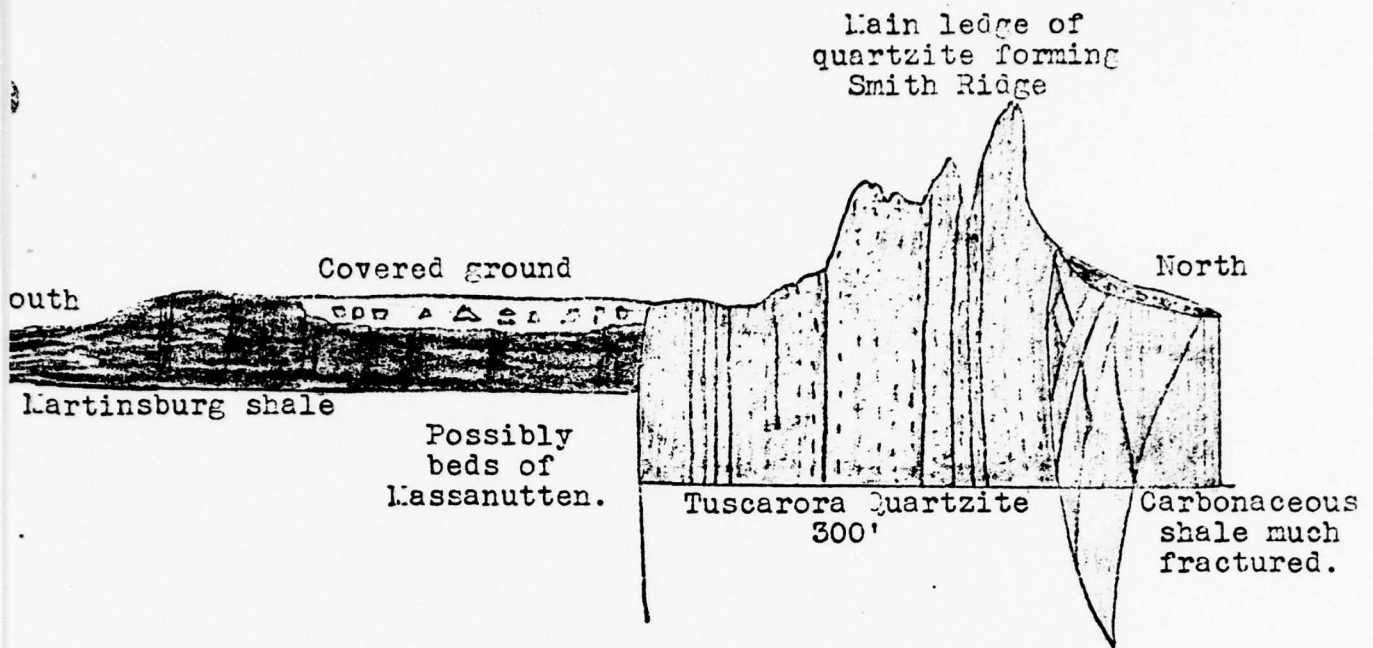
A sketch Cross Section of the rock formations at the immediate site of the proposed dam, showing the Tuscarora quartzite, 300 feet thick, standing on edge, the Martinsburg shale below, and the carbonaceous, much fractured shales above this member.

The important thing here, of course, is the fact that the quartzite formation, which is 300 feet thick and stands up on edge, is so hard and resistant to erosion that it forms a barrier ridge and on this the fall in the stream is developed. Thus the stream flows over solid rock at this point and has cut a very narrow notch, giving an excellent setting topographically for a dam.

If a dam could be located on this main ledge, it would apparently have a sound foundation and excellent supports for the two ends. The chief question in connection with the problem in this form is whether, after all, the foundation is as sound and continuous as it looks, or whether there is some other structure beneath that could in any way endanger it.

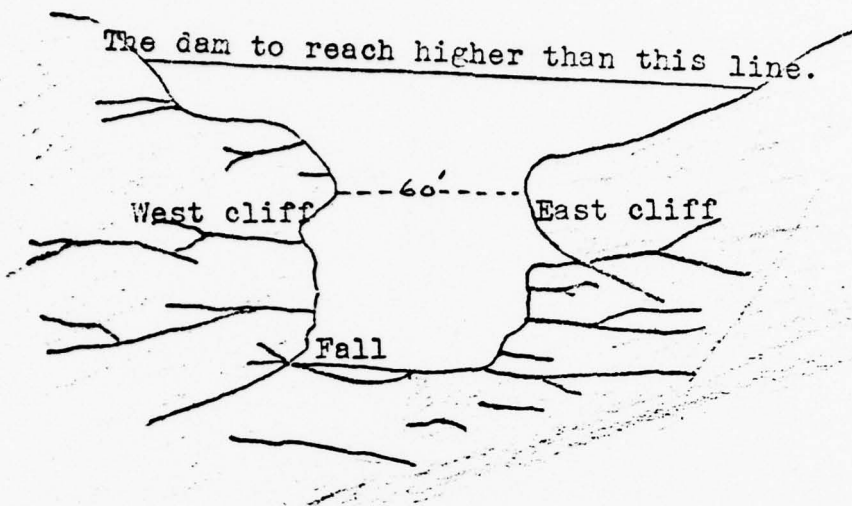
The notch cut through the main quartzite ridge by Carvins creek, as seen looking up stream. The irregular jointing of the rock ledges is shown, but the bedding structure runs from right to left and cannot be shown in this section.

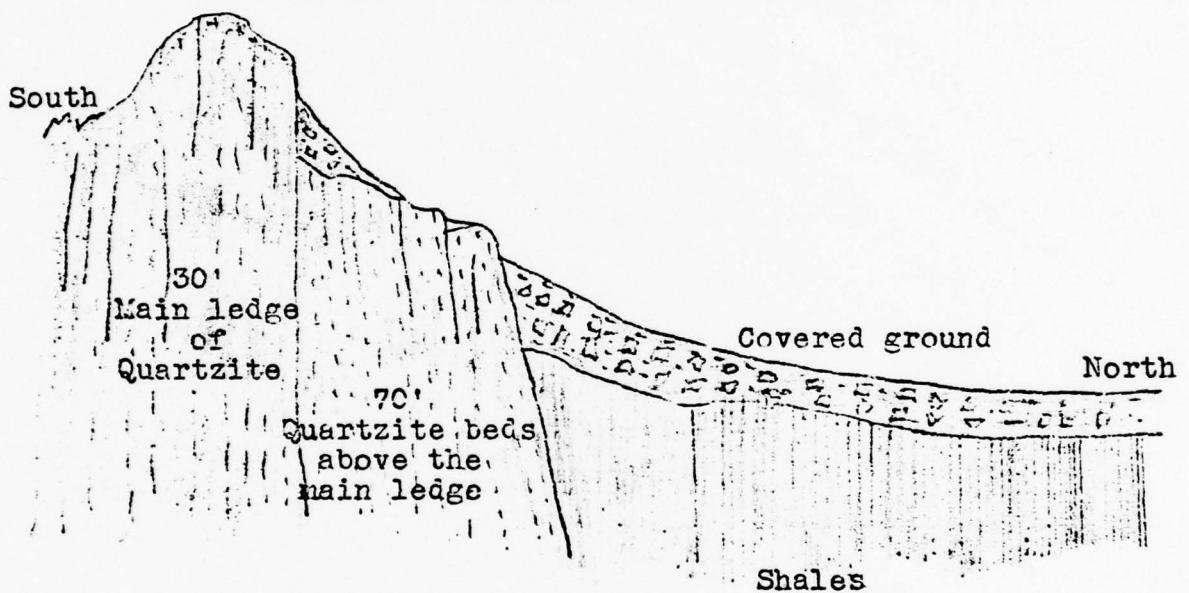
A cross section designed to illustrate the relations of ledges to covered ground.

The quality of the cover on top of the rock floor immediately in front of the main ledge is somewhat less certain. The material is made up doubtless of blocks of quartzite and fragments of shale and some more disintegrated soil mixtures, but it can not be very good quality and probably will require removal wherever the foundations are to be laid, no matter what kind of design is adopted. It might be desirable to put down a test pit in this material at one or two points within reach of the principal operations, simply to see what the quality is and how deep it is to rock. These points have to do with construction estimates.

The ledges immediately behind (downstream from) the main quartzite ledge at the fall, for a distance of 30 or 40 feet, are thin bedded and show some slipping (bed faulting) between the beds so that there is somewhat more weakness in this zone of 30 or 40 feet than in most other portions of the quartzite formation. This is reflected in the local topography of the ledge, for it is marked by a depression taken advantage of by the fall and this is continued on both sides of the stream, as well as in the bottom. It is this ground that breaks away a little better or a letter faster than does the main quartzite ledge. The weaknesses that are in it, however, run practically parallel to the bedding and are essentially tight. A little circulation, doubtless, could take place along these weaknesses but they run parallel to the ridge instead of across it. Therefore, they are of little consequence in considering any possible loss of water through the ledge and dam.

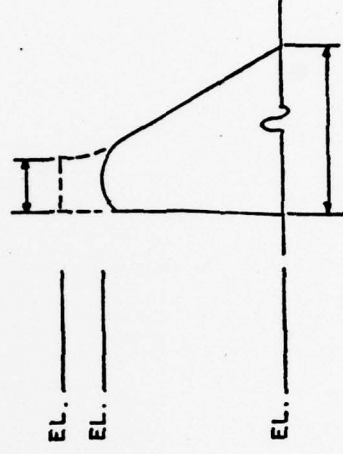
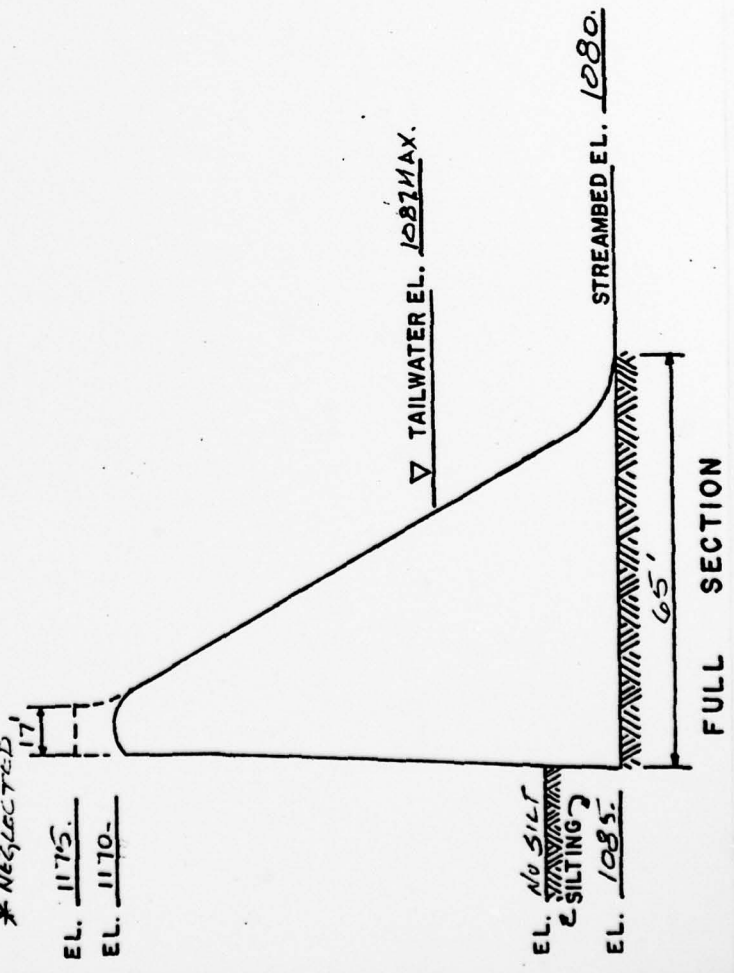
The dam meets the stability criteria for the 100 year storm. The results of the stability analysis for the loading condition of the PMF show 42% of the base in compression and a factor of safety against sliding of 4.04.

The percent of base in compression for the loading condition of the PMF is considerably below the 100% required. However, the dam under conditions of the PMF loading is not in eminent danger of failure.

LOADING CASE	ELEV. HEAD WATER	ELEV. TAIL WATER	ΣV	ΣH	ΣH / ΣV	LOCATION RESULTANT FROM TOE	% BASE IN COMPRESSION	FACTOR SAFETY SLIDING	FOUNDATION PRESSURE	
									TOE	HEEL
OPERATING CONDITIONS	1170.	0	324. K	226. K	.7	24'	100%	5.55	8.9 KSF	1.07 KSF
100 YR. FLOOD	1175.	0	314. K	253. K	.81	20.5'	94%	4.93	10.2 KSF	—
P.M.F.	1184.	1087.*	297. K	306. K	1.03	9'	42%	4.04	22 KSF	—

7.2.2 Other Recommendations: The conservative analysis included in this report cannot accurately determine if remedial measures are necessary to improve structural stability, but strongly indicate that further more rigorous analysis is required. It is recommended that the owner of the dam immediately undertake an engineering study to determine remedial treatments to reduce the overtopping potential threatening the stability of the dam and the integrity of the abutments.
