Name Of Dam: GEORGE F. BRASFIELD

Inventory Number: VA 04101

# PHASE I INSPECTION REPORT

## NATIONAL DAM SAFETY PROGRAM

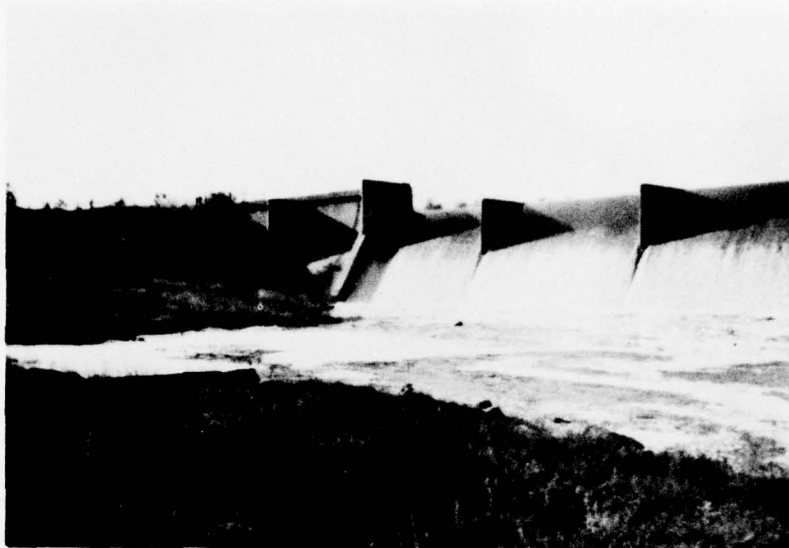
3.3.2 Abutments: The erosion on the downstream slope of the right abutment is considered a problem that will require corrective action. If allowed to continue, the unimpeded erosion could possibly cut the abutment slopes back to the abutment and end of dam contact. This action would result in a shorter seepage path and a possible failure of the abutment. Additional erosion was observed on the upstream shoreline of the left abutment. This erosion can be corrected by the use of approved shore protection.

GEORGE F. BRASFIELD - VIEW OF RIGHT ABUTMENT
