# CRANBERRY LAKE DAM

## PHASE I INSPECTION REPORT

### NATIONAL DAM SAFETY PROGRAM

NY 00397

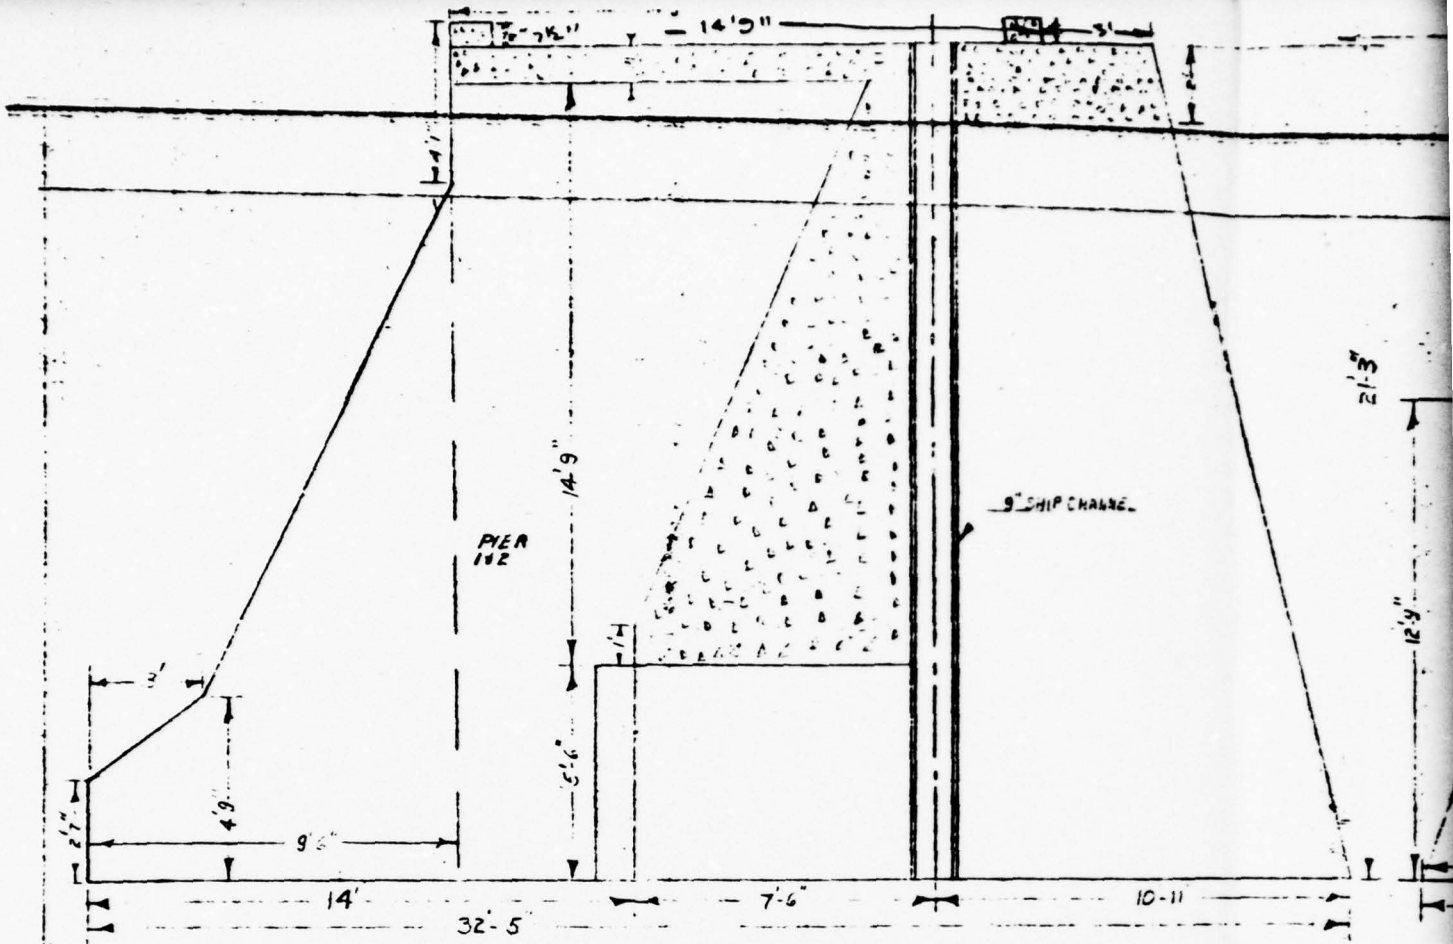
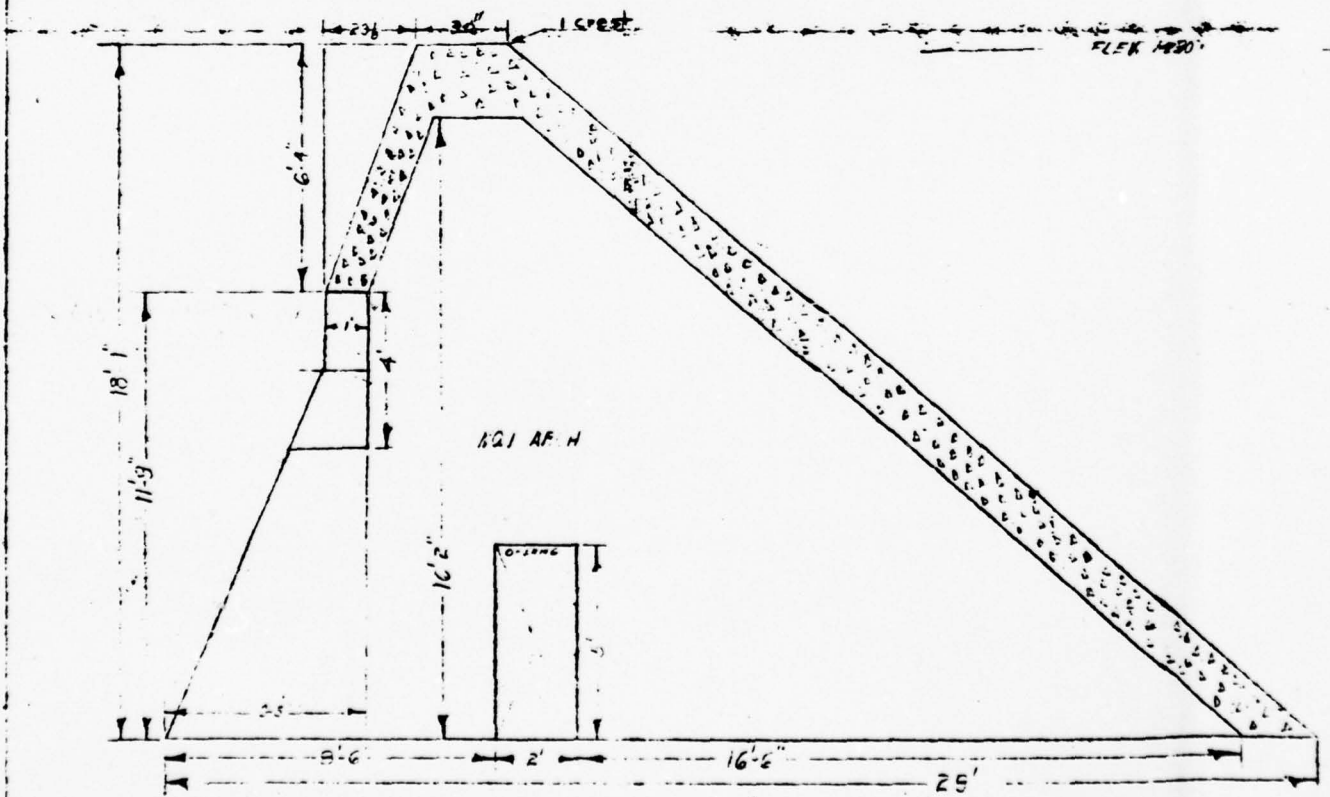
FIGURE 4

The crest of the embankment is about 200 feet wide and is grass covered. A sinkhole-type depression was located in the embankment about 50 feet from the training wall and 100 feet from the upstream slope. The existence of a concrete cut-off wall (as shown on Figure 4) in the embankment could not be verified.
