STILLWATER RESERVOIR DAM

PHASE I INSPECTION REPORT NATIONAL DAM SAFETY PROGRAM

NY 00316

Prepared by: O'Brien and Gere Engineers, Inc.

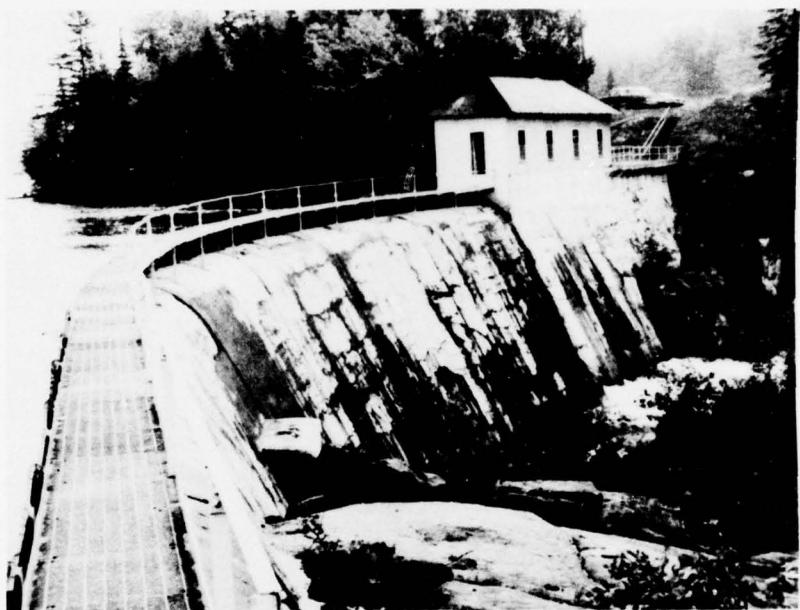
CONCRETE SPILLWAY AND GATE HOUSE

The downstream face of the non-overflow section shows signs of deterioration. A protective surface treatment (gunite) which was applied to the structure has weathered and cracked. Some spalling of the gunite was noted in the downstream slope of the non-overflow section.

The downstream face of the spillway has also been surfaced with a protective material. A much more significant deterioration of the material than observed on the non-overflow section was evident. In areas where the material had dislodged from the structure, spalled concrete was again noted. No seepage was observed in the toe area of the gravity section.

3. Remove and replace the deteriorated concrete surface protection material as required.

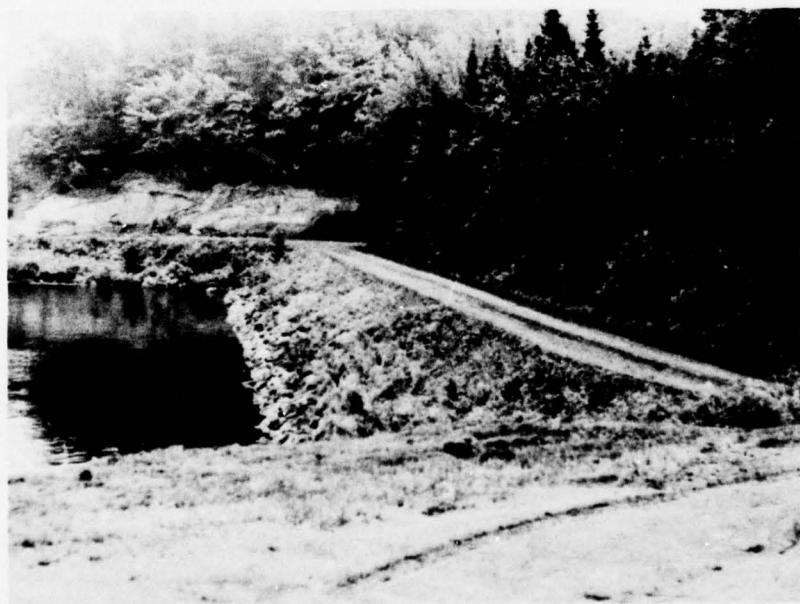
SOUTH DAM LOOKING SOUTH

The downstream slope of the embankment is covered with a relatively dense growth of trees and brush for its entire length. Some riprap was noted interspaced along the slope. Pools of water were observed at three locations at the toe of the downstream slope, however, no movement which would indicate flow was detected in any of the pools. The upstream slope of the embankment is surfaced with riprap consisting of semi-angular granitic type rock weighing from about 75 to 300 pounds each. The riprap protection extends about six feet above the present water level. Vegetation along this slope is limited to a few small trees and brush. The embankment appears to be straight and no noticeable indications of settlement or erosion were noted.
