National Dam Safety Program. Big Spring Dam (NDS I.D.-461), Ohio River Basin, Big Spring Run, Westmoreland County, Pennsylvania. Phase I Inspection Report.

BIG SPRING DAM

PHASE I INSPECTION REPORT
NATIONAL DAM INSPECTION PROGRAM

JUNE 1978

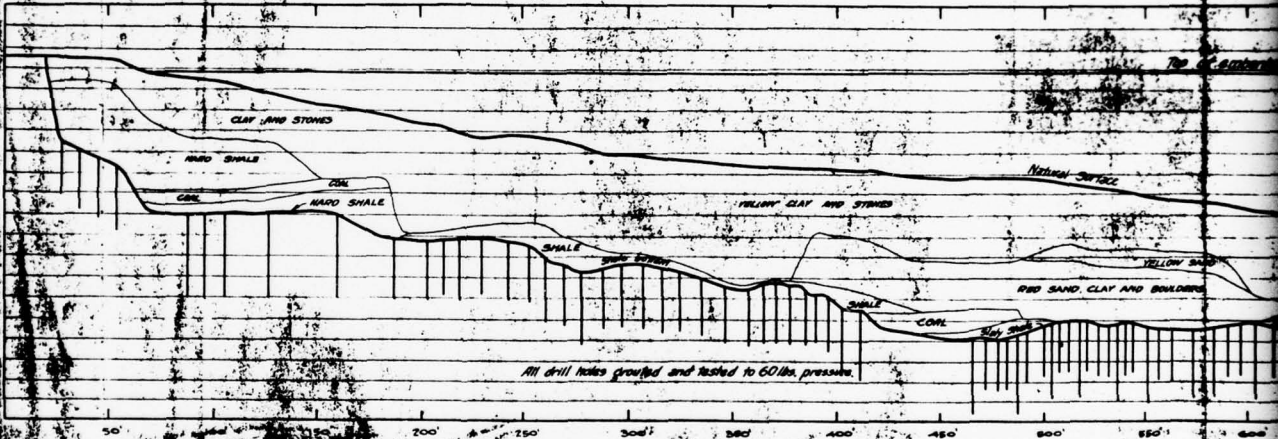
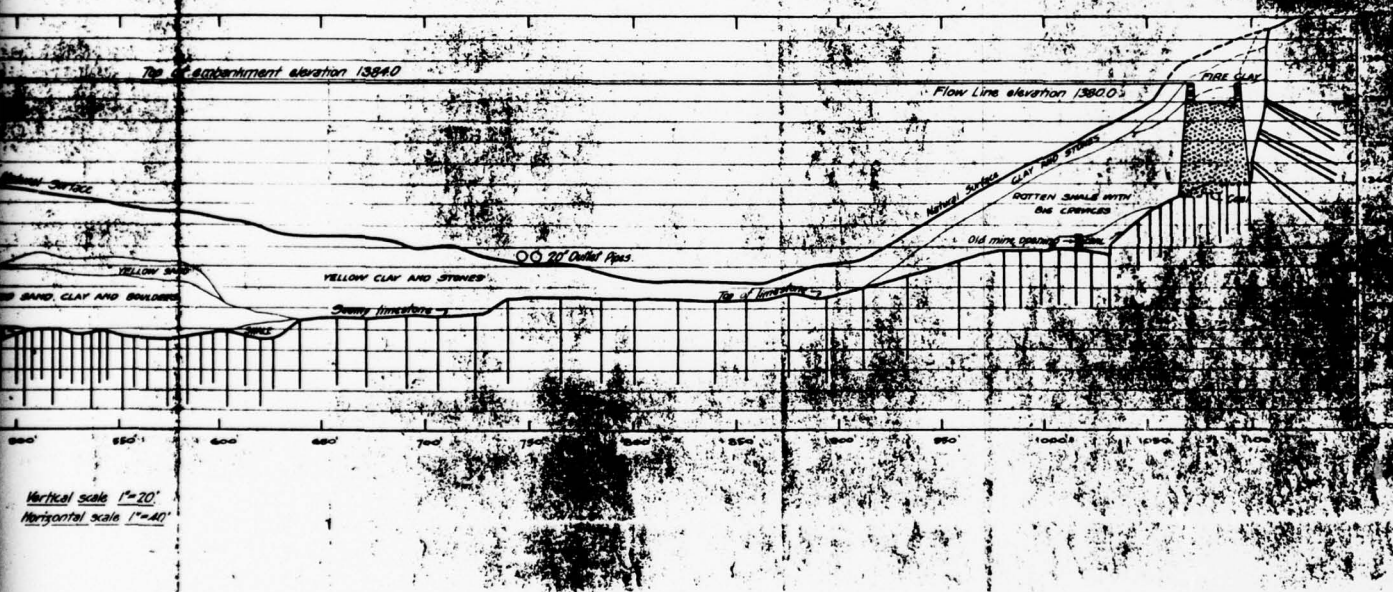
PLATE 3

- (d) In the same reference, it was reported that the subsurface investigation was made by means of borings and test pits. Plate 3 illustrates the subsurface profile of the valley derived from the foundation investigation. It consists of "yellow clay and stones" varying in thickness from 5 to 35 feet, underlain by shale on the east side of the valley and limestone on the west side of the valley. A 5-foot coal seam is shown on the east abutment side at an elevation of 1355 feet, which is approximately 30 feet below the dam crest. An old mine opening is reported on the west abutment at an elevation of 1345 feet. The subsurface profile through the valley indicates that the foundation of the puddle trench was grouted.

All drill holes grouted and tested to 60 lbs. pressure.

A preliminary review of the regional geology indicates that the site is located in the Allegheny Mountain section of the Appalachian Plateau province. The dam is on the west limb of the Laurel Hill Anticline, near its northern nose, and the east limb of the Ligonier Syncline. The rock strata dip approximately 750 feet per mile to the northeast. The bedrock contains members of the middle portion of the Allegheny Series, probably the Middle Kittanning Sandstone, the Lower Kittanning coal, and the Clarion Sandstone. The Vanport Limestone may be present in the area approximately 40 feet below the Lower Kittanning coal. The profile of the dam (Plate 3) indicates limestone being present in the bottom of the valley.

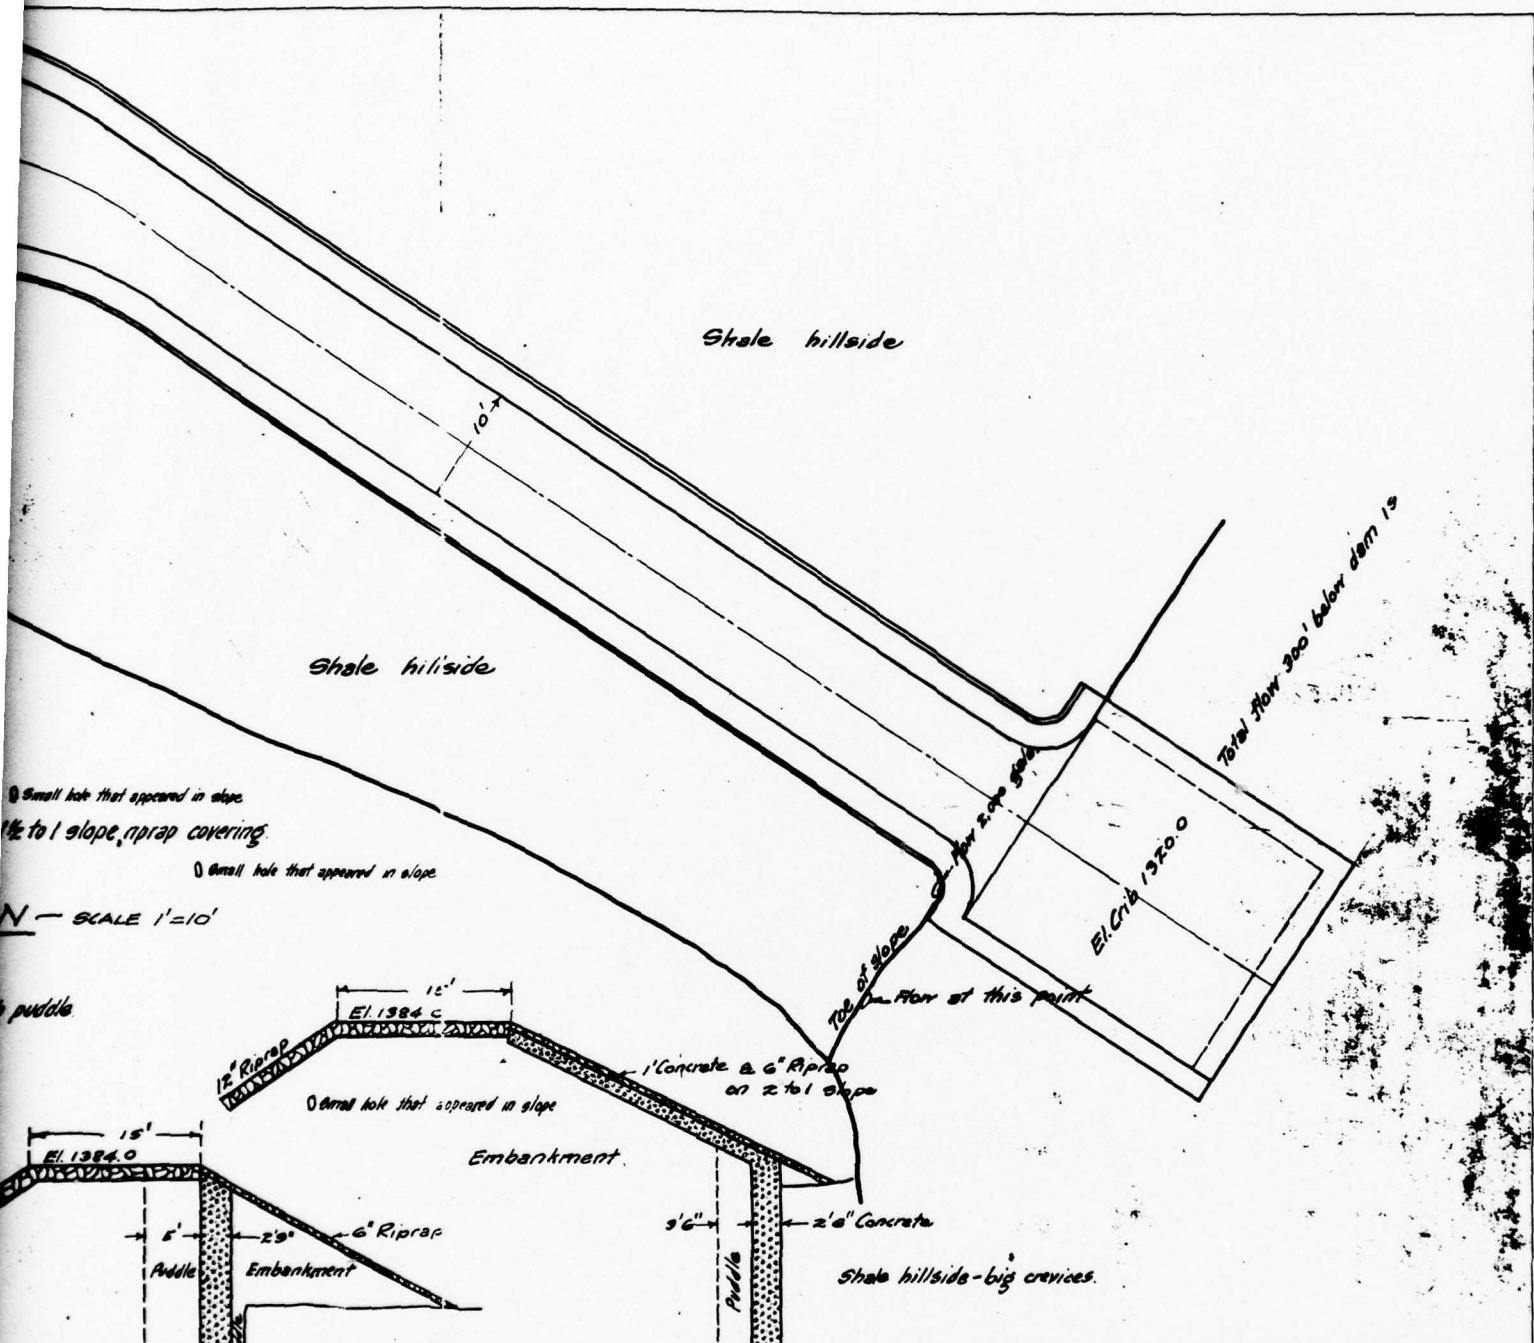
HIGH RIDGE WATER SUPPLY CO
PLAN SHOWING METHOD OF
REINFORCING S. END OF EMBANKM'T
BIG SPRINGS RESERVOIR
SEWARD, PA.

d. Post-Construction Changes. As described in Section 2.2, shortly after the completion of the dam, the reservoir was drained and the seepage condition observed on the left abutment was corrected by the construction of a concrete cutoff wall.

Small hole that appeared in slope
 1/2 to 1 slope, riprap covering
 Small hole that appeared in slope
 SCALE 1"=10'
