BOYD KELLER RESERVOIR DAM

INVENTORY NUMBER NDS 745

### PHASE I INSPECTION REPORT

## PHASE I REPORT NATIONAL DAM INSPECTION PROGRAM

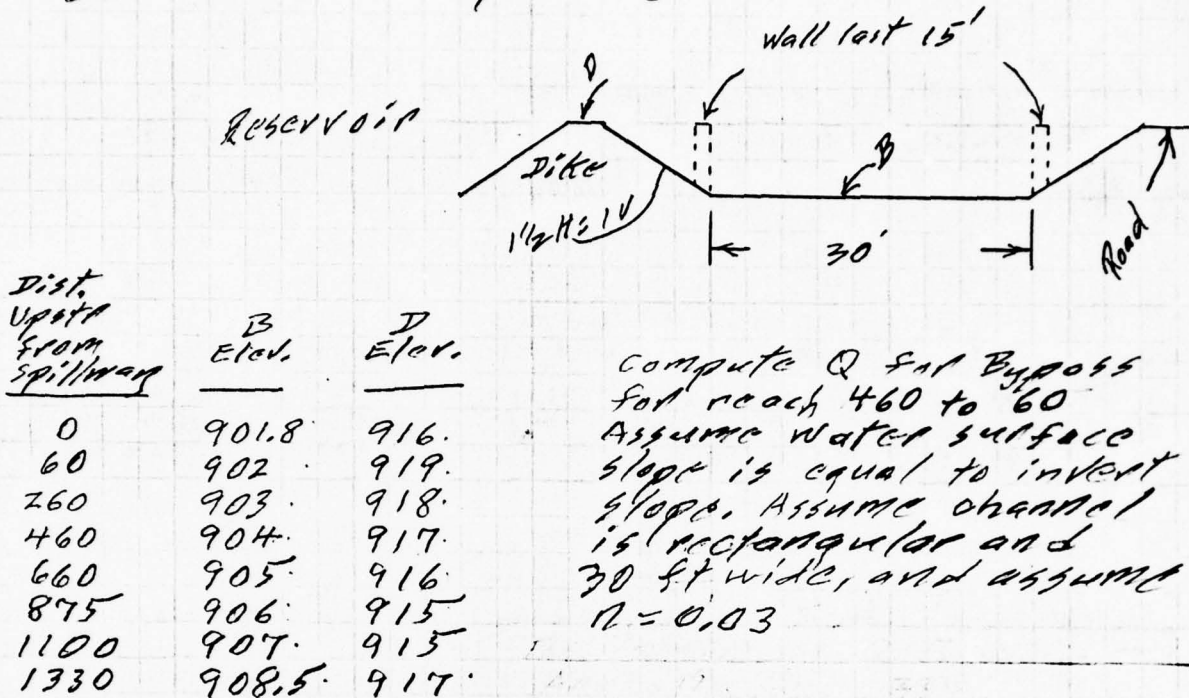
Bypass channel Capacity

For water surface at sta. 460 = 915

Area =  $30 \times 11 = 330$  sq. ft.

\* At this station, top of dike is at elev. 917, so water will overflow into reservoir. The 6,030 cfs is the flow that will proceed down channel and bypass the dike.

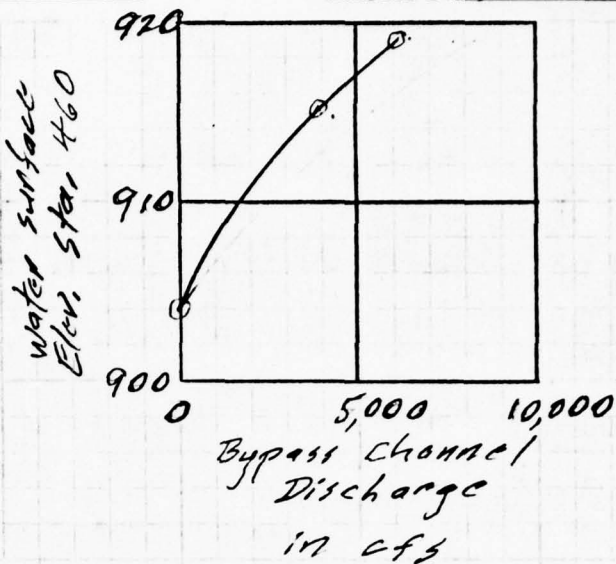
Spillway capacity (free fall)

The above two classifications indicate a Spillway Design Flood (SDF) of PMF. Since the total of spillway and bypass channel capacity for this reservoir is 23,000 cfs or 66 percent of PMF peak inflow, the flood discharge facilities are considered to be inadequate, but not seriously inadequate.

High-flow angle of approach to spillway  $24^\circ$  from perpendicular.  
 Cosine = 0.9135

$$Q = .9135 \times 3.87 \times 130 \times (11)^{3/2} = 16,800 \text{ cfs}$$

Bypass channel	6,030
Spillway	16,800
<u>Total</u>	<u>22,830</u>

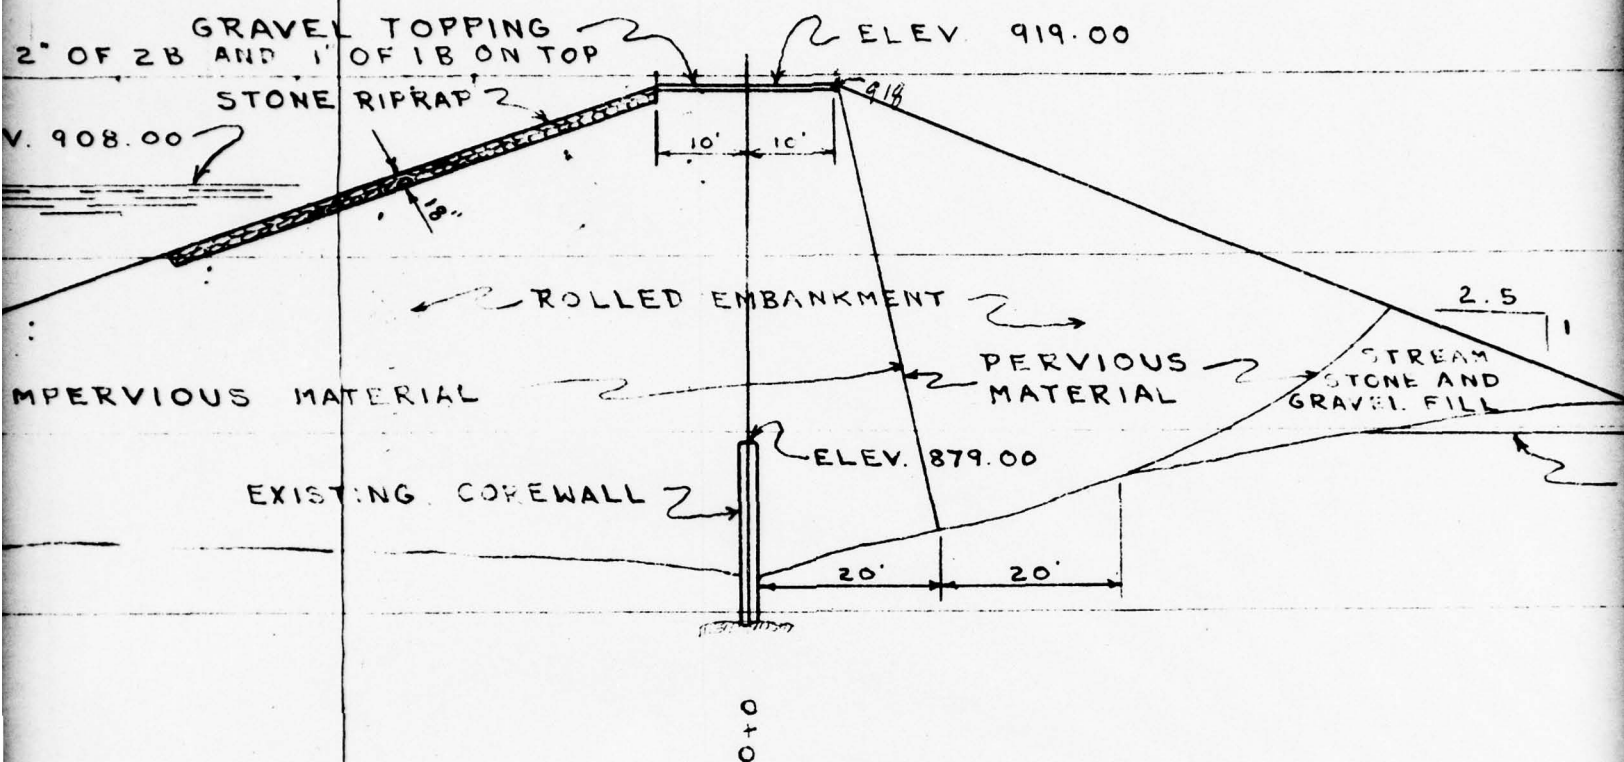
CROSS - SECTION OF BREAST AT STA. 1+0 RIGHT  
 SCALE 1" = 20'

There are no design criteria for the embankment stability available. The construction drawings indicate good foundations for vertical loads. The small amount of grouting accomplished in 1915 at the right abutment would have little effect on the overall volume of leakage through the foundations. The amount of seepage is relatively constant and there is no turbidity in the water. The present dam was constructed in 1956 and incorporates some of the features of the old dam (See Appendix D, Plate VII). The slopes of the embankment appear to be adequate.
