Green Lick Dam (NDI PA-219), Ohio River
Basin, Green Lick Run, Fayette County,
Pennsylvania. Phase I Inspection Report.

PHASE I REPORT

Green Lick Dam

27 April 1978 (visual inspection)

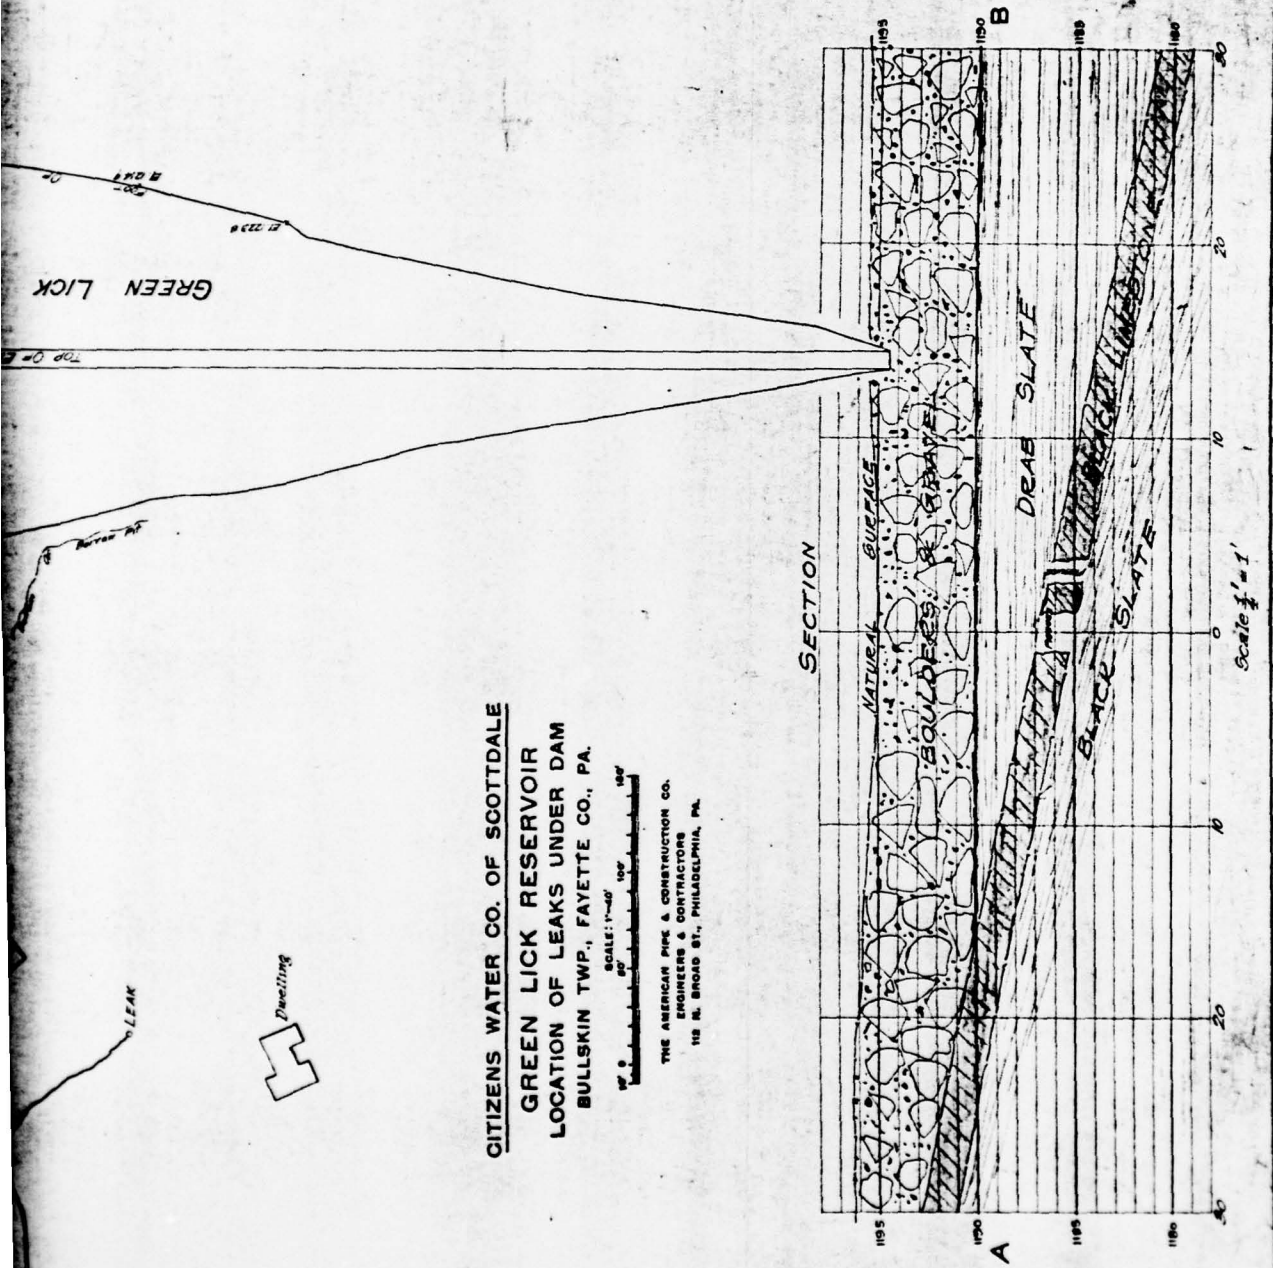
FIGURE 3

CITIZENS WATER CO. OF SCOTTDALE
GREEN LICK RESERVOIR
LOCATION OF LEAKS UNDER DAM
BULLSKIN TWP., FAYETTE CO., PA.
