**LARCHMONT WATER COMPANY  
DAM NO 2**

**WESTCHESTER COUNTY  
NEW YORK**

**INVENTORY NO 112**

**PHASE I INSPECTION REPORT  
NATIONAL DAM SAFETY PROGRAM**

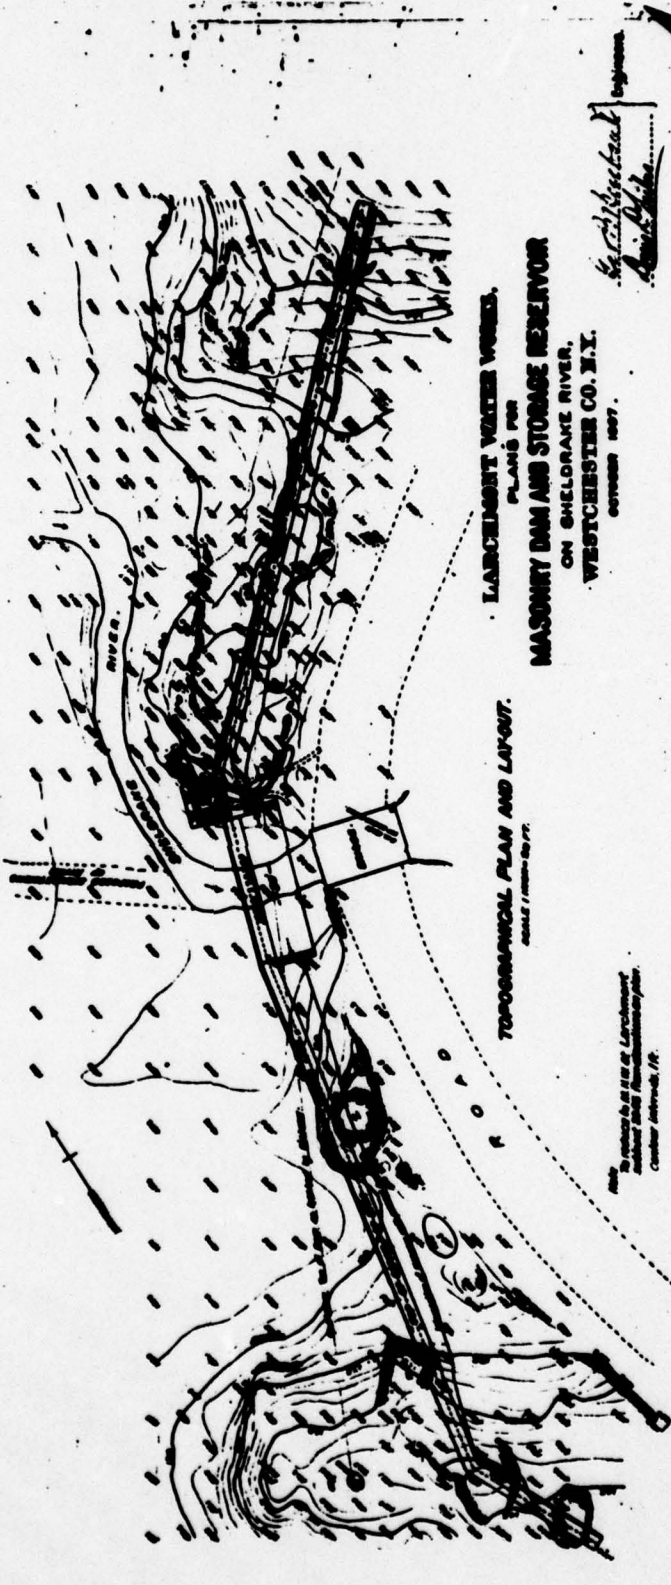
**FIGURE 3**

Only one section of the raised dam was analyzed due to lack of information on the drawings which were made available to the dam inspection team. It could not be determined whether this was the critical section. The section was taken from Figure 7, Section C-C. The downstream elevation shown in Figure 3 generally indicates that the location of Section C-C is in the higher section of the dam. Further work on the structure could seek to determine whether higher dam sections exist. In the event they can be located and measured, additional stability computations should be performed.

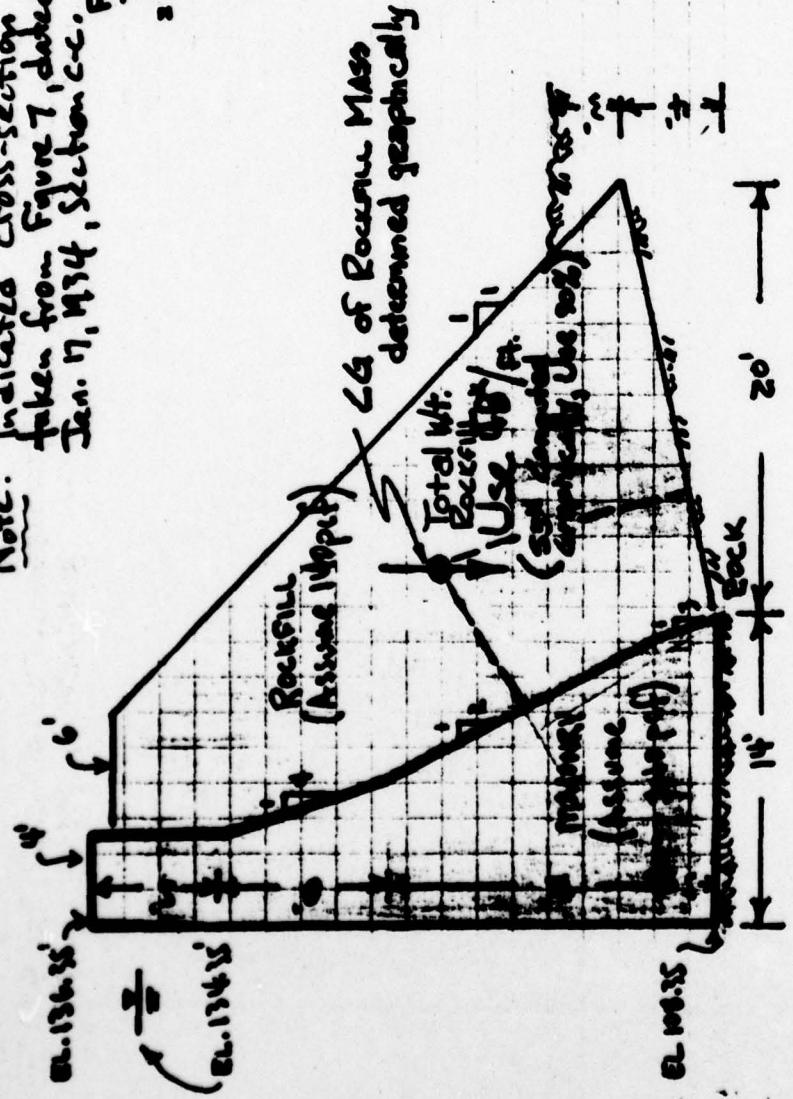
DAM CROSS-SECTION INDICATED FROM COMPOSITE DESIGN DRAWINGS (ORIGINAL DESIGN AND SUBSEQUENT ENLARGEMENT)

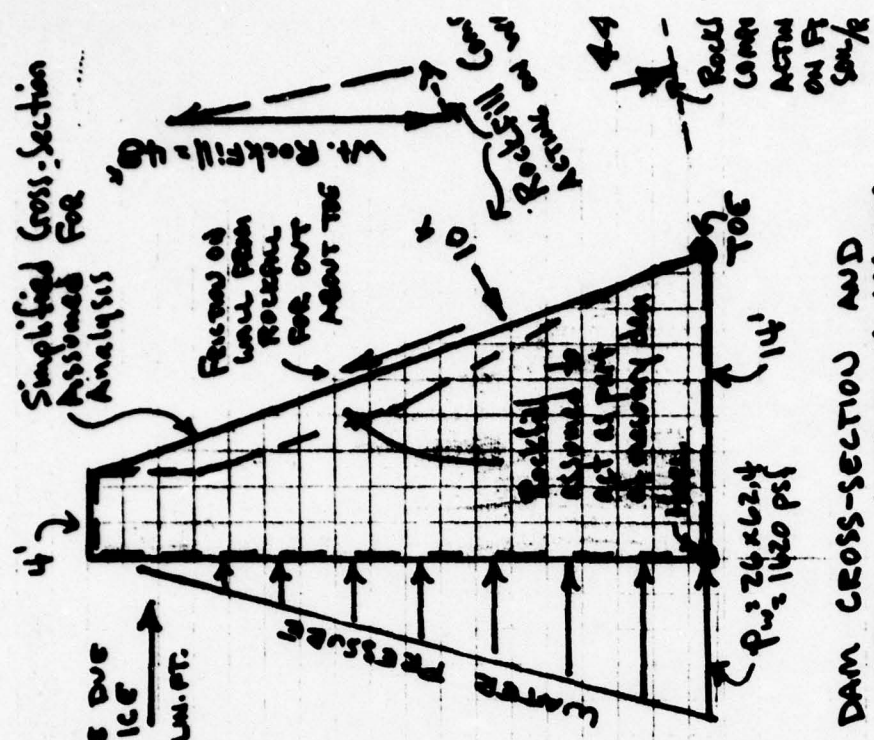
DAM CROSS-SECTION AND LOADING CONDITIONS ASSUMED FOR ANALYSIS TO EVALUATE OVERTURNING ABOUT TOE

- (1) Dam masonry and rockfill have a unit weight of 140 pcf.
- (2) Rockfill behind original masonry dam does not act as an integral part of the dam structure to resist overturning (conservative assumption) but does exert lateral force and friction on the back face of the masonry dam.
- (3) Ice force near reservoir surface is due to ice one-ft. thick subject to temp change of 10°
