BRUSH MOUNTAIN DAM

NDI I.D. NO: 539

PHASE I INSPECTION REPORT  
NATIONAL DAM INSPECTION PROGRAM

JULY 1978

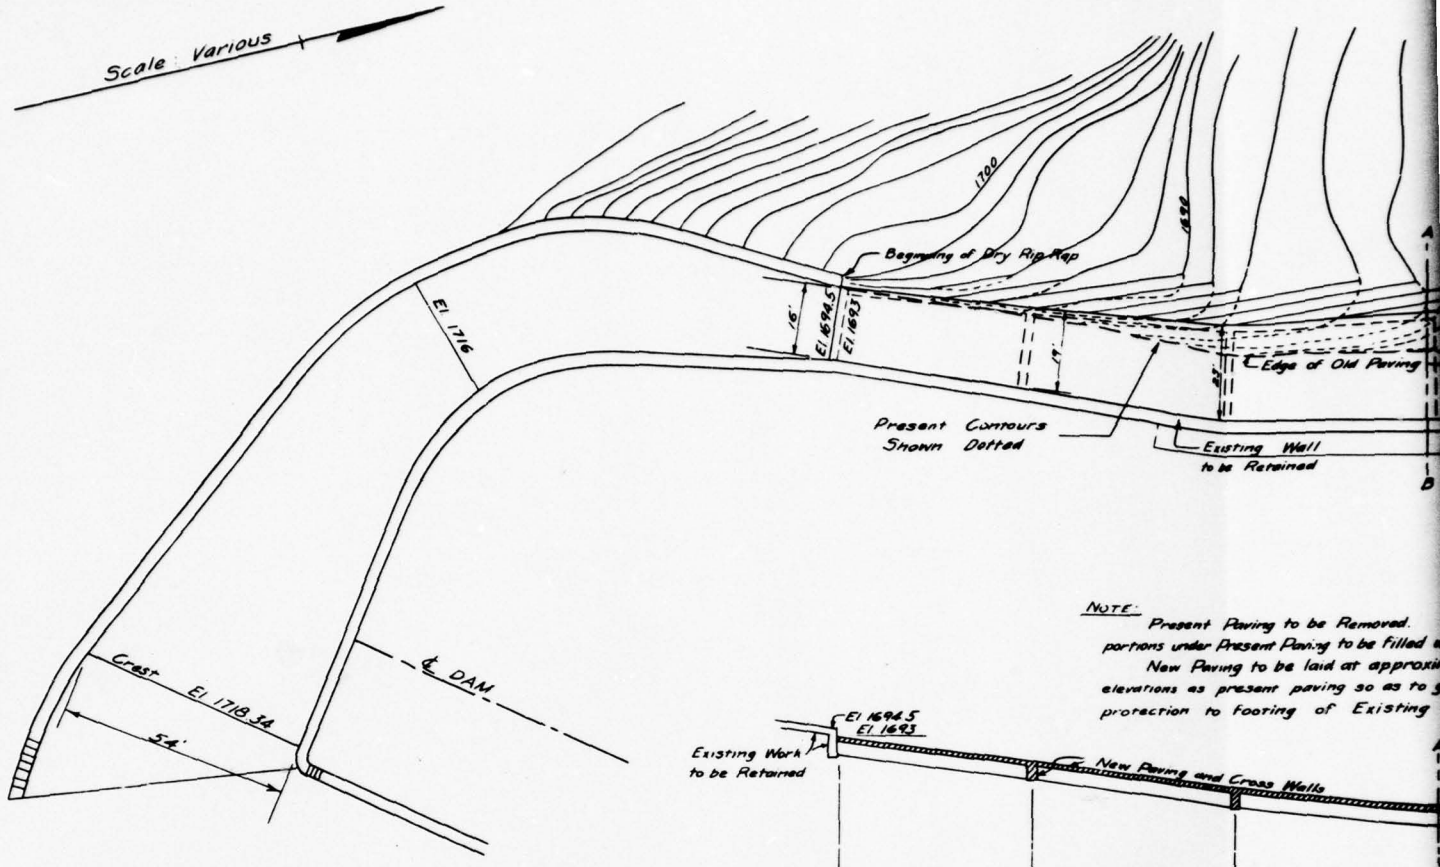
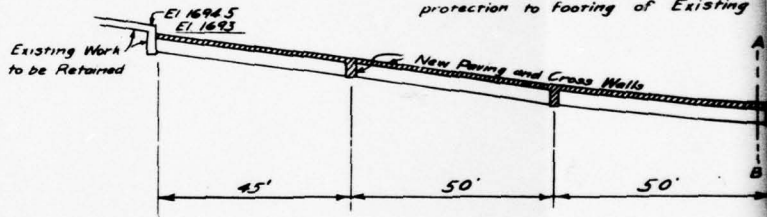
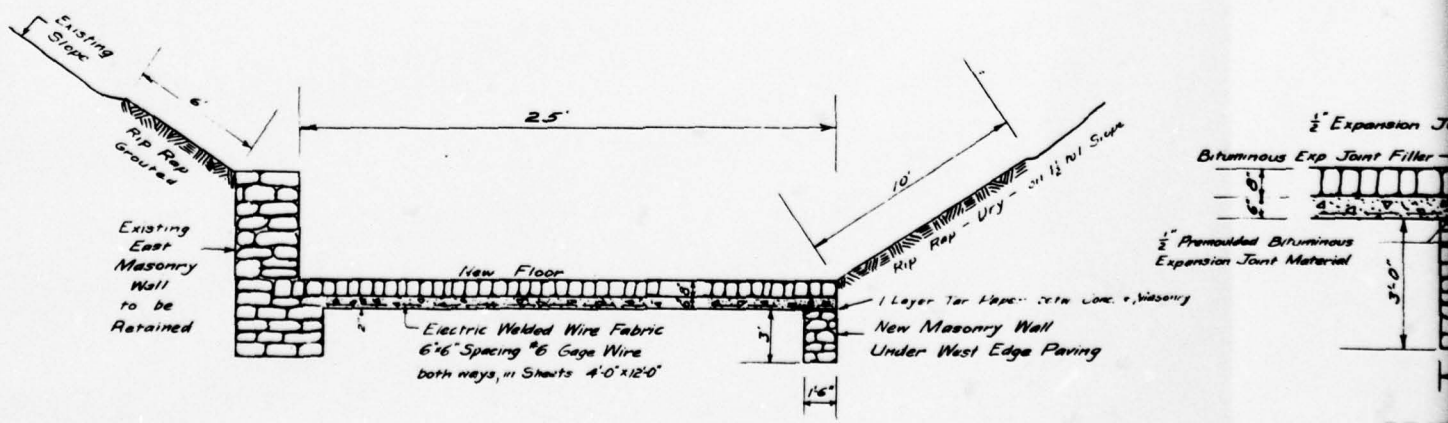
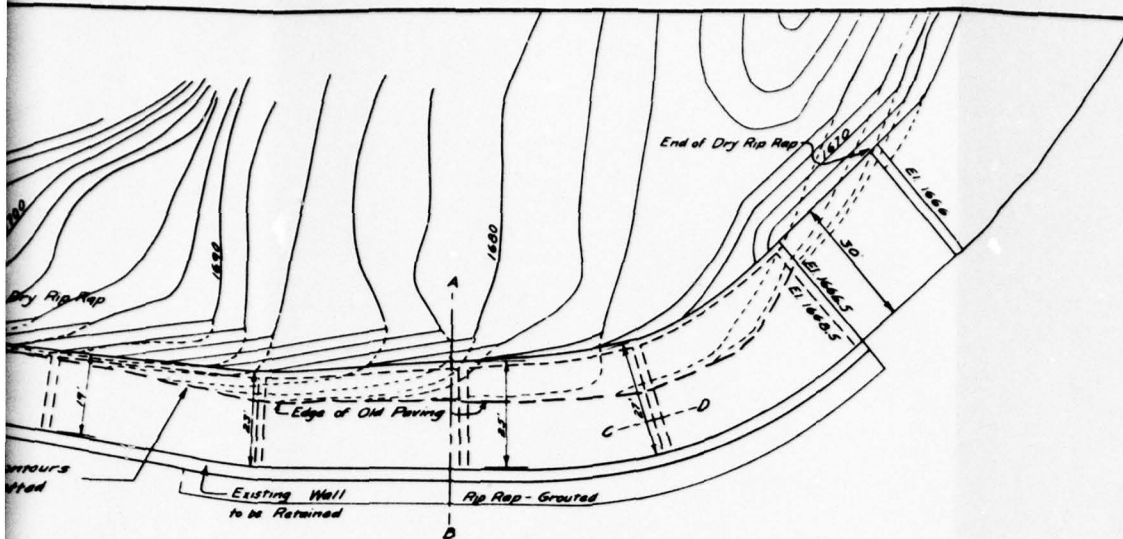
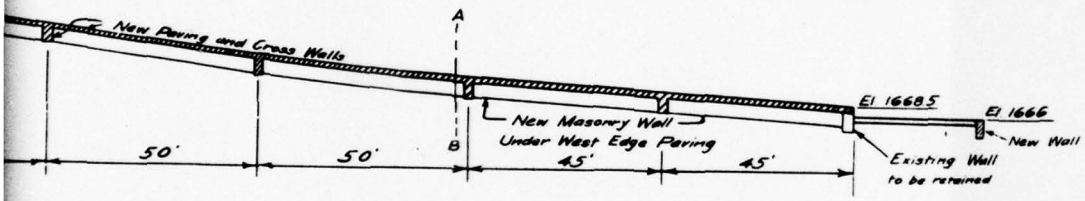
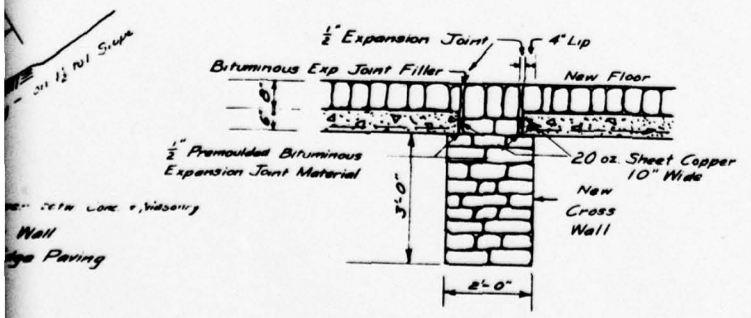
BLAIR GAP WATER SUPPLY CO.  
 BRUSH MT. DAM  
 PROPOSED WASTEWAY CHANNEL  
 SCALE AS INDICATED JF 6-12-36

The spillway structures were examined for deterioration or other signs of distress and obstructions that would limit flow. It was observed that most of the grouted riprap channel floor pavement that was constructed in 1936 in the spillway channel below Elevation 1693 has been eroded away; however, this has not affected the overall performance of the channel. The remaining parts of the spillway are considered to be in good condition.

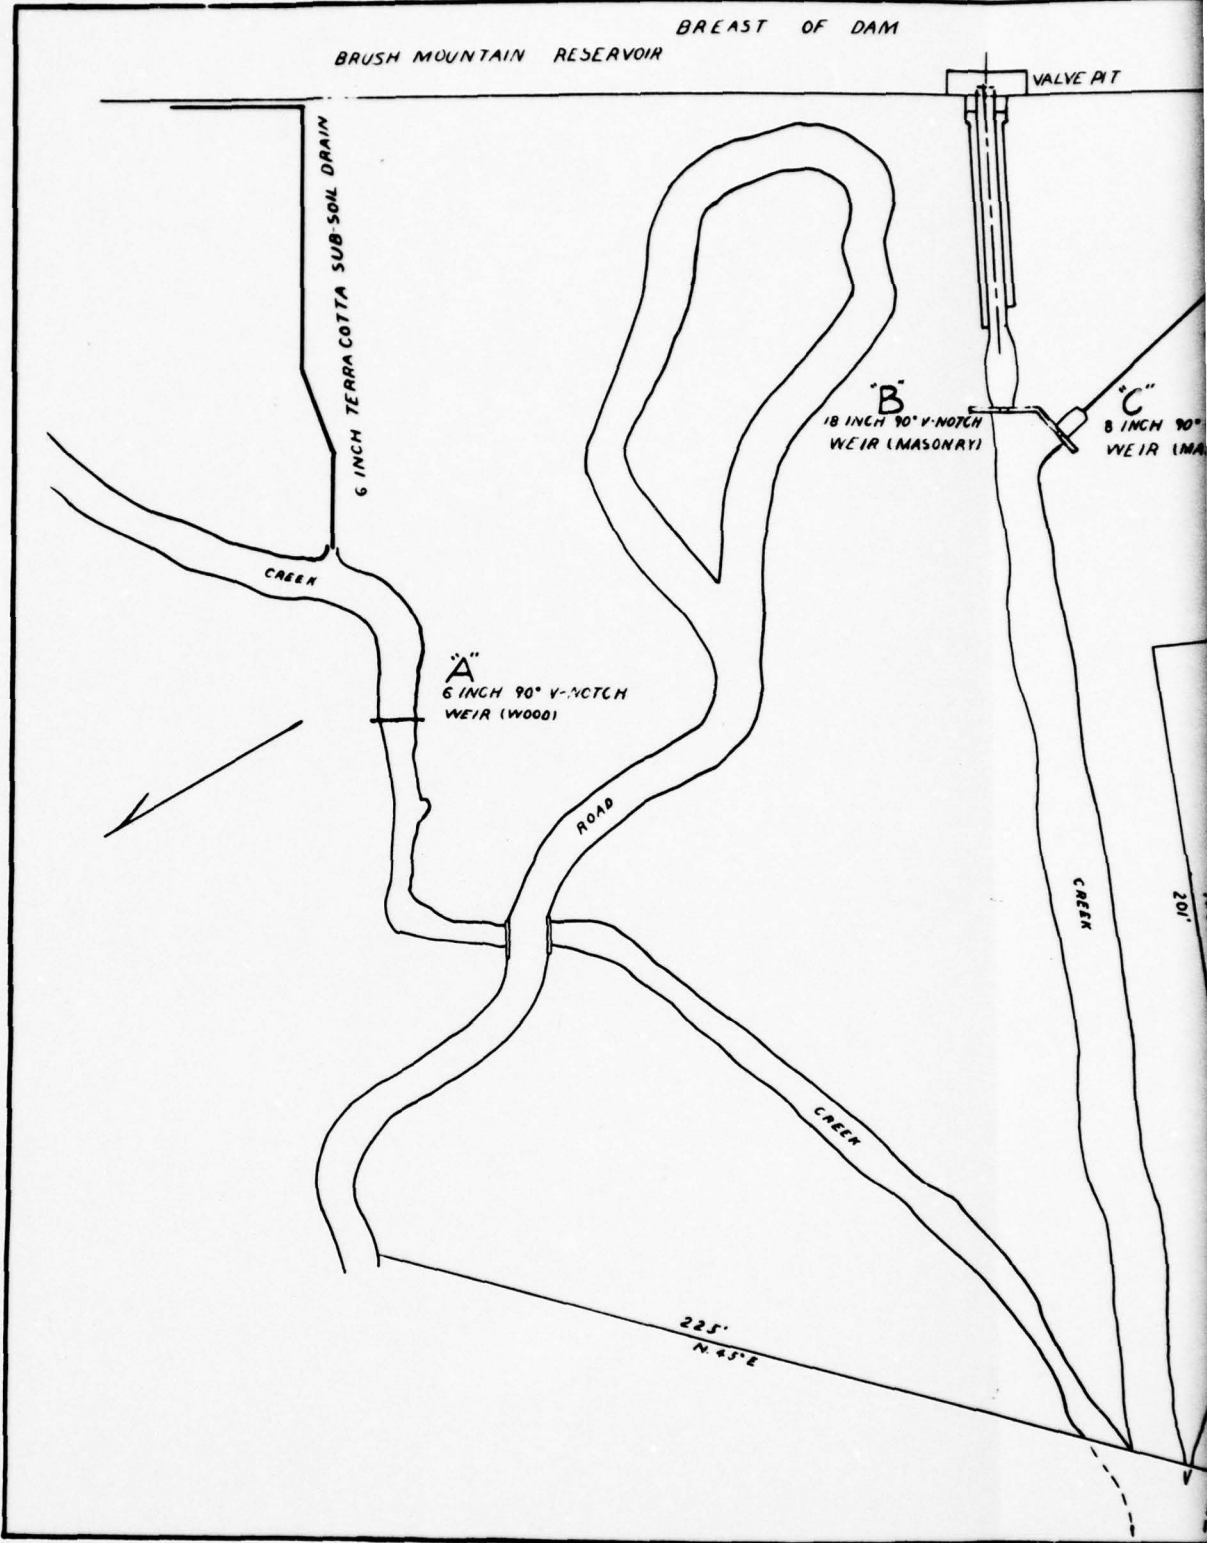
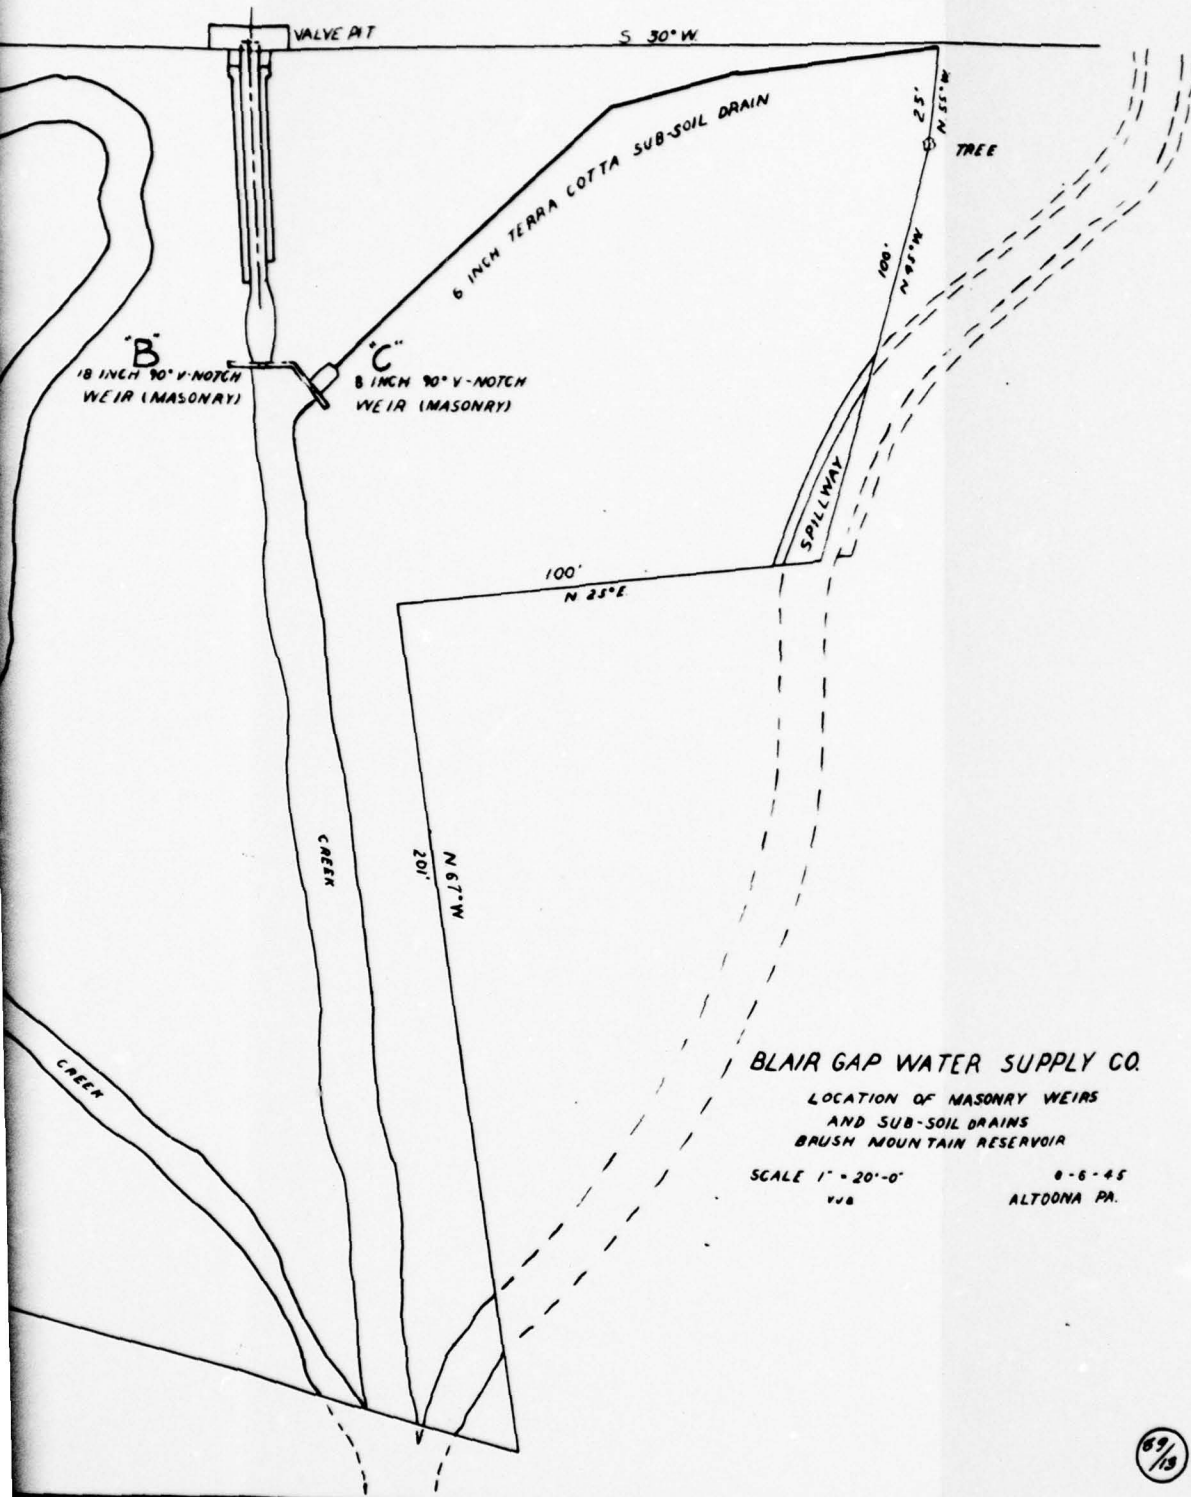
BLAIR GAP WATER SUPPLY CO.  
 LOCATION OF MASONRY WEIRS  
 AND SUB-SOIL DRAINS  
 BRUSH MOUNTAIN RESERVOIR  
 SCALE 1" = 20'-0"  
 WVB

1. All seepage areas observed at the toe of the dam (Plate 6) coincided with the seepage areas that previously existed as implied by the locations of the monitoring weirs (Plate 5). Total seepage flow from the right abutment area was estimated to be 90 gallons per minute (gpm). The seepage on the left side of the outlet works discharge channel was estimated to be 50 gpm. Total flow in the outlet works discharge channel was estimated to be 100 gpm.
2. Minor seepage was observed in the spillway discharge channel and the seepage quantity was estimated to be 5 gpm.
