PEACE VALLEY DAM
BUCKS COUNTY, PENNSYLVANIA
NATIONAL I.D. NO. PA 00790

PHASE I INSPECTION REPORT
NATIONAL DAM INSPECTION PROGRAM.
Peace Valley Dam (ID PA-00790), Delaware
River Basin, North Branch Neshaminy Creek,
Bucks County, Pennsylvania. Phase I
Inspection Report.

WOODWARD-CLYDE CONSULTANTS
5120 Butler Pike
Plymouth Meeting, Pennsylvania 19462

PHASE I INSPECTION REPORT
NATIONAL DAM INSPECTION PROGRAM
PEACE VALLEY DAM
NATIONAL ID # PA 00790
DER ID #9-169

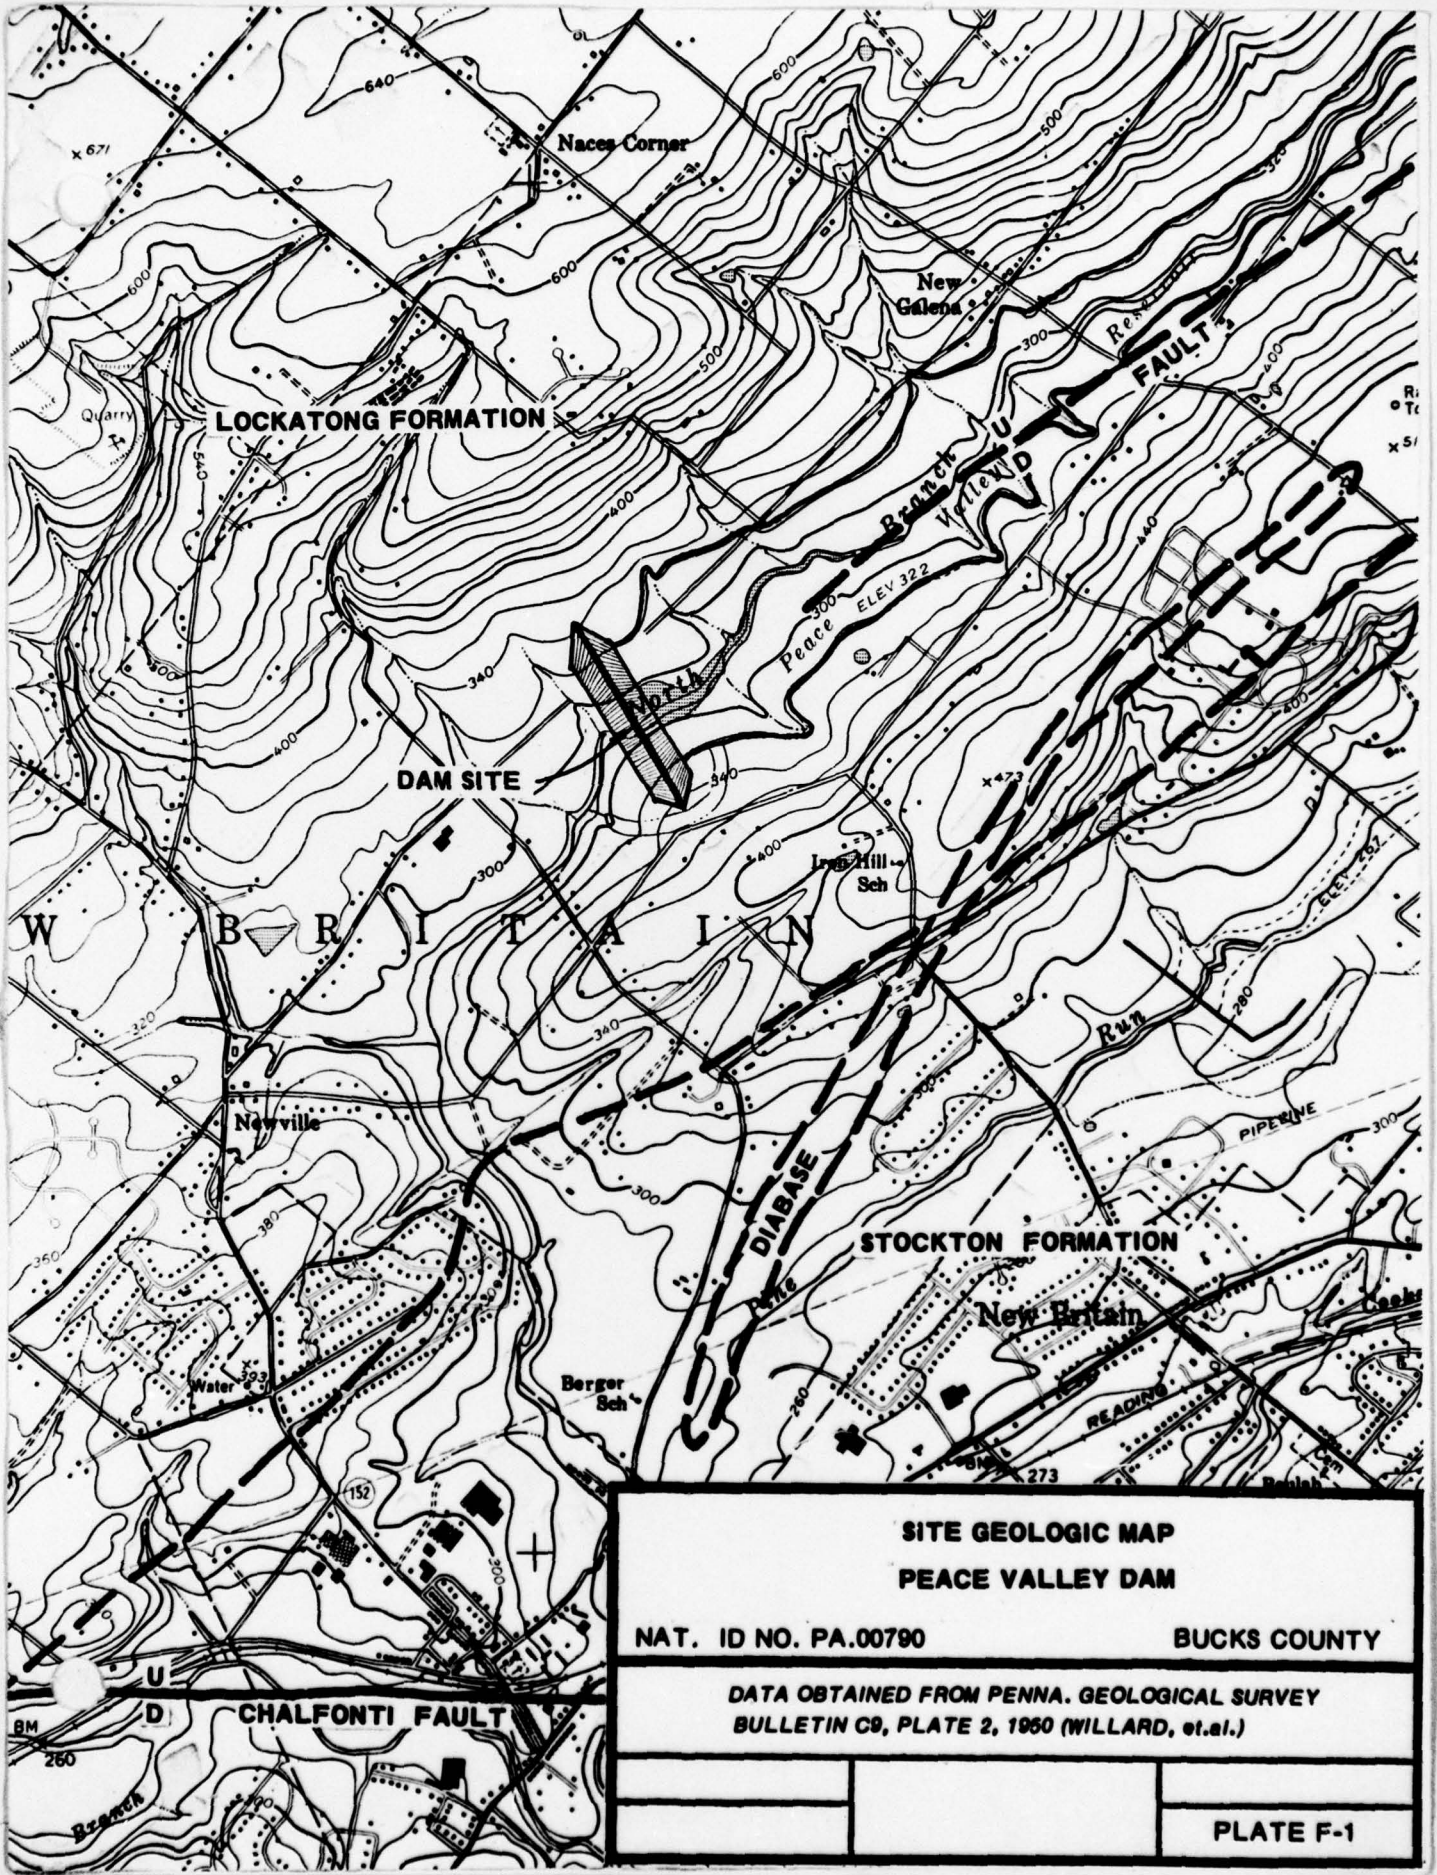
**SITE GEOLOGIC MAP
PEACE VALLEY DAM**

The Danborough fault, an eight mile long normal fault has been mapped (Willard, et. al. 1959), as striking along the axis of the reservoir (perpendicular to the dam). Although, as shown on Plate F-1, the fault has not been mapped under the dam (terminating approximately 2000 feet east of the structure); this mapping does not preclude the possibility that the fault may extend beneath the dam (Willard, et. al., 1959). Although the fault trace is not exposed at the surface, mineralized friction breccias have been noted at several places along its length and may be present along the fault and along the associated joints near the dam.

Downstream seepage could be a potential problem if the fault and fracture system and associated breccias extend beneath the dam, and if the fault and fracture system are zones of groundwater transport.
