SCHUYLKILL RIVER BASIN
INDIAN RUN CREEK, SCHUYLKILL COUNTY

PENNSYLVANIA
ID NO. PA.00696

INDIAN RUN DAM

PHASE I INSPECTION REPORT NATIONAL DAM INSPECTION PROGRAM

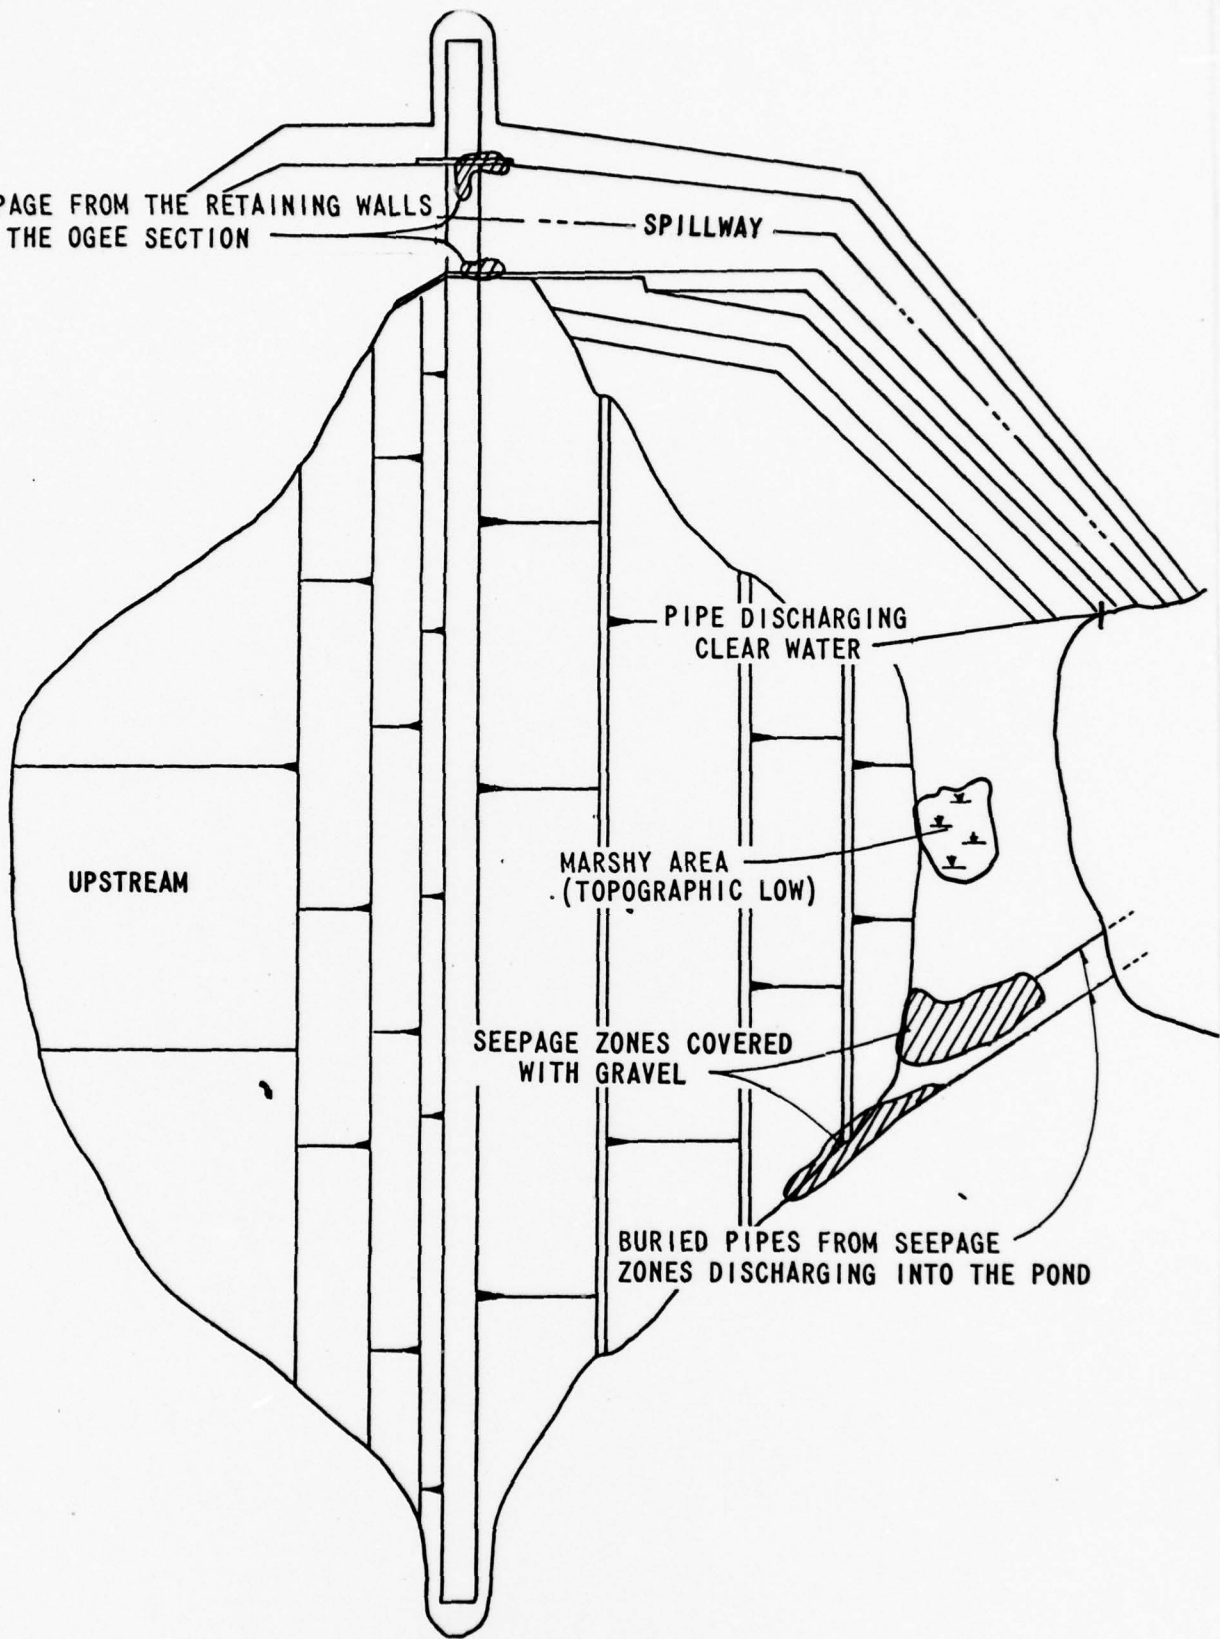
SEEPAGE FROM THE RETAINING WALLS
AND THE OGEE SECTION

SPILLWAY

PIPE DISCHARGING
CLEAR WATER

1. The spalled concrete along the spillway chute and retaining walls should be repaired. All leakage should be sealed.
2. The intake tower should be drained and inspected to evaluate the condition of the tower.
