**STRAIGHT RUN DAM**

**NDI No. Pa. - 283**

**PHASE I INSPECTION REPORT  
NATIONAL DAM INSPECTION PROGRAM**

PHASE I INSPECTION REPORT  
NATIONAL DAM INSPECTION PROGRAM  
STRAIGHT RUN DAM  
NDI# PA-283, PENNDER# 32-76

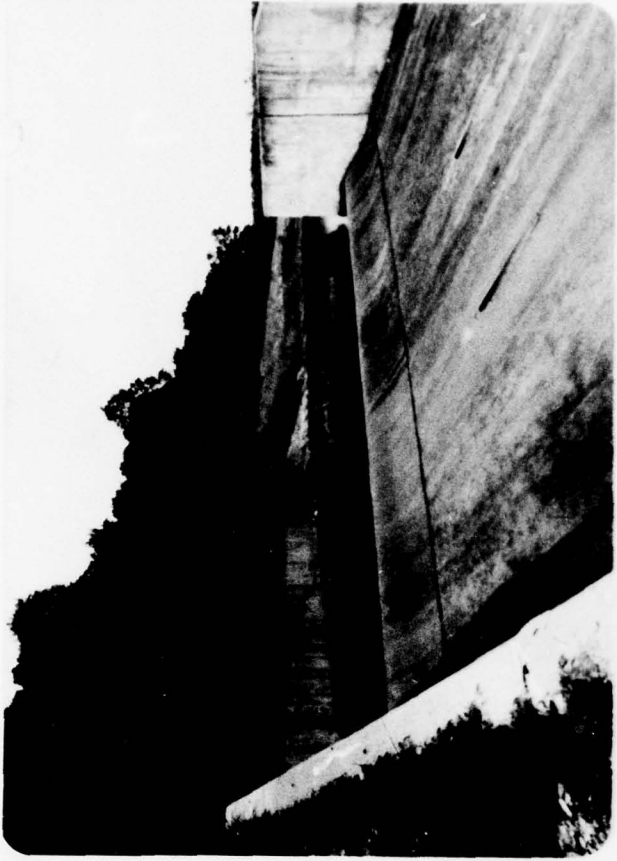
6

1. Emergency Spillway. The emergency spillway is in good condition (see Photographs 6, 7, and 8). Some minor spalling and scaling were located along isolated areas of the spillway wingwalls. Slight vertical movement was noted at several wingwall construction joints but the movement is not considered to be a problem at this time.
