DELAWARE RIVER BASIN
ARIEL CREEK, WAYNE COUNTY

PENNSYLVANIA
ID NO. PA.00166

ROAMING WOODS LAKE DAM

PHASE I INSPECTION REPORT
NATIONAL DAM INSPECTION PROGRAM

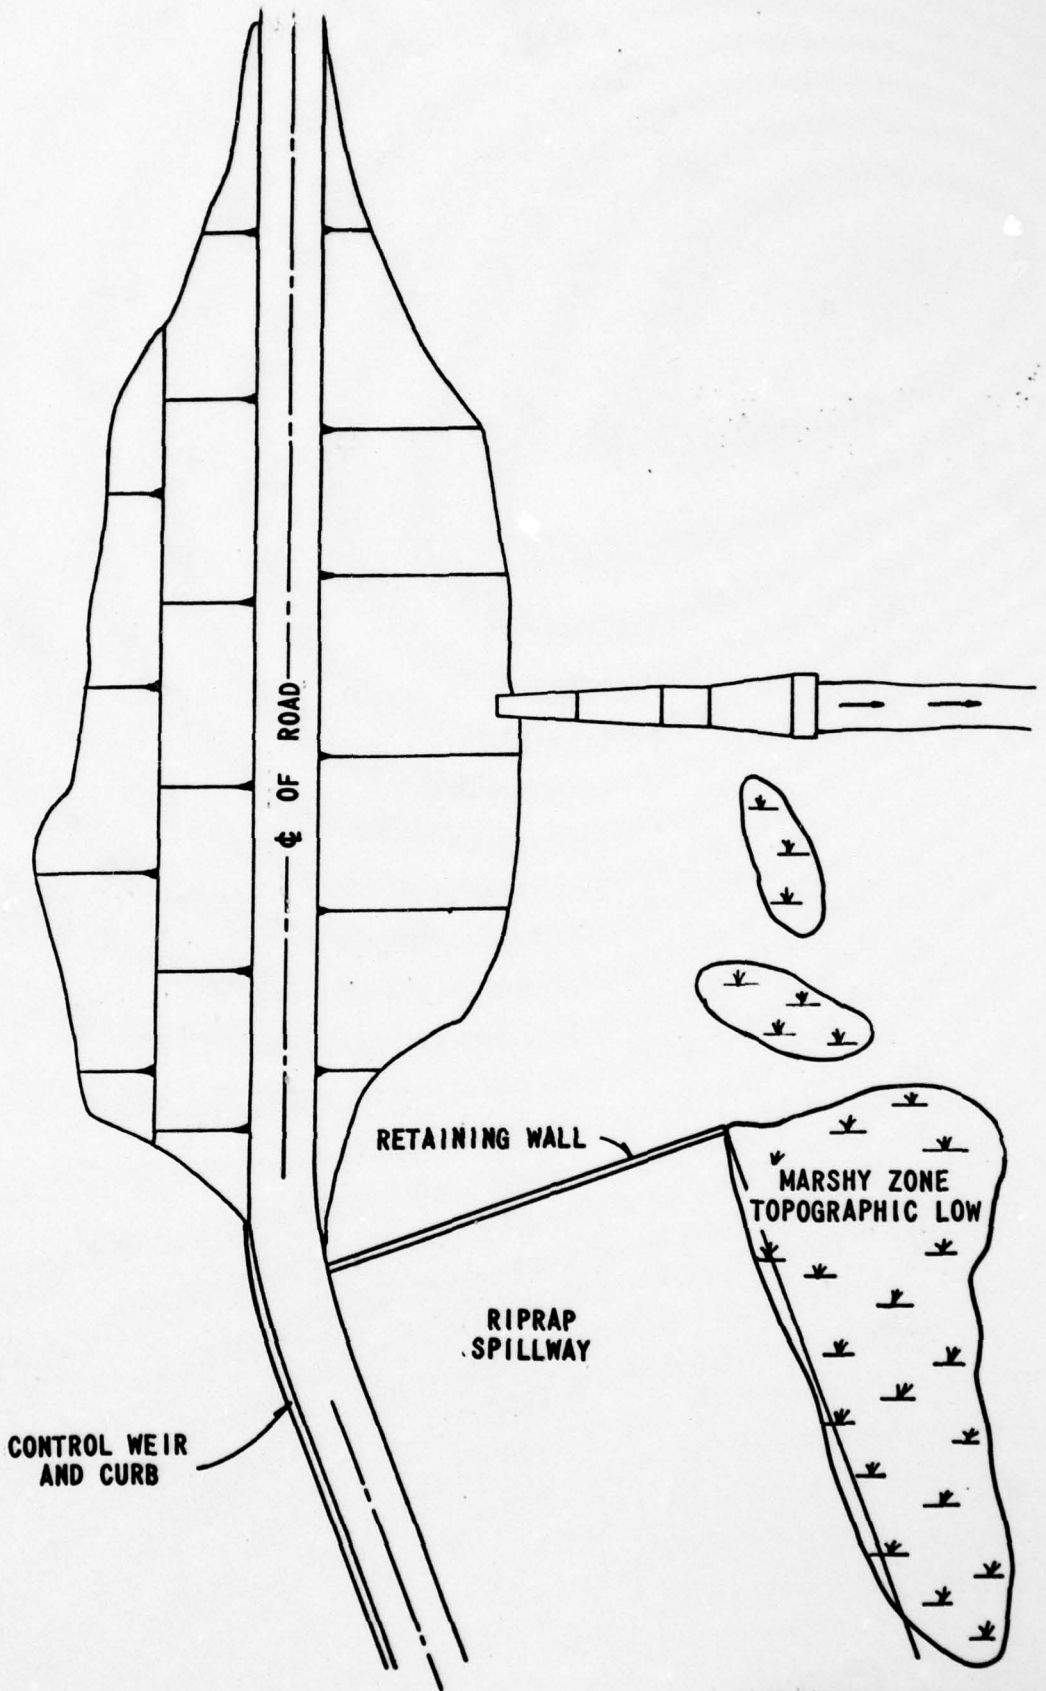
SEEPAGE LOCATION PLAN
ROAMING WOODS LAKE DAM

RIPRAP FAILURES	<i>Riprap along the upstream face appears to have been washed down the slope below the water level due to wave action. The riprap generally appeared to be small, generally less than 12 inches nominal dimension. Also, the riprap did not extend the full height of the embankment and some soil erosion was noted immediately above the riprap. It was also noted that very little riprap existed on the upstream face near the left abutment.</i>
