NDI No. Pa. - 176
PYMATUNING RESERVOIR

PHASE I INSPECTION REPORT
NATIONAL DAM INSPECTION PROGRAM,

⑪ AUGUST 1978

PHASE I REPORT NATIONAL DAM INSPECTION PROGRAM

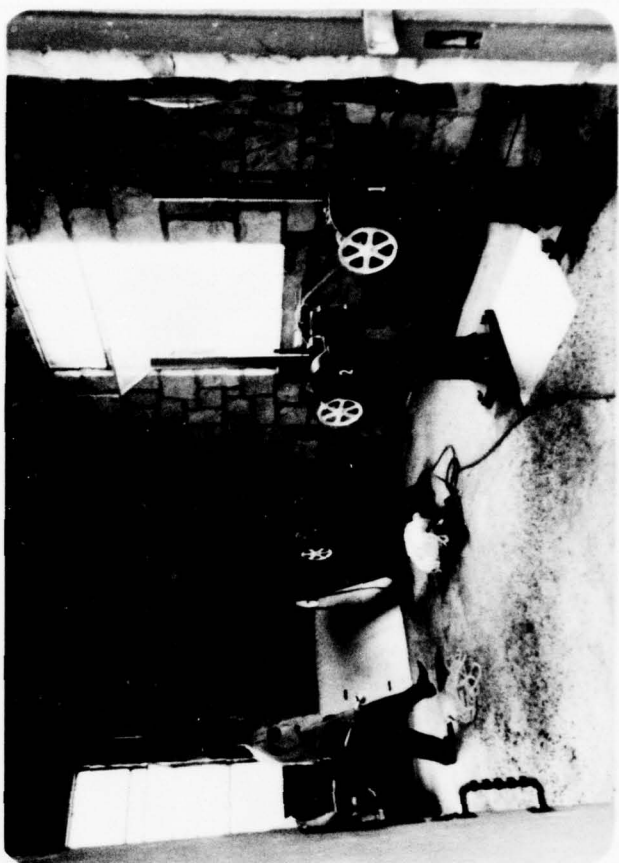
b) Outlet Works. Controlled release from the reservoir is discharged through two 6-foot by 8-foot rectangular concrete conduits. Flow is controlled within the gate house located to the right of dam center (see Photographs 2 and 4) via four sluice gates measuring 2-1/2 feet wide by 4 feet high.
