RILEY RUN DAM  
NDI No. Pa. - 386

PHASE I INSPECTION REPORT  
NATIONAL DAM INSPECTION PROGRAM.

Riley Run Dam (NDI PA-386), Ohio River  
Basin, Riley Run, Elk County,  
Pennsylvania. Phase I Inspection Report.

29 June 1978 (visual inspection)

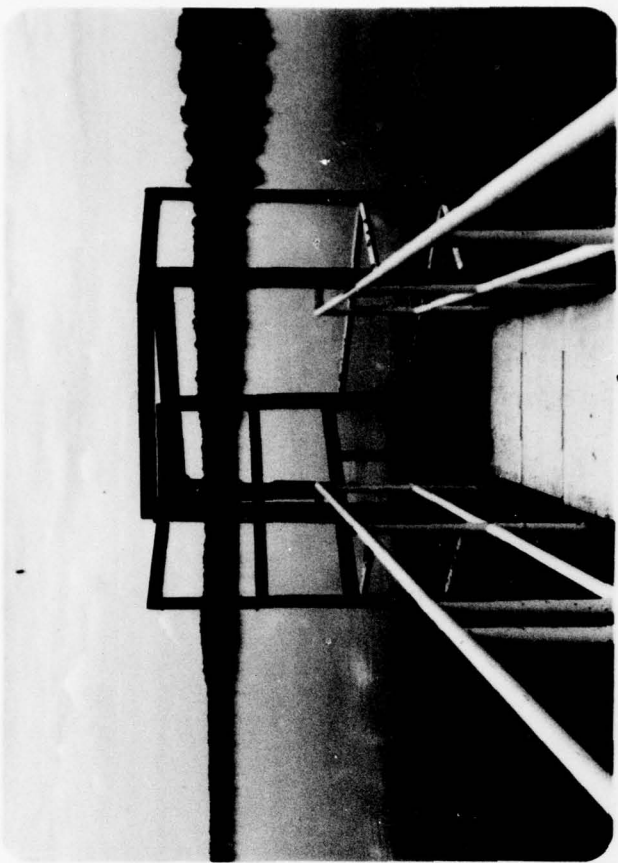
**PHOTOGRAPH 7** Detailed view of the Riley Run outlet showing corrosion of steel grating and deterioration of the concrete surface.
