(6) National Dam Inspection Program
LAKE GORDON DAM, (NDS-242), *(1)*
Potomac River Basin.
COMMONWEALTH OF PENNSYLVANIA

PHASE I INSPECTION REPORT

NATIONAL DAM INSPECTION PROGRAM

by
BERGER ASSOCIATES, INC
CONSULTING ENGINEERS
HARRISBURG, PA.

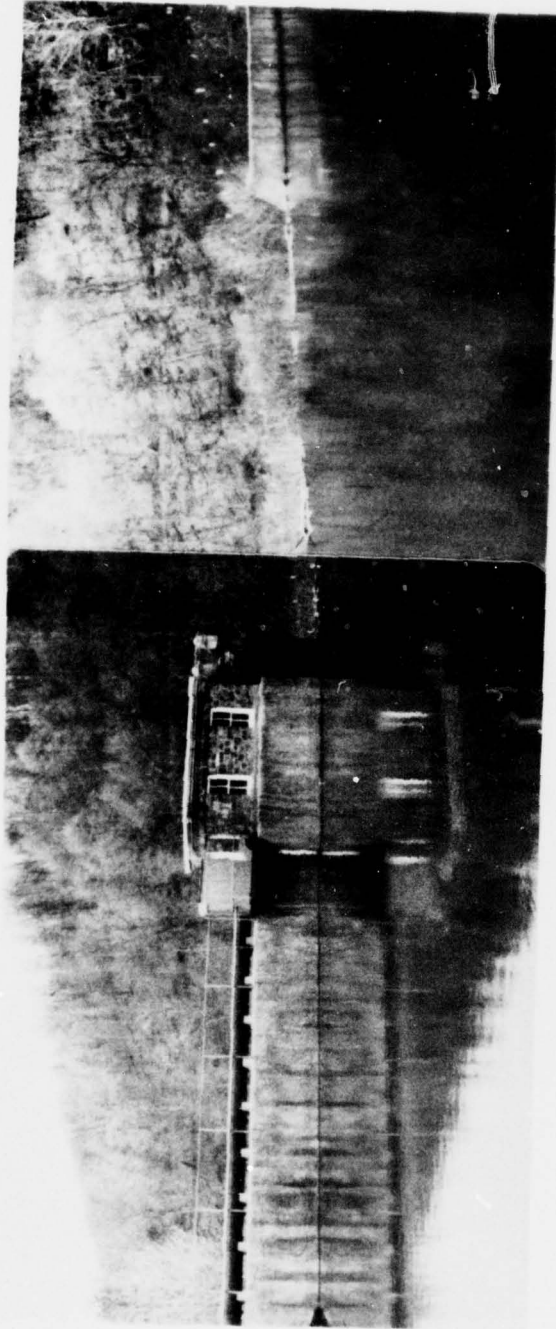
Upstream Face of Dam

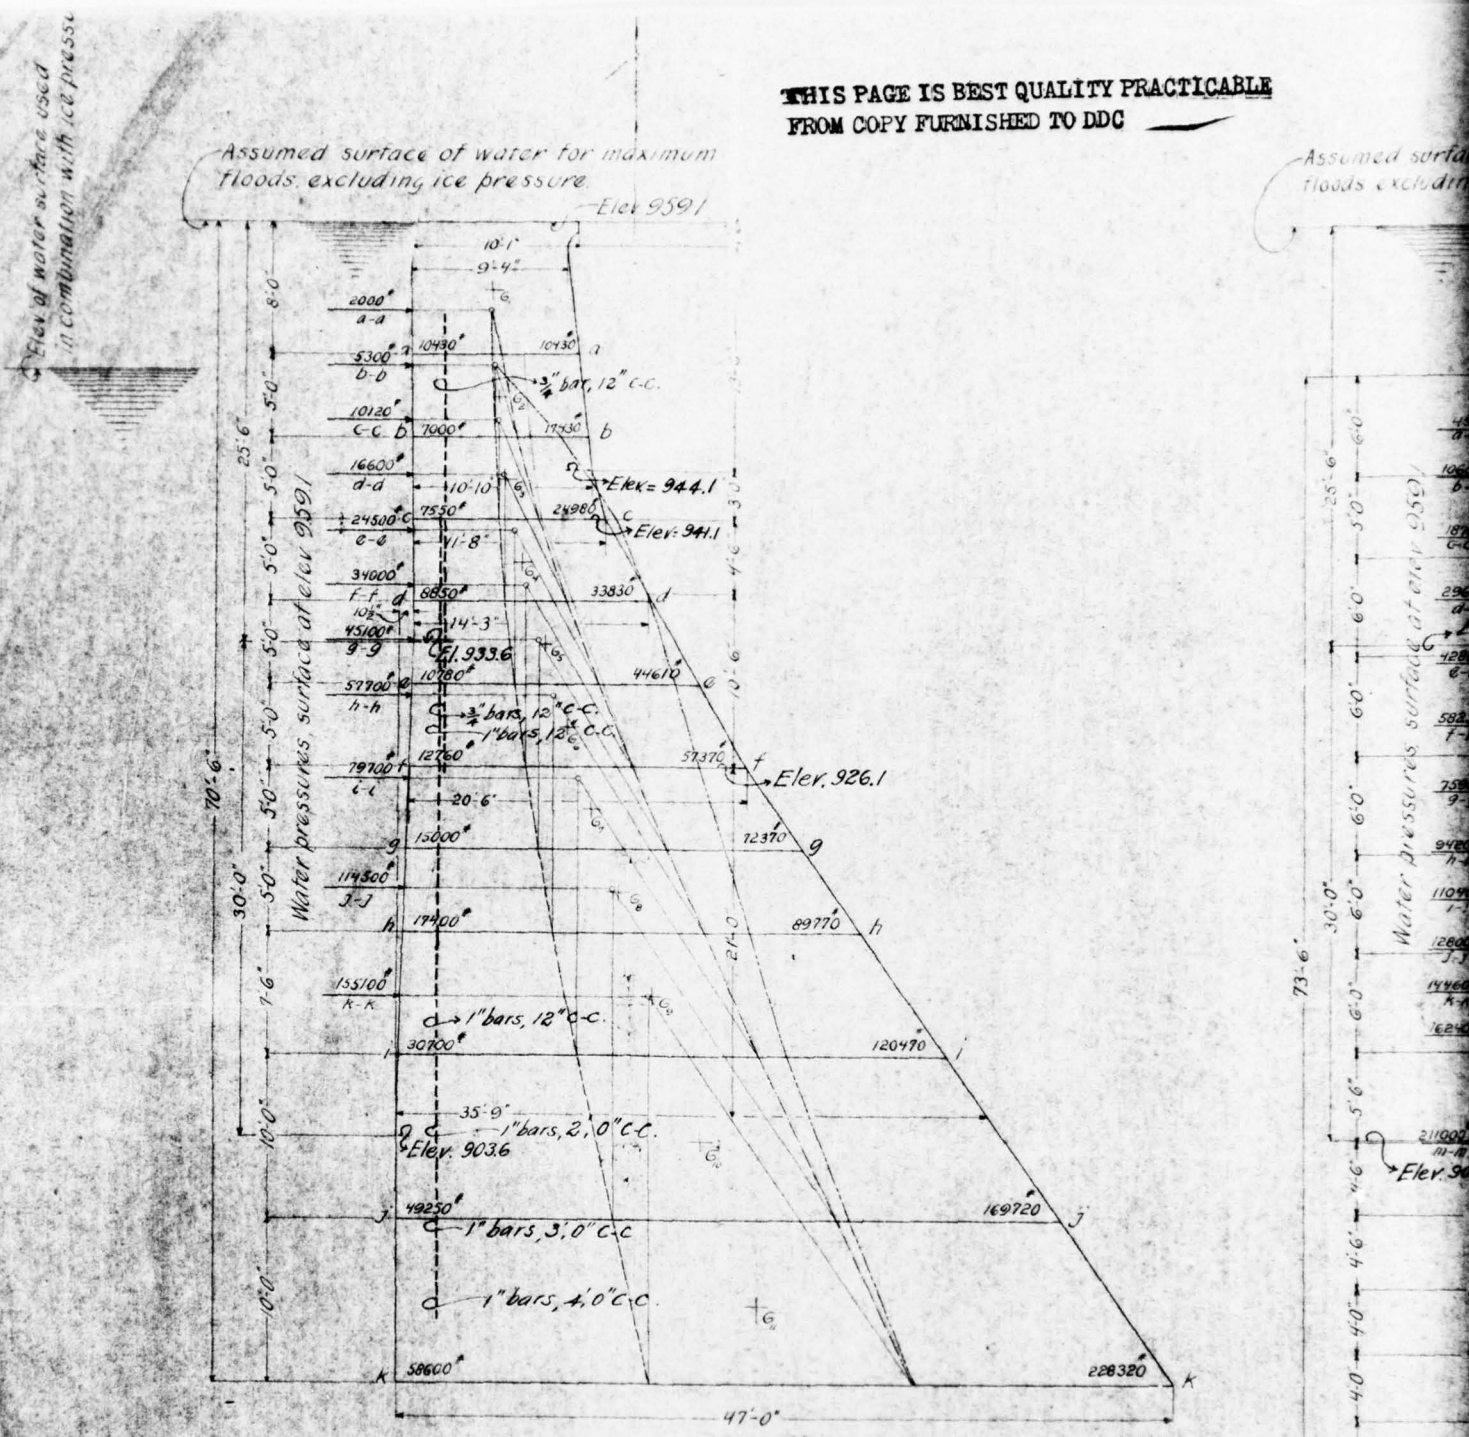
SECTION ON LINE A-A, SHEET 7-a.

The design drawings indicate the general construction information and the design assumptions. A maximum toe pressure of 4.84 tons per square foot is indicated. The location of the dam was based on a geological investigation and moved slightly southward from the original location due to the existence of a weak foundation strata.

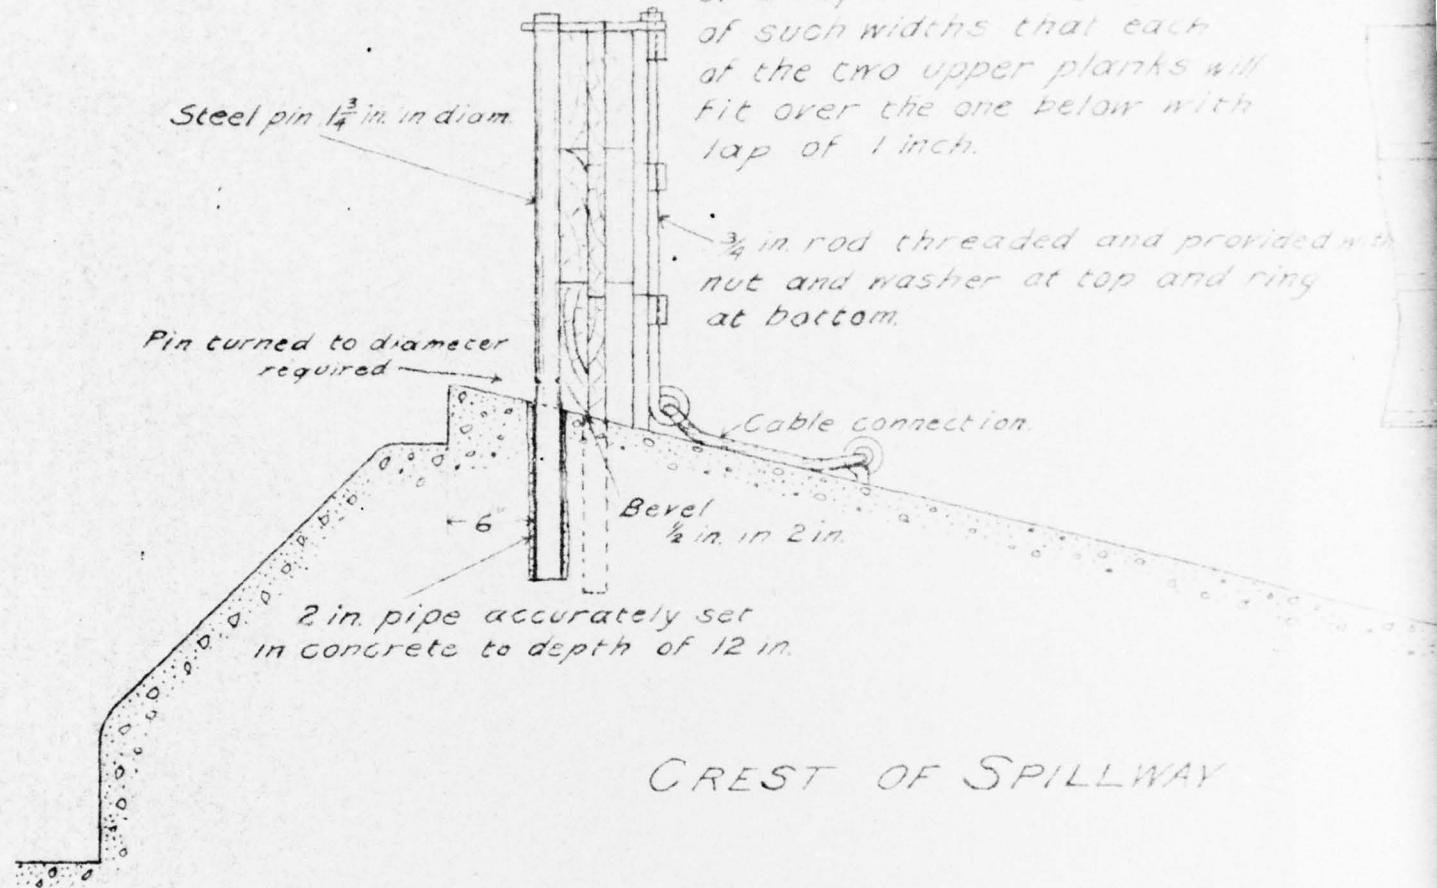
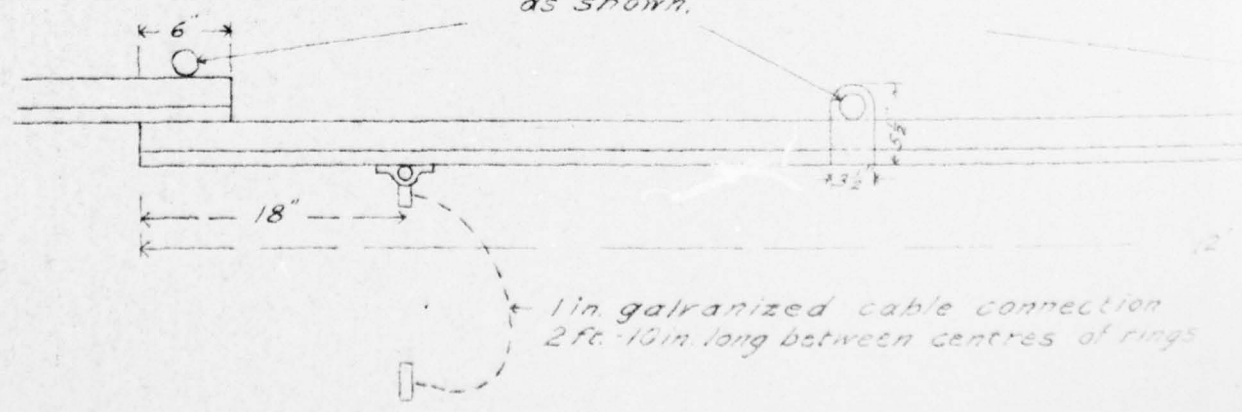
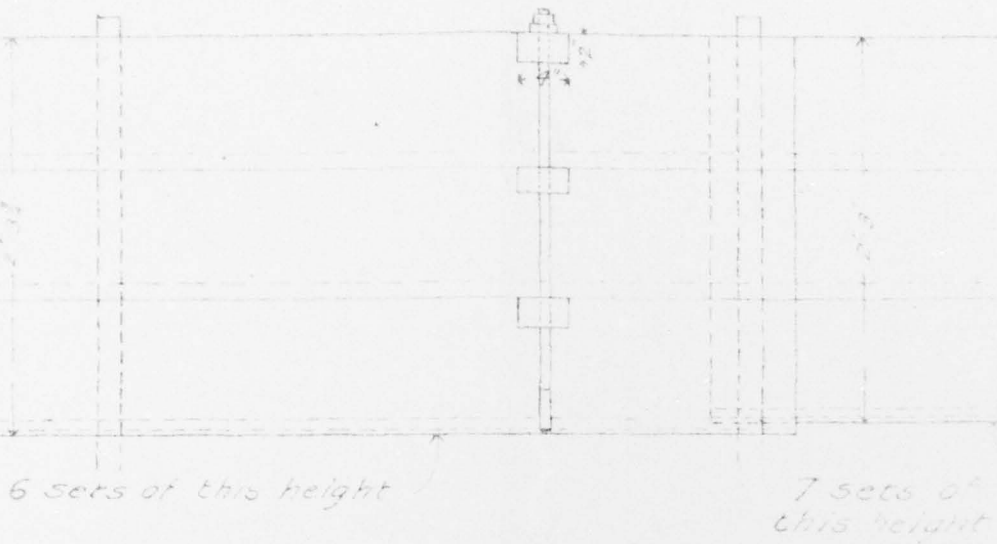
PLATE XI

In 1927, approval was given for the installation of a 24 inch high flashboard, which was supposed to break if the water were to rise to 18 inches above the flashboards. Time of actual installation is not known. The flashboards caused a considerable increase in leakage at the abutments and as a result they were removed in 1977.

The two foot high flashboards have been removed, although the pins and a 3-inch x 8-inch boards remain. These items are to be removed this summer. According to the superintendent, the flashboards had considerably increased the leakage at the abutments. Due to the amount of flow over the spillway, the condition of the spillway could not be observed, but it appeared to be reasonably good. Many exposed rock ledges on the downstream side of the dam indicated a varying degree of weathering and showed exposed open seams discharging water.

1. The flashboard base and pins should be removed immediately.
2. Additional studies should be performed to ascertain the methods of enlarging the spillway capacity, including all necessary studies to ascertain the structural capacity of the dam under maximum conditions. These studies should include but not be limited to hydrologic and hydraulic analysis, foundation investigation, erosion control in case of overtopping, foundation condition embankment studies.
3. Studies and repair work should be implemented to control leakage.
4. The 48 inch blowoff should be made operable for emergencies.
