SUSQUEHANNA RIVER BASIN
GARDNER CREEK, LUZERNE COUNTY

GARDNER CREEK DAM
NDS ID NO. PA-00575
DER ID NO. 40-1

PENNSYLVANIA GAS AND WATER COMPANY
PHASE I INSPECTION REPORT
NATIONAL DAM INSPECTION PROGRAM

JUNE 1978

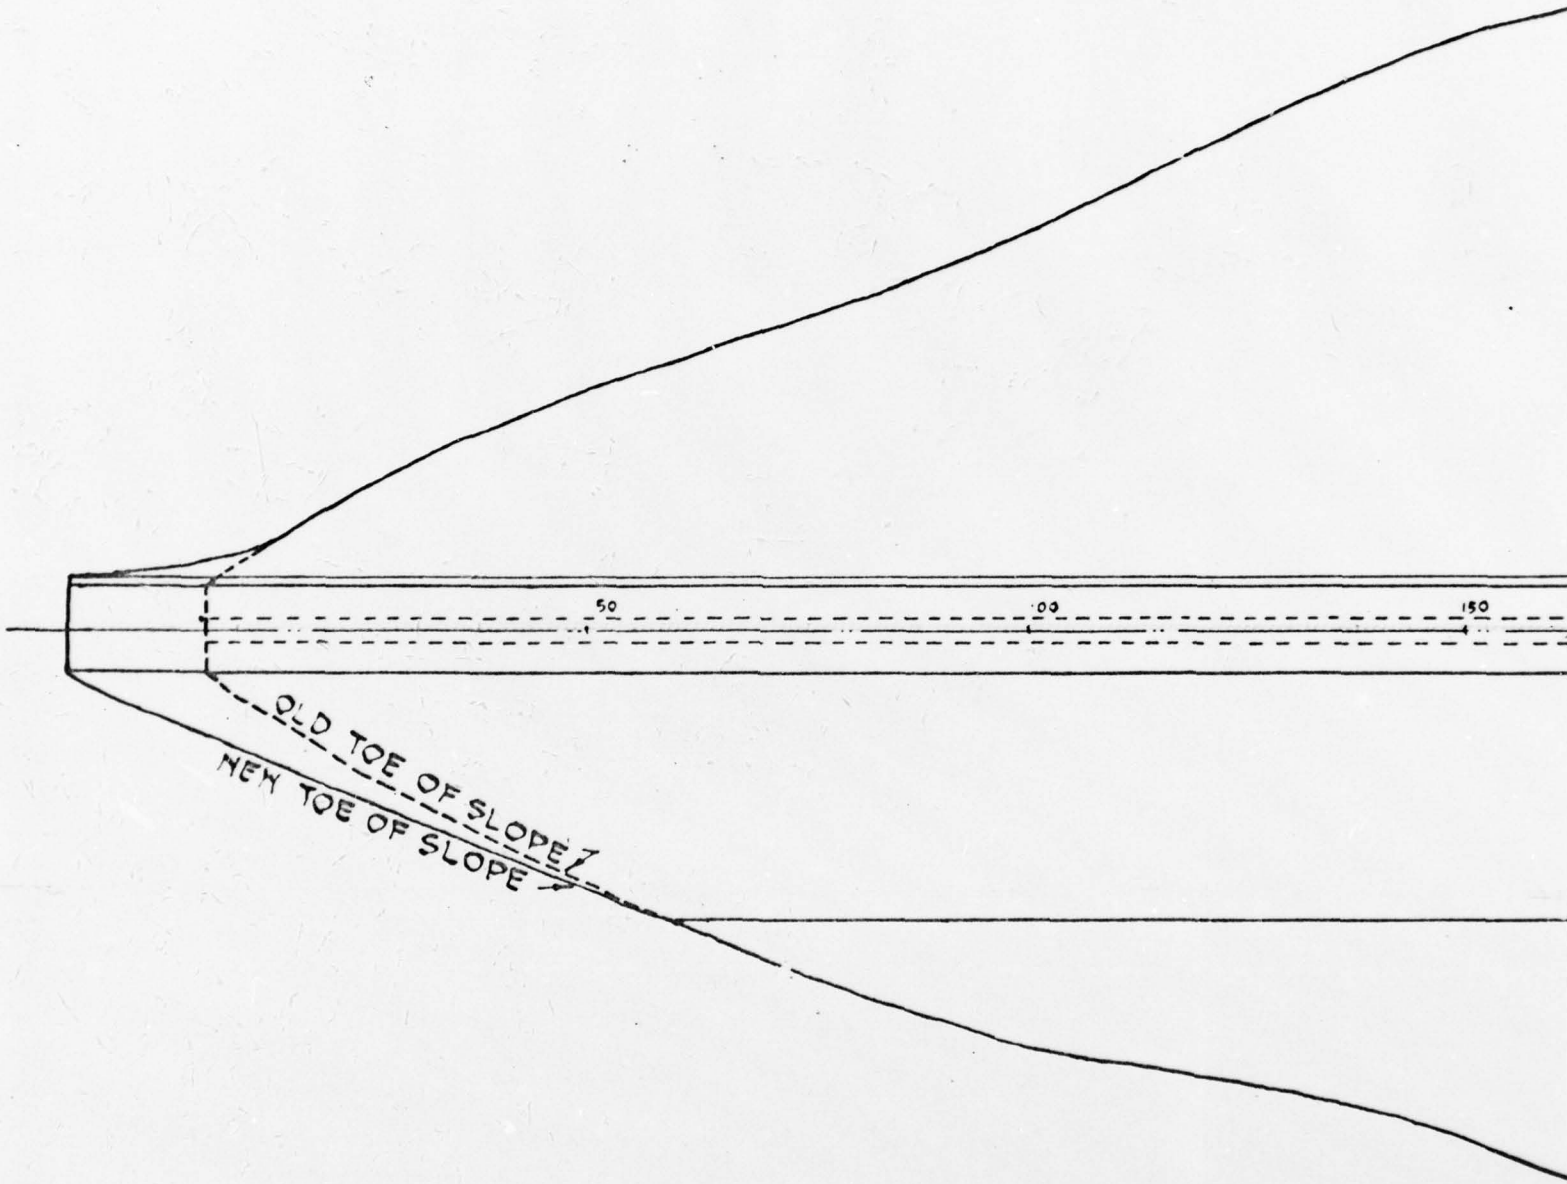
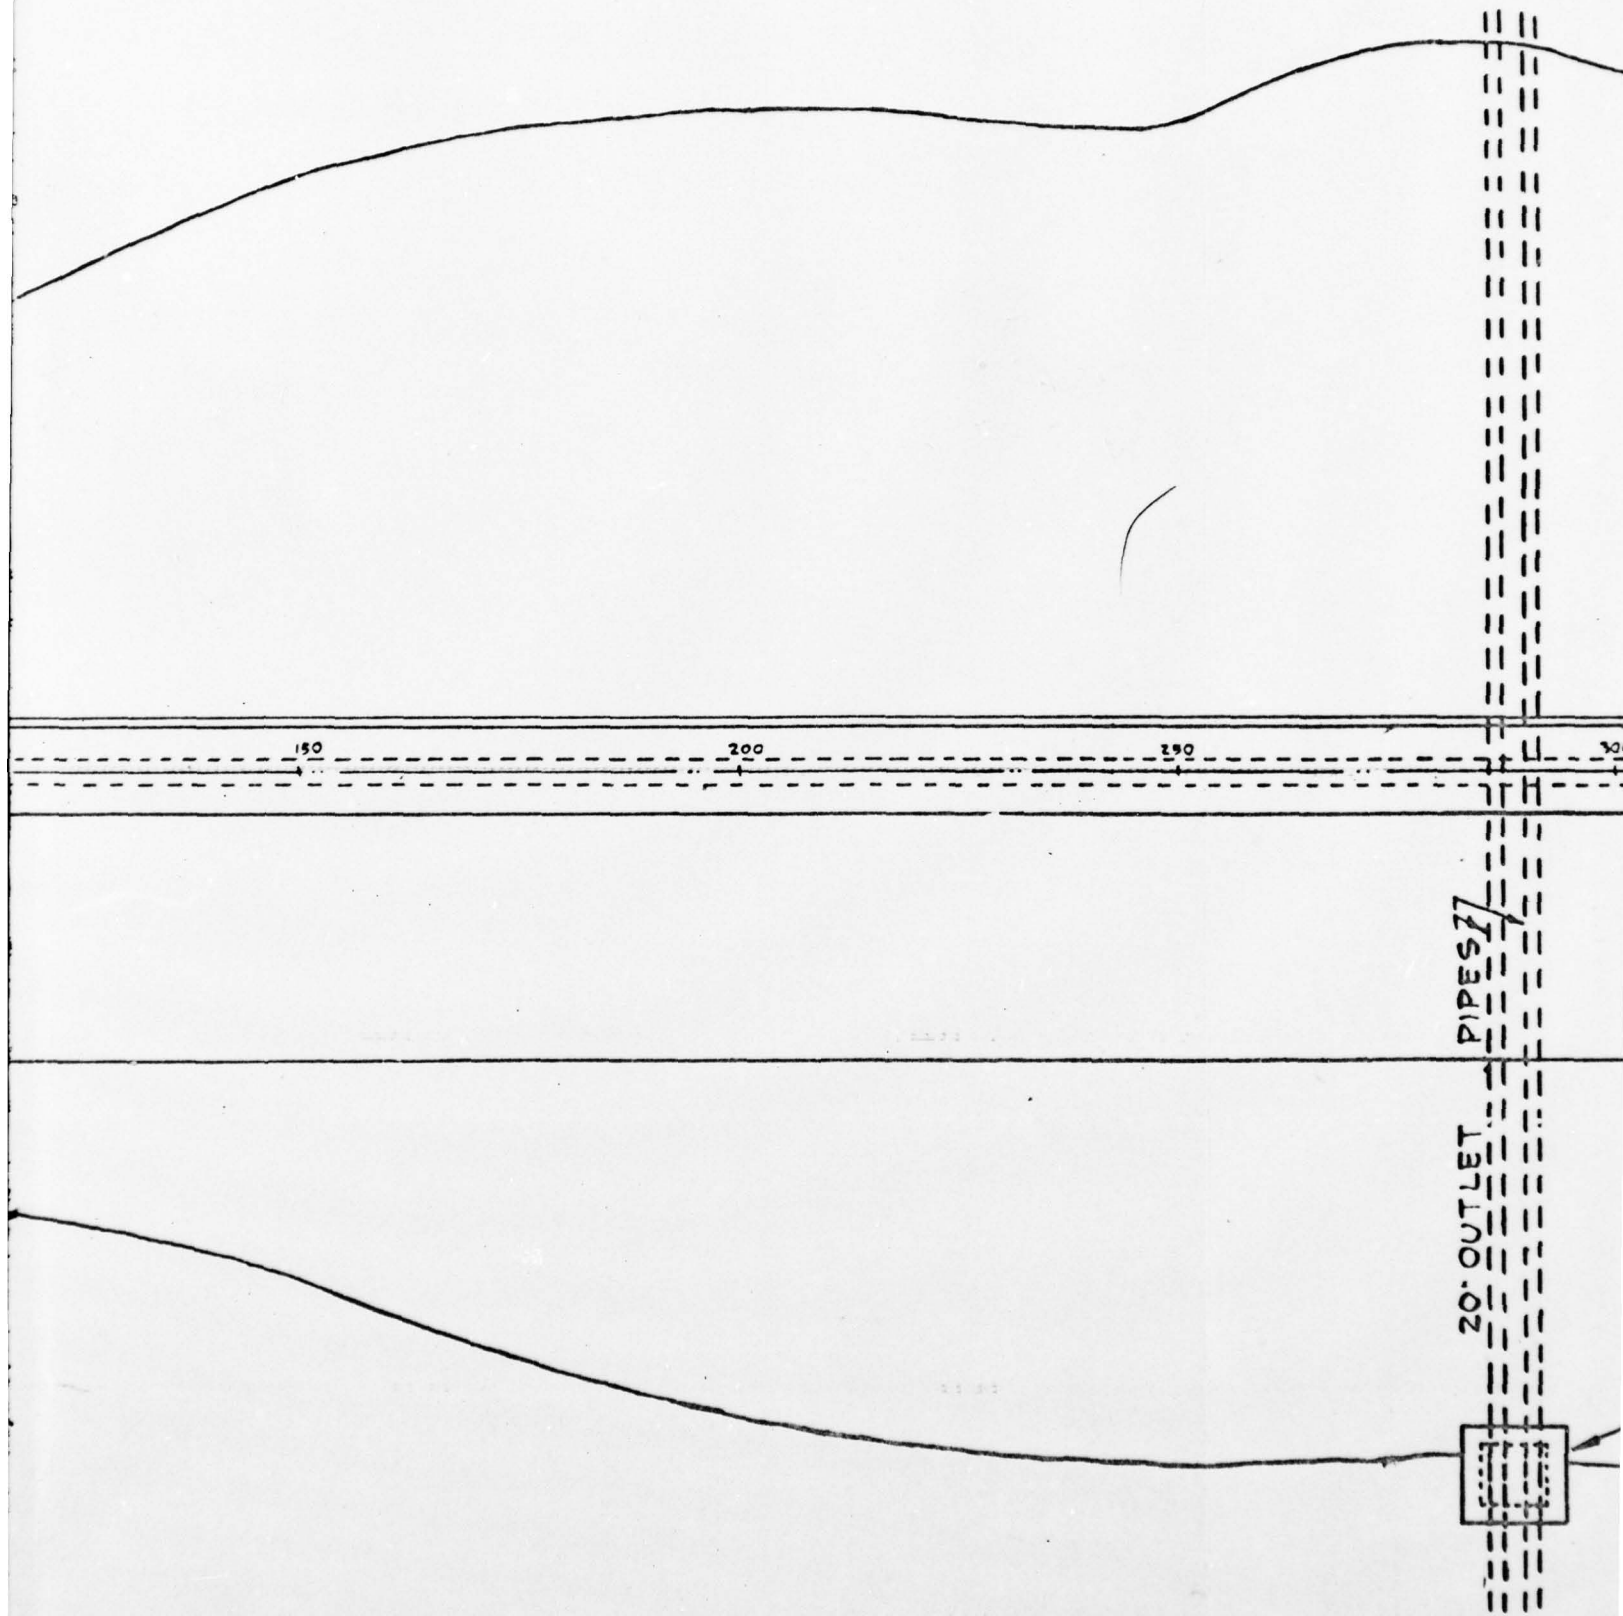
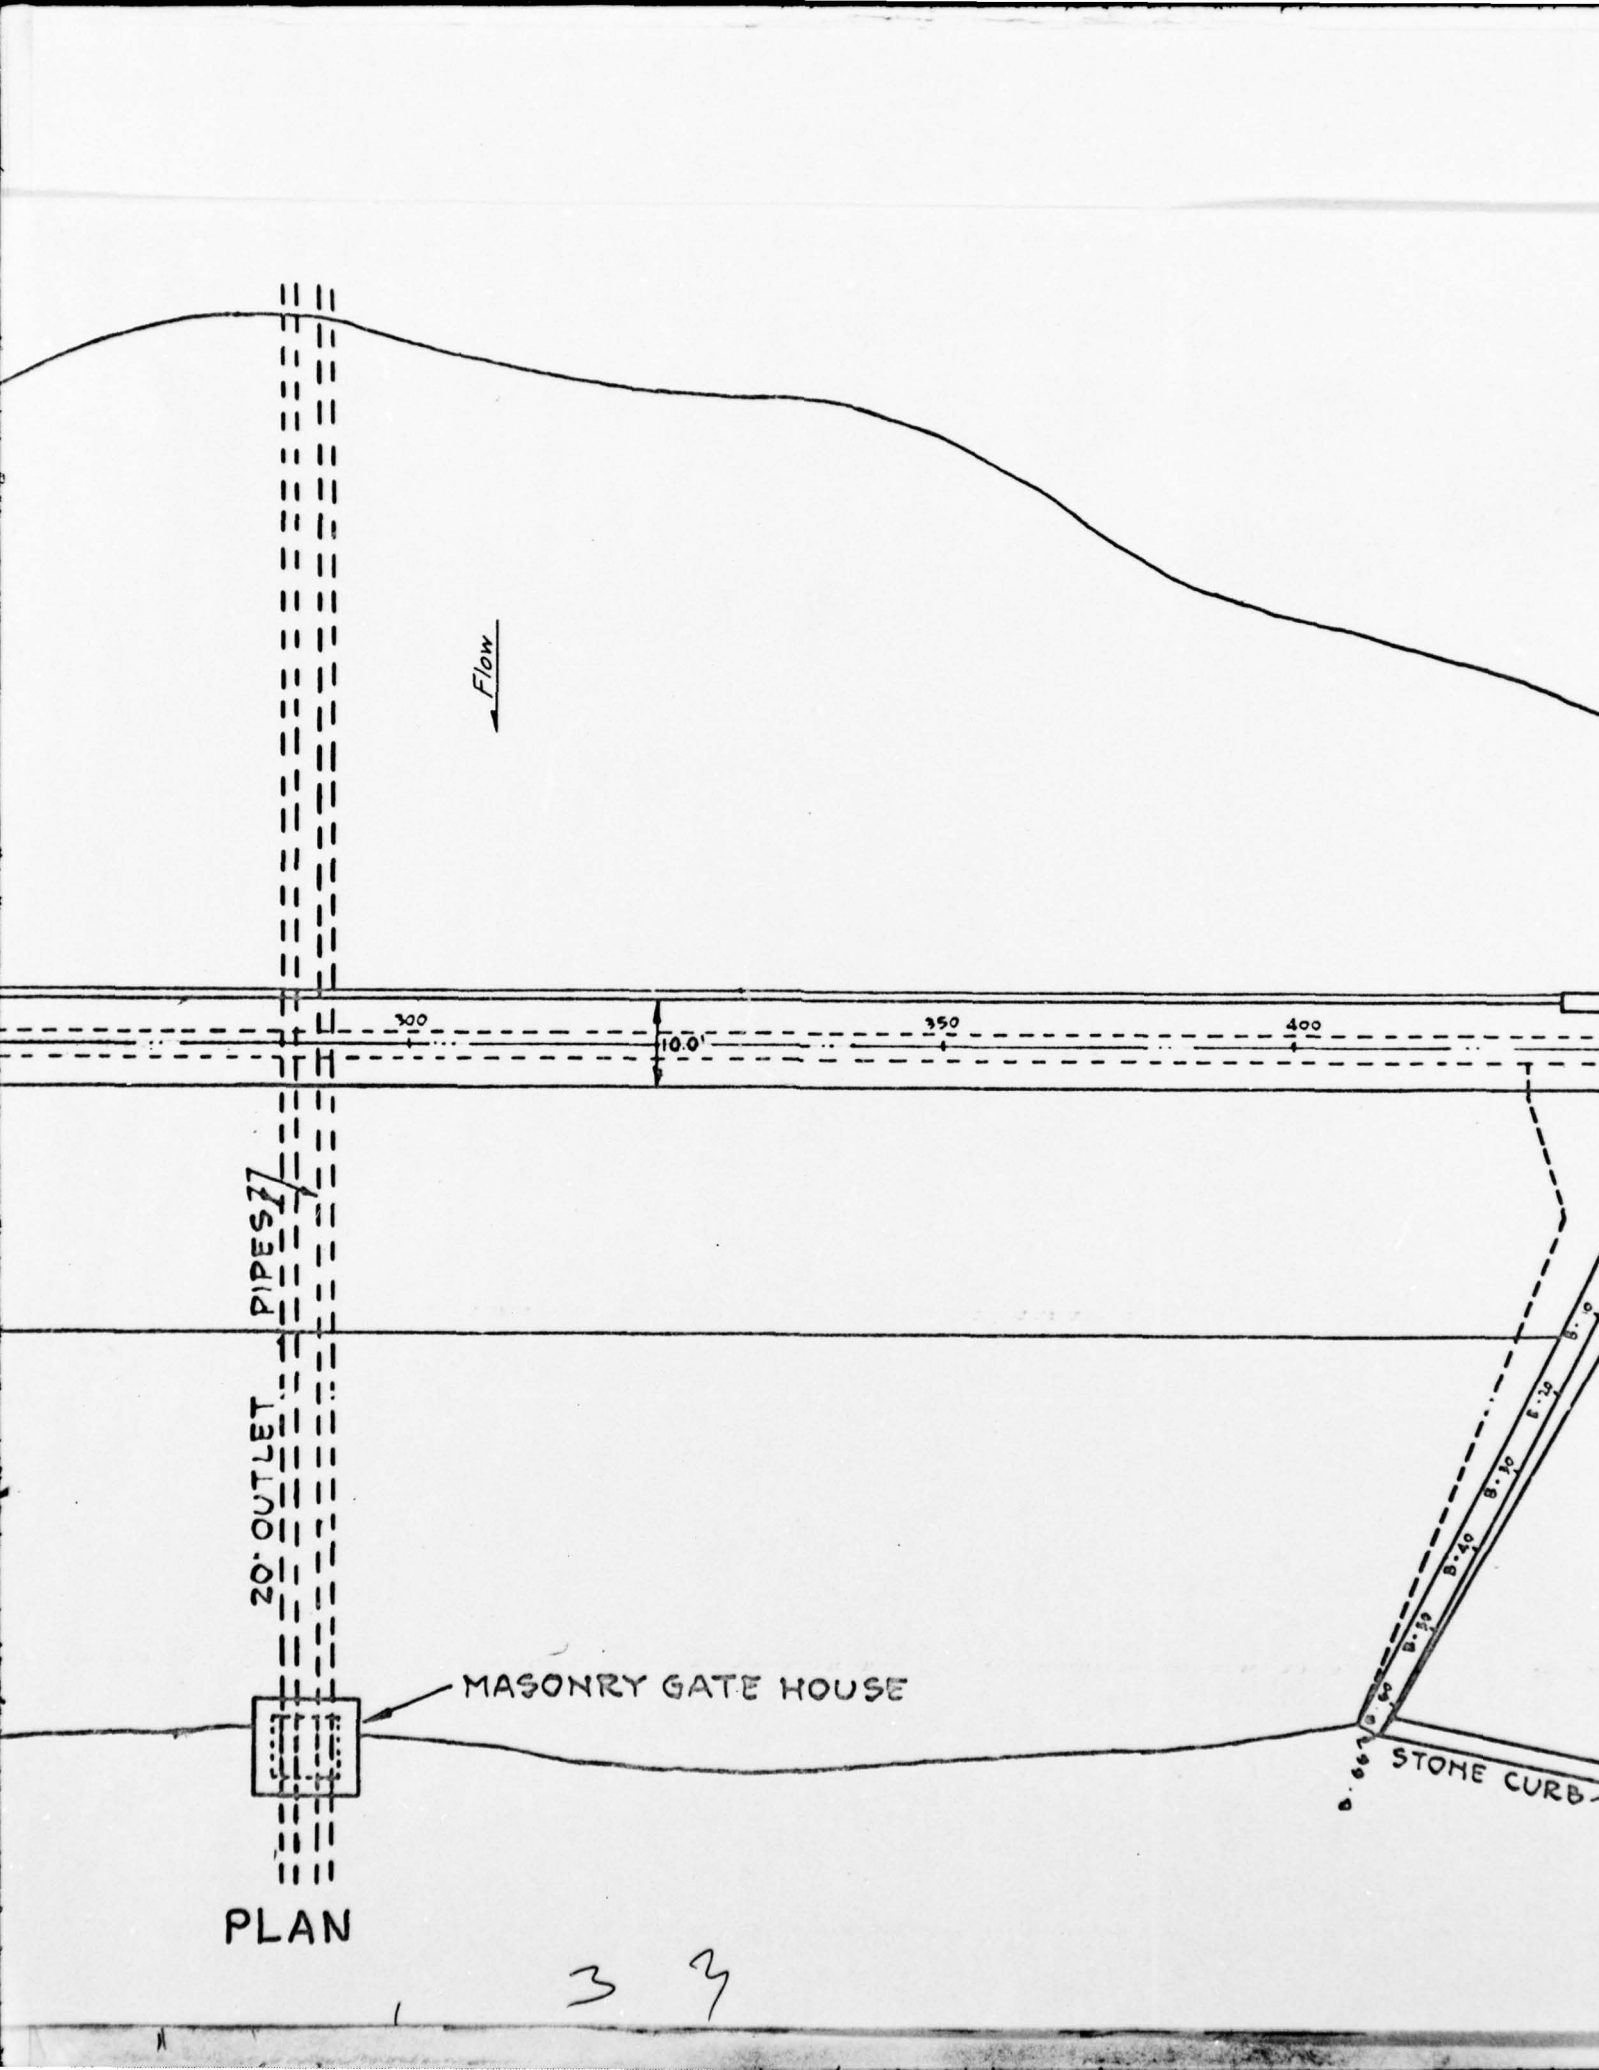
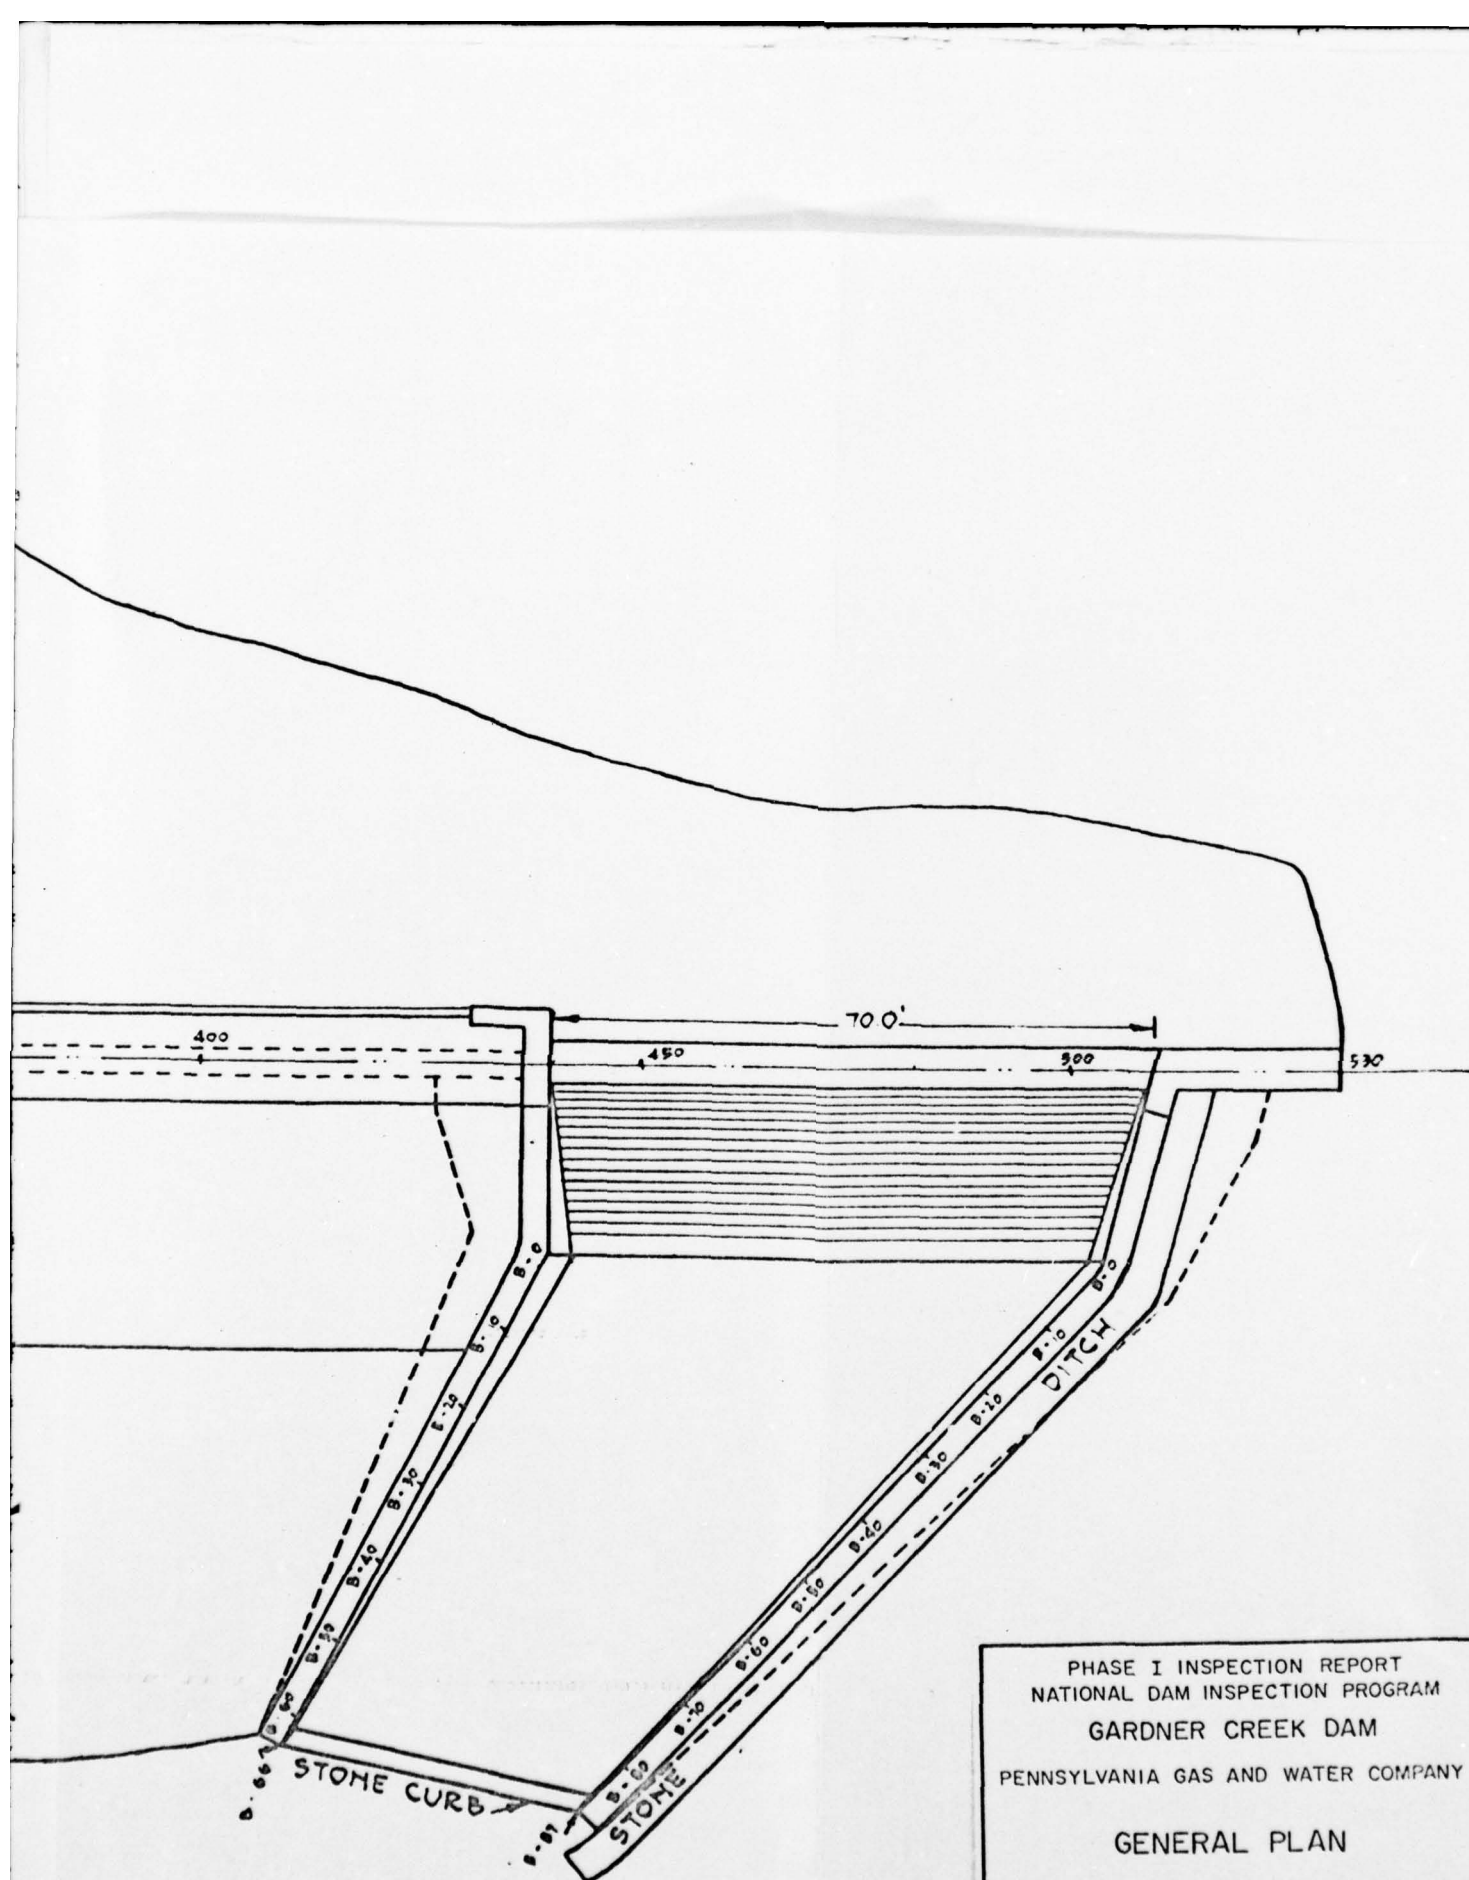
JUNE 1978 PLATE 2

b. Design Features. The primary features of Gardner Creek Dam include an earthen embankment with a masonry core wall, a concrete gravity spillway, and an outlet works. A general plan is shown on Plate 2 and a profile along the axis of the dam is shown on Plate 3.

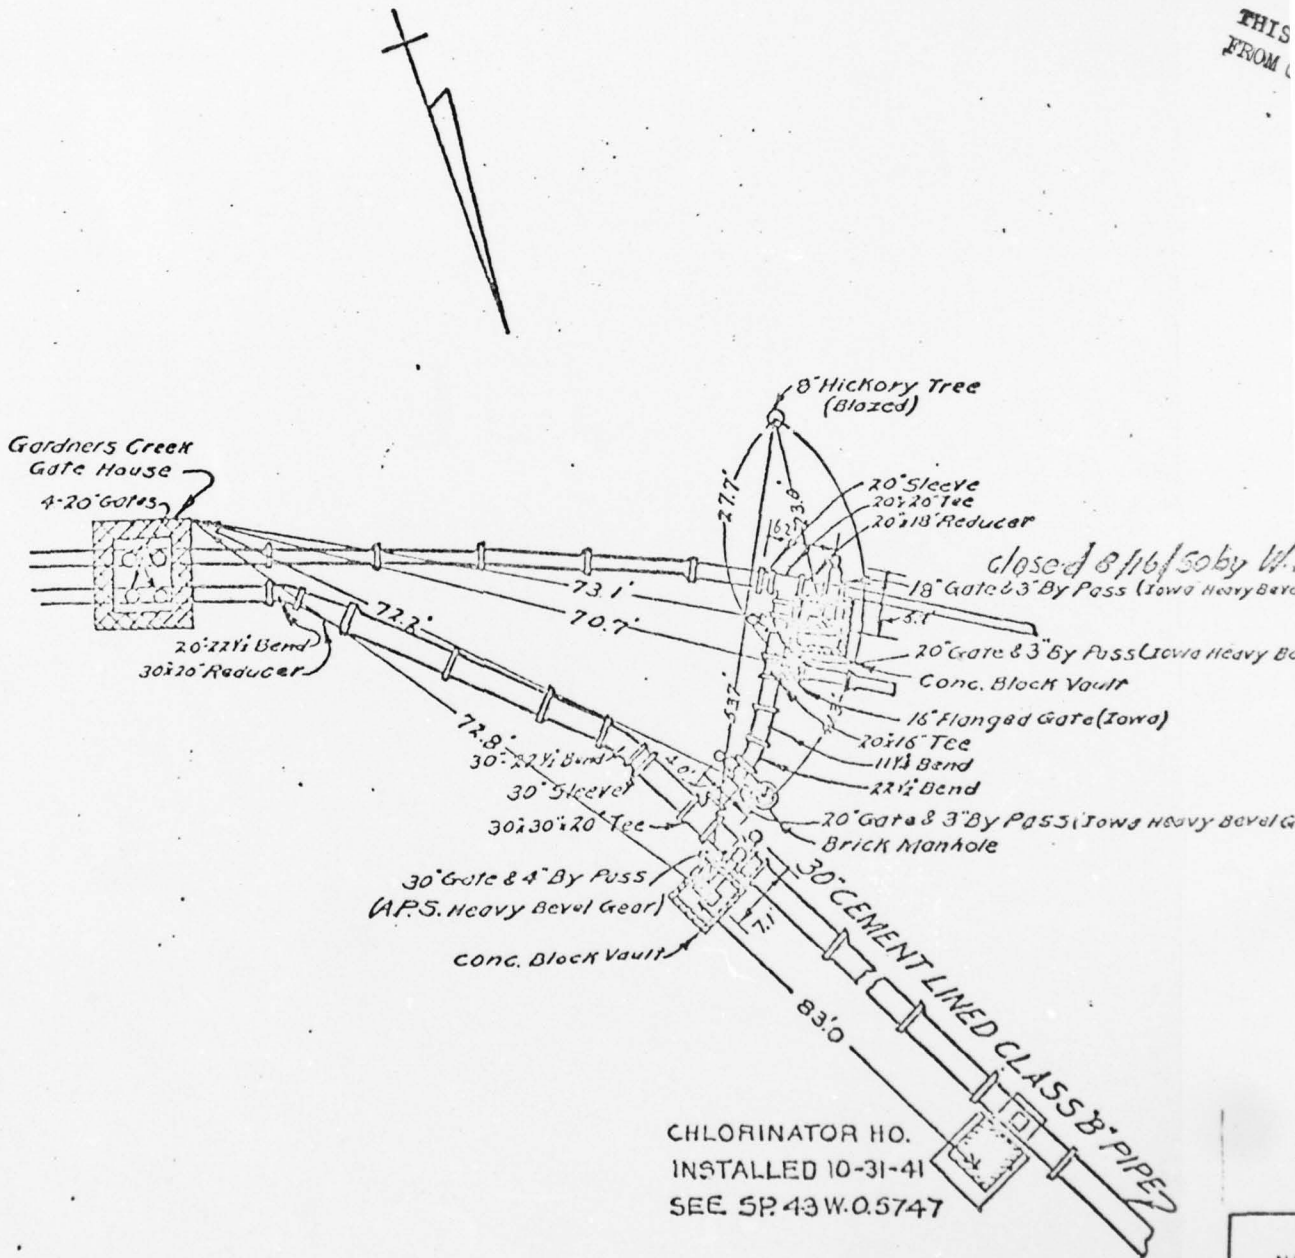
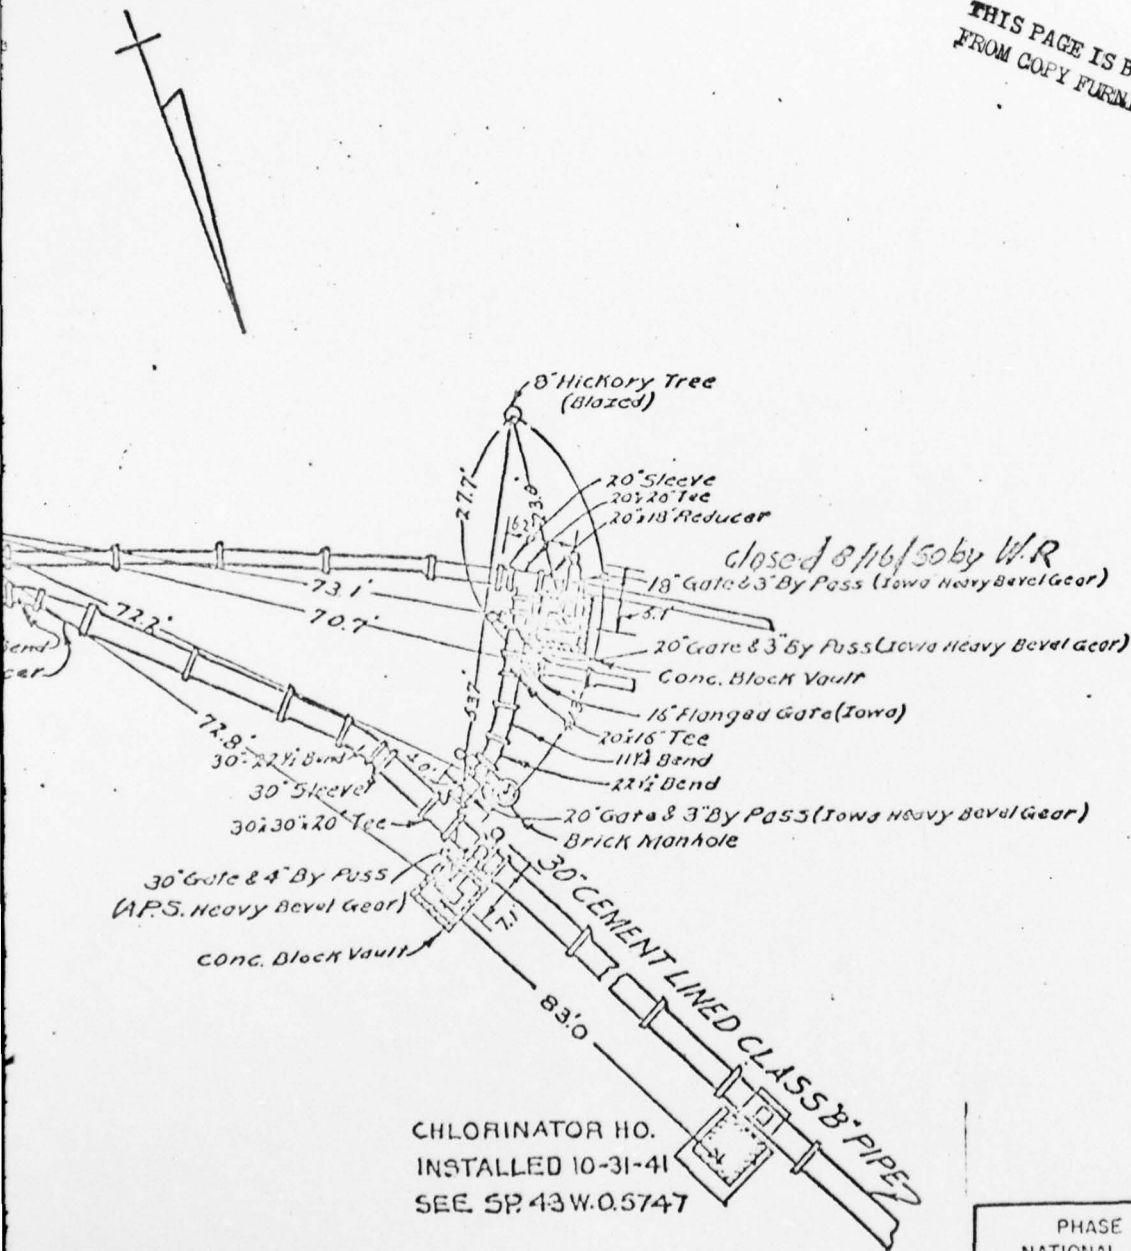
PHASE I INSPECTION REPORT
NATIONAL DAM INSPECTION PROGRAM
GARDNER CREEK DAM
PENNSYLVANIA GAS AND WATER COMPANY
PLAN OF OUTLET WORKS
JUNE 1978
PLATE 6

The outlet works consists of two 20-inch diameter cast-iron pipes through the embankment, a gatehouse at the toe of the dam, a 30-inch diameter water supply line, and a 16-inch diameter blowoff line that can be used to lower the water level in the reservoir. According to available information, the 20-inch lines through the embankment, for their full length, are founded on a 2-foot thick masonry bed that rests on a 1-foot thick concrete footing. One-foot thick masonry arches were constructed around the 20-inch lines. In the gatehouse, two gate valves are on each line. Beyond the gatehouse, the two 20-inch lines are cross connected to feed water into a 30-inch supply line. A 16-inch blowoff line is joined to the cross connection. One 16-inch gate valve is located underground to control the blowoff line. A plan of the outlet works is shown on Plate 6.
