National Dam Inspection Program. Indian Creek Dam (NDI-PA-199), Ohio River Basin, Indian Creek, Fayette County, Pennsylvania. Phase I Inspection Report.

INDIAN CREEK DAM
NDI No. Pa. - 199

PHASE I INSPECTION REPORT
NATIONAL DAM INSPECTION PROGRAM

22 June 1978 (visual inspection)

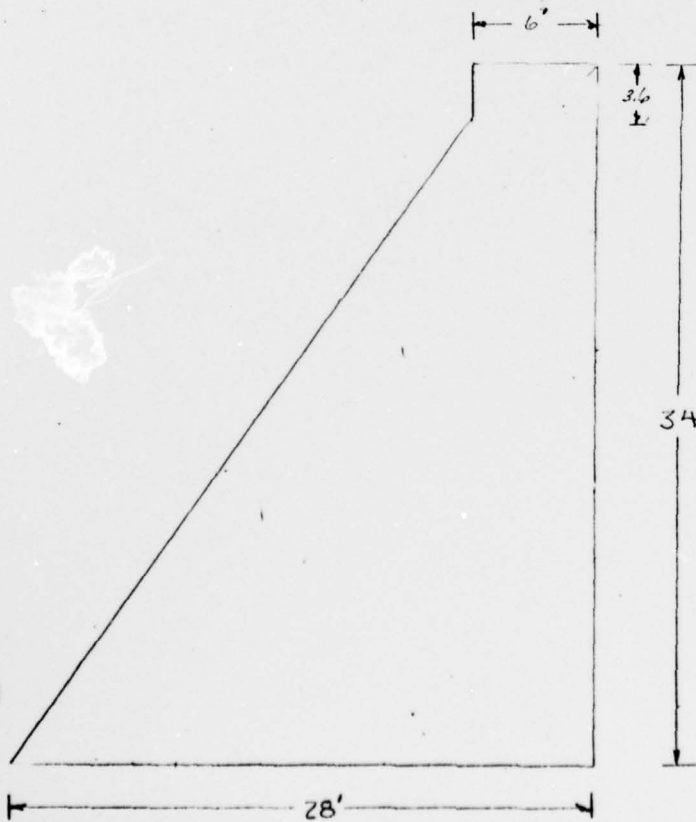
THE DAM WILL BE ANALYZED FOR OVERTURNING AND SLIDING BY CONSIDERING A CROSS SECTION TAKEN AT THE SPILLWAY UNDER RESERVOIR FULL CONDITIONS; 5 FT. OF WATER OVER THE CREST AND 9 FT. OF WATER OVER THE WEST. IN EACH CASE 100% OF UPLIFT AND NO TRAIL WATER ARE ASSUMED.
OVERTURNING (MAXIMUM HEAD CONDITIONS)

THE CRITICAL SECTION TO BE ANALYZED IS A CROSS SECTION TAKEN AT THE SPILLWAY WITH DIMENSIONS APPROXIMATED AS SHOWN BELOW

NOTE - REFER TO SHEET 3 FOR ELEVATIONS AND ADDITIONAL REFERENCES
DIMENSIONS TAKEN FROM FIGURE 1
