NEIFERT CREEK DAM  
SCHUYLKILL COUNTY, PENNSYLVANIA  
NATIONAL I.D. NO. PA 00654

PHASE I INSPECTION REPORT  
NATIONAL DAM INSPECTION PROGRAM

PHASE I INSPECTION REPORT  
NATIONAL DAM INSPECTION PROGRAM  
NEIFERT CREEK DAM  
NATIONAL ID #PA 00654  
DER ID #54-173

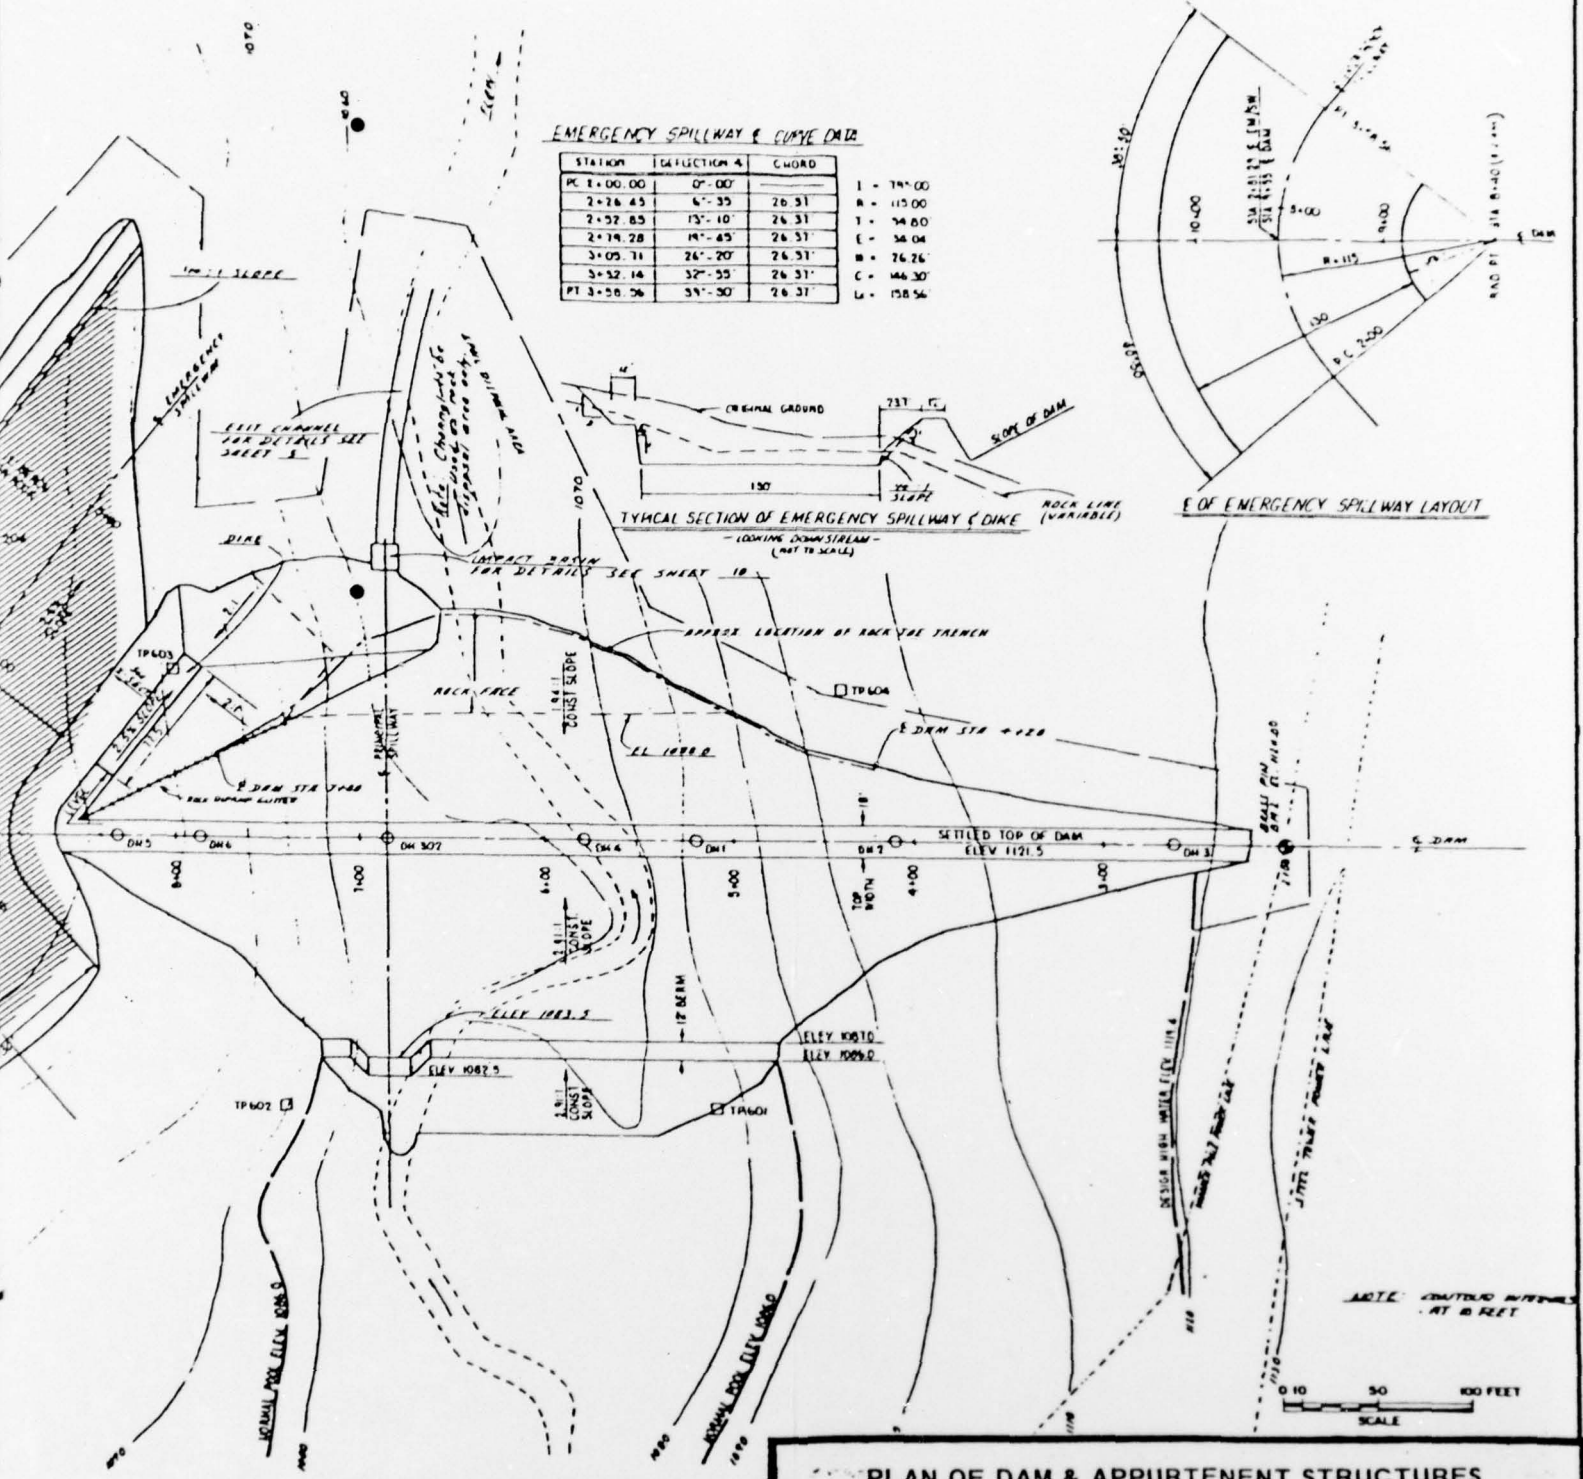
| THIS PAGE IS BEST QUALITY PRACTICABLE<br>FROM COPY FURNISHED TO DDC | <b>PLATE 2</b> |

b. Dam. During the visual inspection, there were no indications or evidences observed of distortions in alignment or grade that would be indicative of movement of the embankment or the foundation. All slopes appeared to be in good condition and the crest, although unprotected, was also evaluated to be in good condition. Some erosion was noted along the crest and along the upstream slope which can be attributed to motor bike traffic. One small seep, located as shown on Plate 2 of Appendix E, was noted during this inspection. A photograph of this seep is enclosed herein as Photo No. 6.

**LEGEND:**  
 ● SEEPAGE LOCATION
