NATIONAL DAM SAFETY PROGRAM. ASHOKAN DAM (NY 41), HUDSON RIVER --ETC(U)

REPORT DOCUMENTATION PAGE		READ INSTRUCTIONS BEFORE COMPLETING FORM
1. REPORT NUMBER	2. GOVT ACCESSION NO.	3. RECIPIENT'S CATALOG NUMBER
4. TITLE (and Subtitle) Phase I Inspection Report Ashokan Dam Hudson River Basin Ulster Co. New York Inventory No. N.Y. 41		5. TYPE OF REPORT & PERIOD COVERED Phase I Inspection Report National Dam Safety Program

PHASE I INSPECTION REPORT  
NATIONAL DAM SAFETY PROGRAM  
ASHOKAN RESERVOIR, INVENTORY NO. 41  
HUDSON RIVER BASIN  
ULSTER COUNTY, NEW YORK

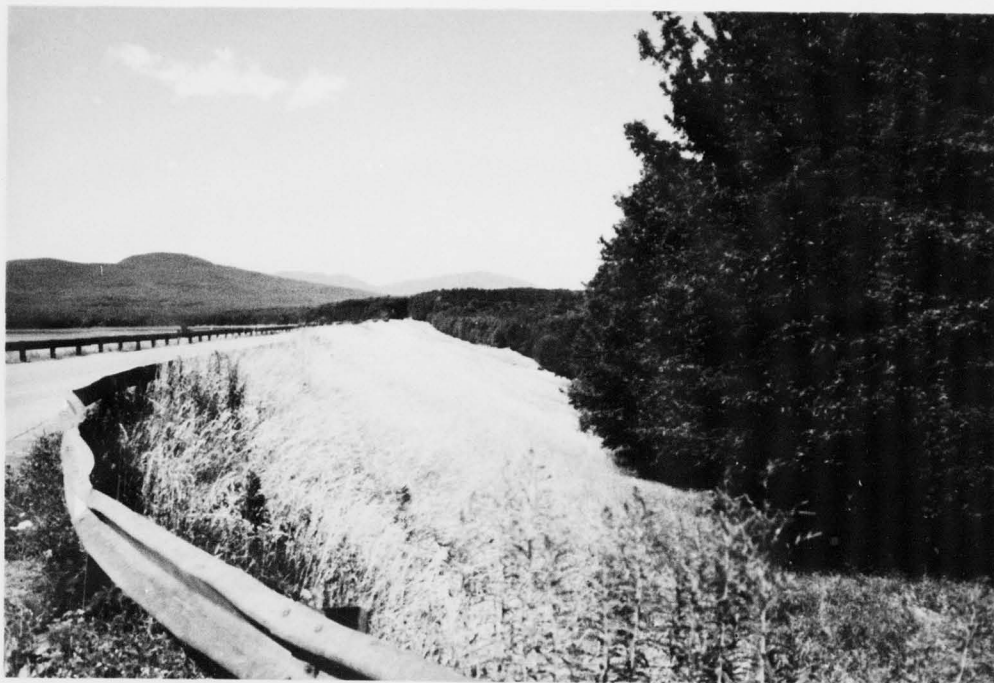
DOWNSTREAM SLOPE OF OLIVE BRIDGE DAM.(LOOKING NORTH)

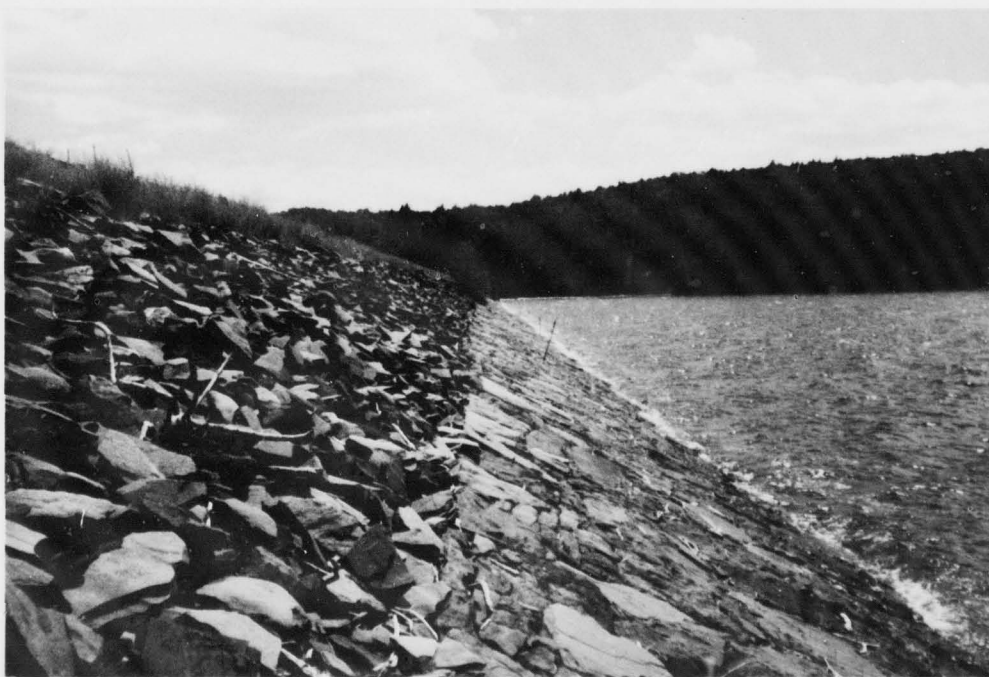
UPSTREAM SLOPE OF SOUTH EMBANKMENT OF DAM.(LOOKING SOUTH)

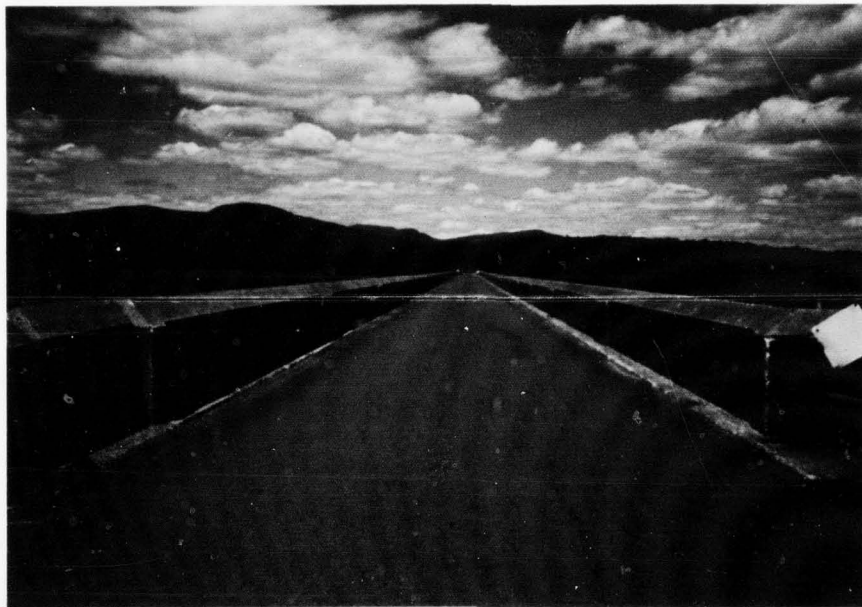
CREST OF OLIVE BRIDGE MASONRY DAM

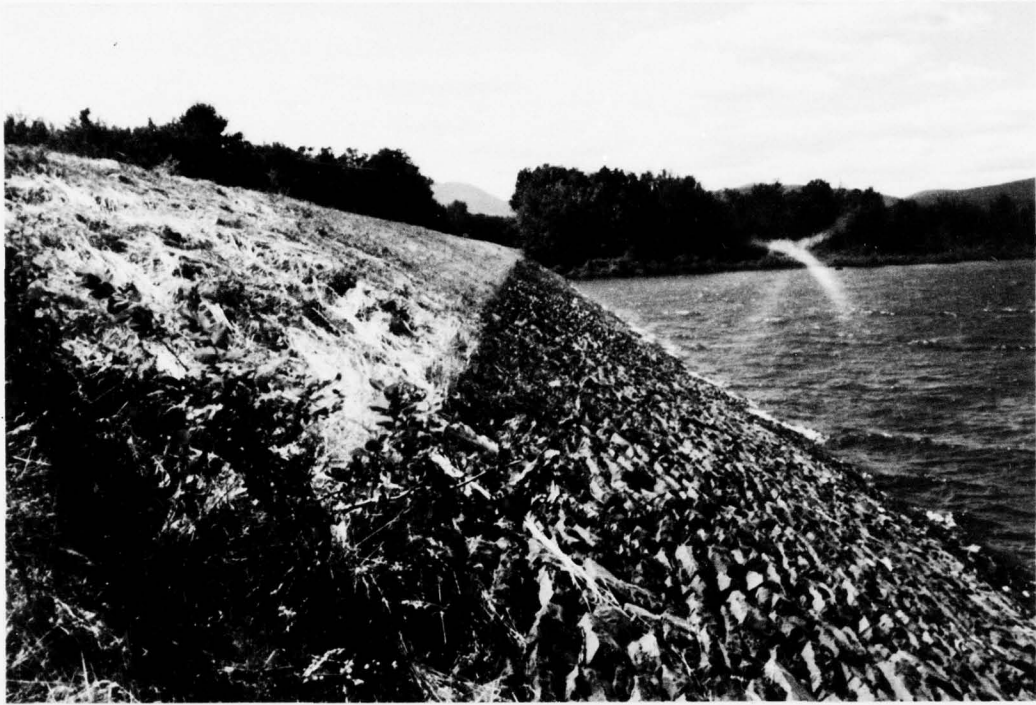
VIEW OF UPSTREAM SLOPE OF EAST DIKE. (LOOKING WEST)

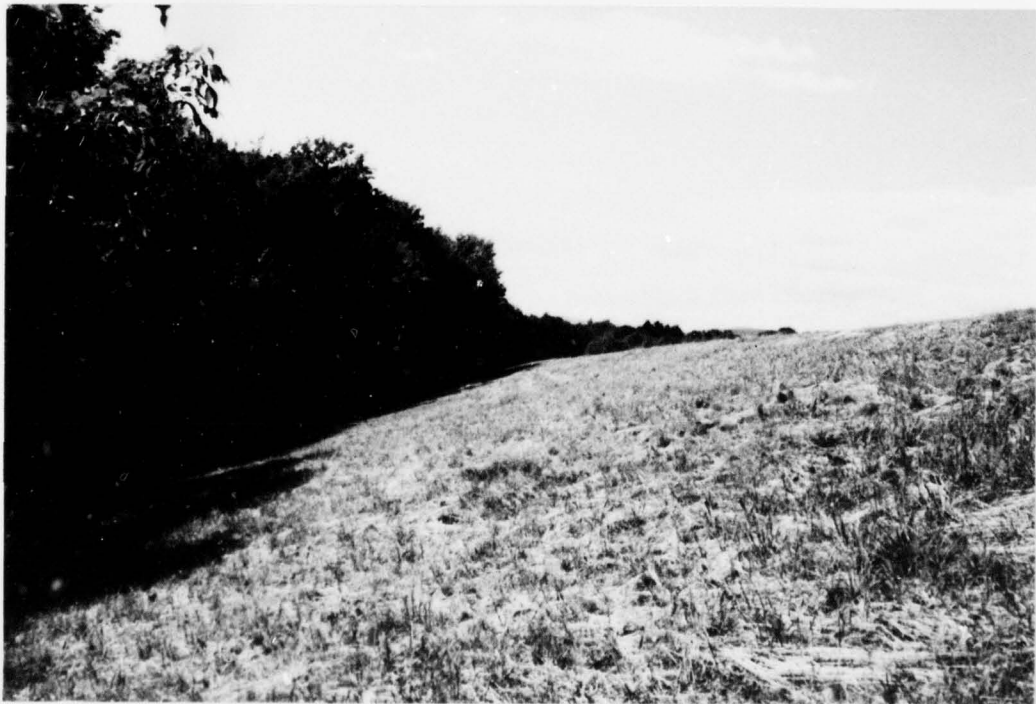
VIEW OF DOWNSTREAM SLOPE OF EAST DIKE. (LOOKING WEST)

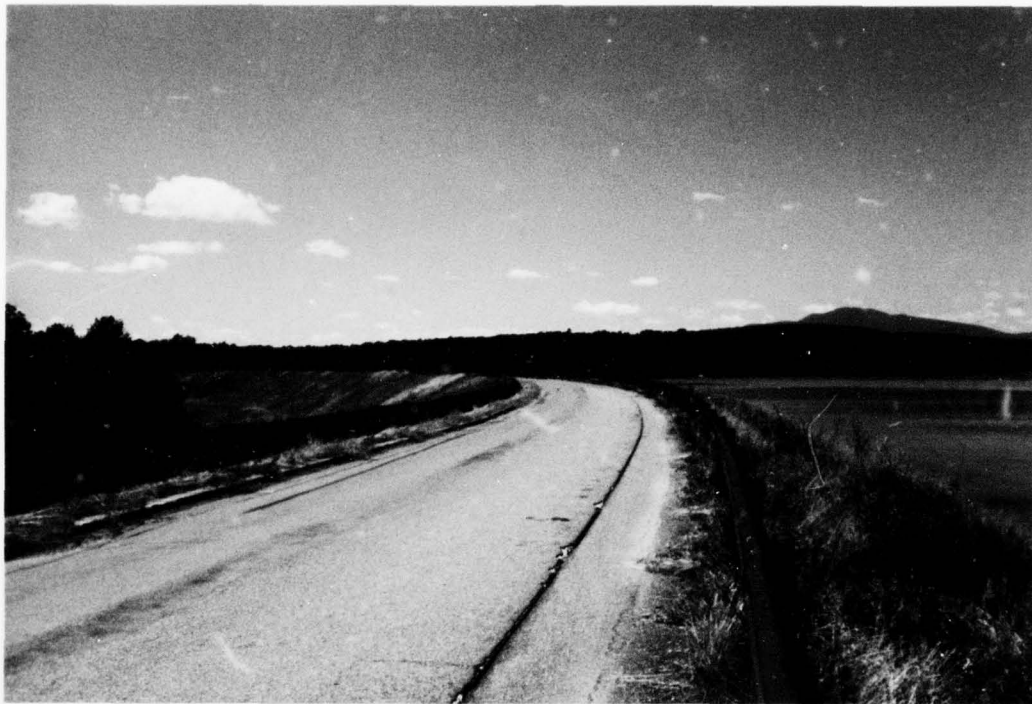
VIEW OF WEST HURLEY DIKE. (LOOKING SOUTH)

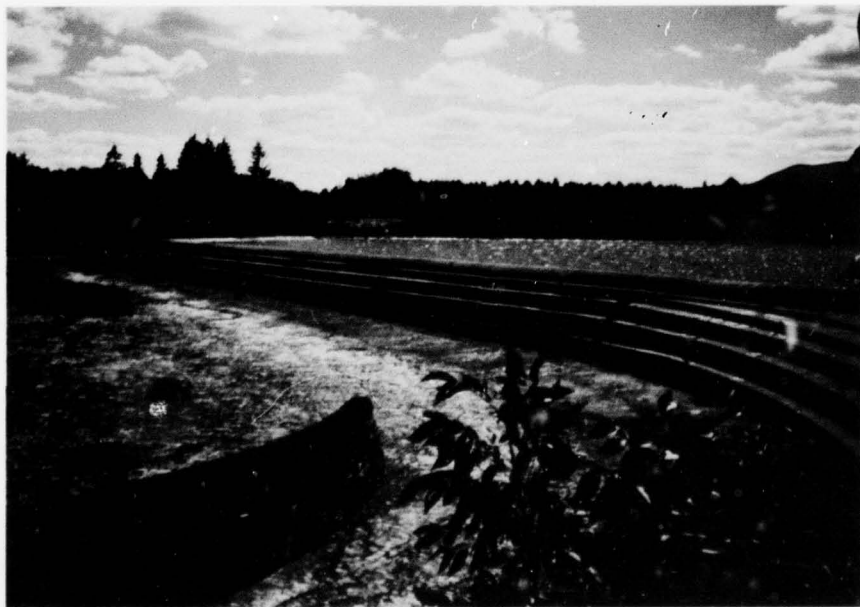
DOWNSTREAM FACE OF SPILLWAY AND FLOOR CHANNEL  
AND MASONRY WALL. (LOOKING SOUTH)

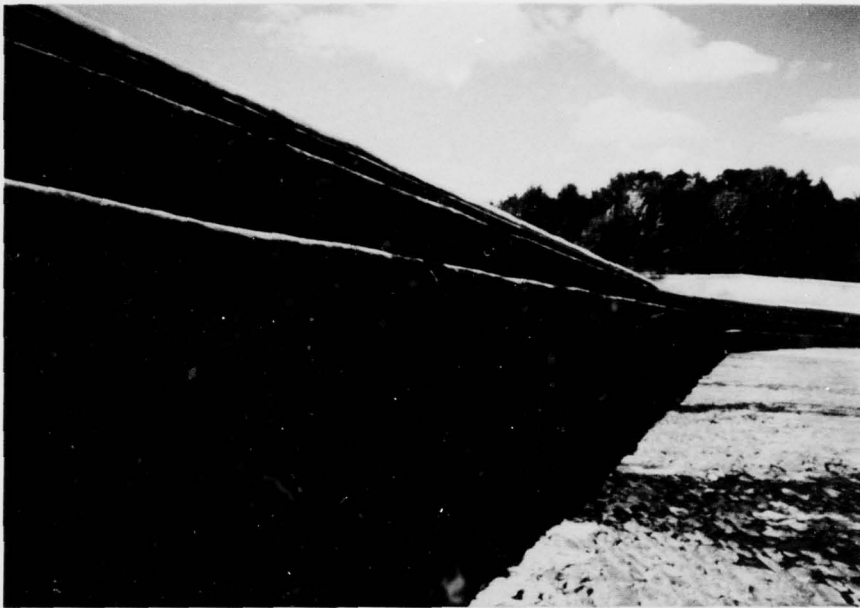
SEEPAGE AT DOWNSTREAM FACE OF SPILLWAY.  
NOTE SEEPAGE FROM JOINTS

THE ORIGINAL CYCLOPEAN MASONRY SPILLWAY (WEIR) WAS REHABILITATED BY APPLYING A GUNITE SURFACING TO THE STRUCTURE. THERE WERE SOME MINOR LEAKS AND SEEPAGE FROM JOINTS OF THE WEIR. HOLES FOR FLASHBOARDS WERE NOT RESTORED TO THE CREST SURFACE. THERE WERE SOME LOOSE STONES IN THE FLOOR.

6. Water Passages, Conduits, Sluices NOT ACCESSIBLE - COULD NOT BE INSPECTED.
7. Seepage or Leakage SEEPAGE AND LEAKS WERE OBSERVED IN SEVERAL AREAS ON THE STEPS OF THE SPILLWAY. A LEAK WAS OBSERVED AT THE BASE OF THE WALL IN NO 10 INSPECTION GALLERY AND OTHER GALLERIES WHERE LOCATIONS COULD NOT BE ASCERTAINED
