CANEADEA DAM

ALLEGANY COUNTY, NEW YORK  
INVENTORY NO. 484

PHASE I INSPECTION REPORT  
NATIONAL DAM SAFETY PROGRAM

**JULY 26, 1978**

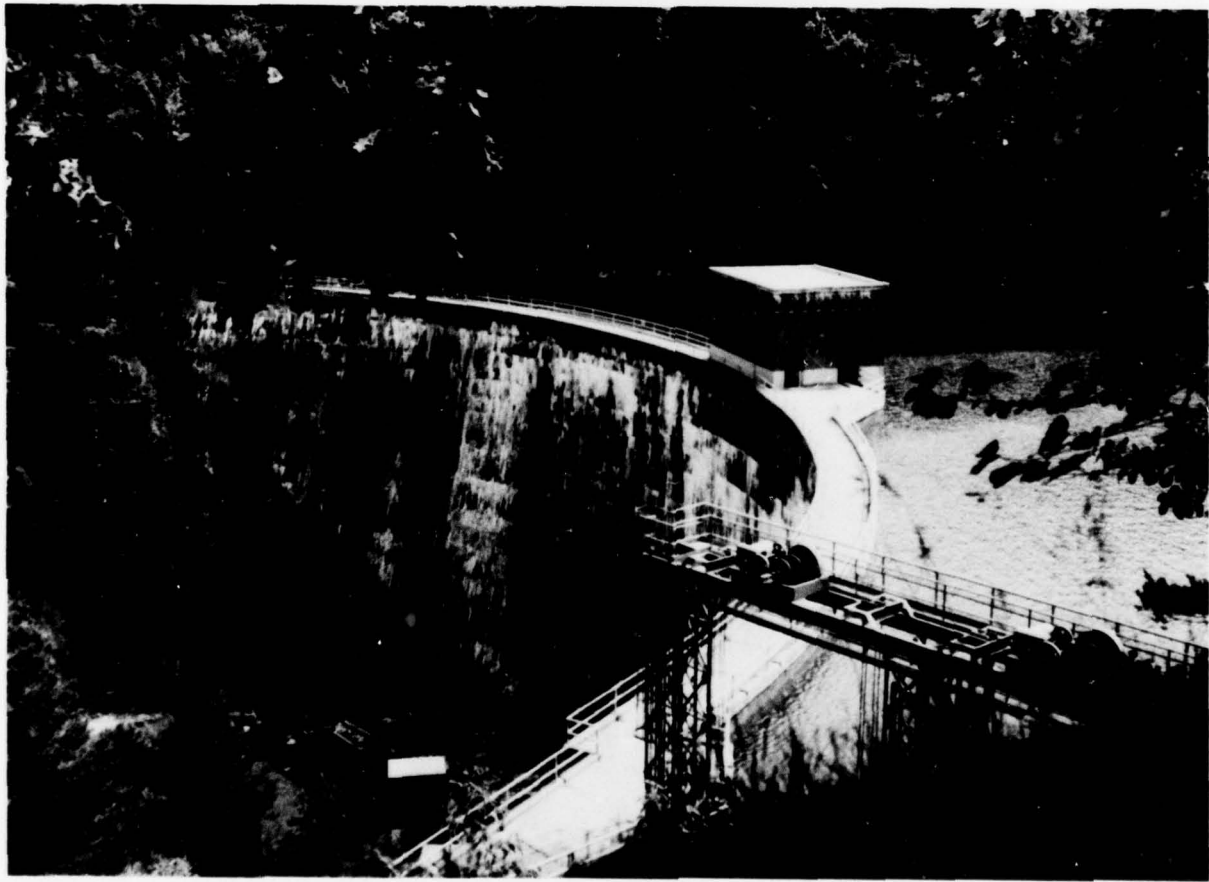
DOWNSTREAM FACE OF DAM AND RESERVOIR VIEWED FROM LEFT EMBANKMENT

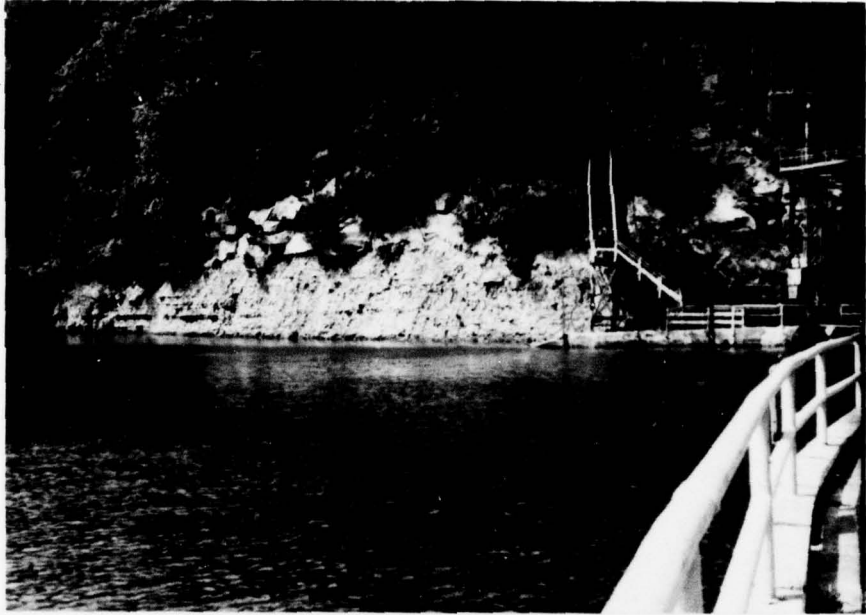
UPSTREAM RESERVOIR SIDE SLOPE ADJACENT TO SPILLWAY CHANNEL

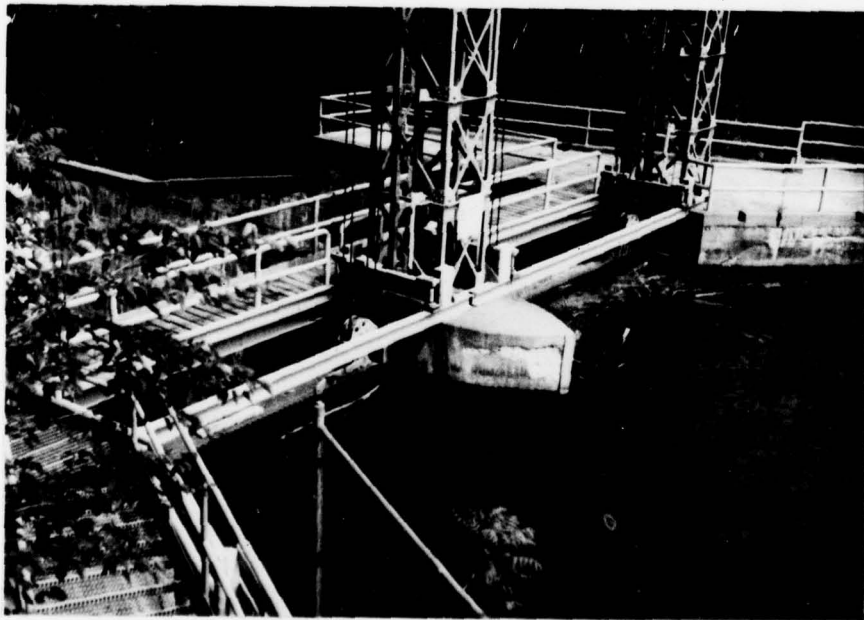
There is general spalling of the concrete surface immediately upstream of the gates.

AREA AT TOP OF SPILLWAY GATES

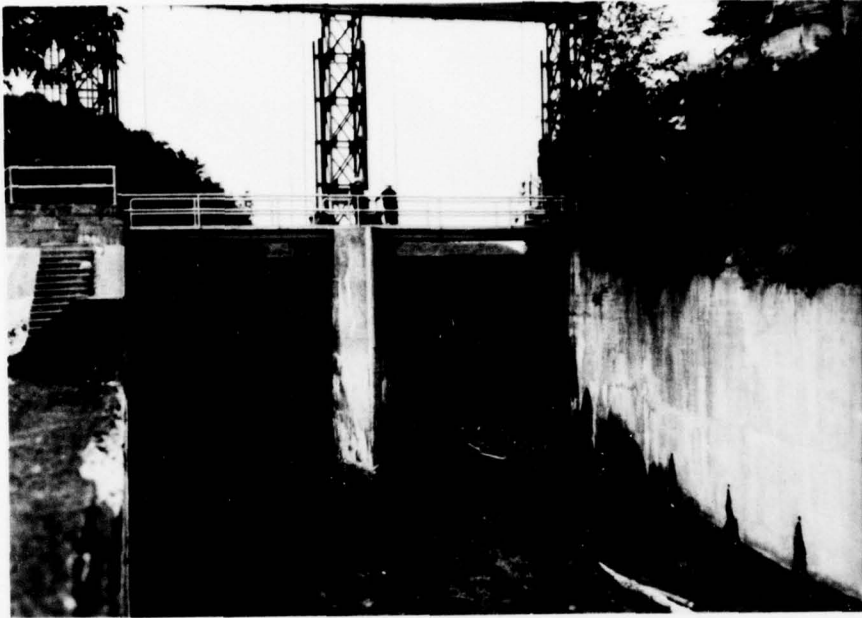
Both spillway gates were closed and the lake surface was about 0.4 ft below the top of gate (El 1440.0). Side seals were tight. At the north gate there was a slight leak at the bottom of the north end and moderate leakage squirting just above the bottom corner of the south end. At the south gate there was light leakage at both bottom corners. It was reported that the north gate bottom timber had been replaced in the spring of 1978 and was thought to be warped. Upstream side J-seals as shown on the drawings were not installed, but were stored in the gatehouse. The visible gate surfaces had patches of rust.

SPILLWAY GATES VIEWED FROM DOWNSTREAM

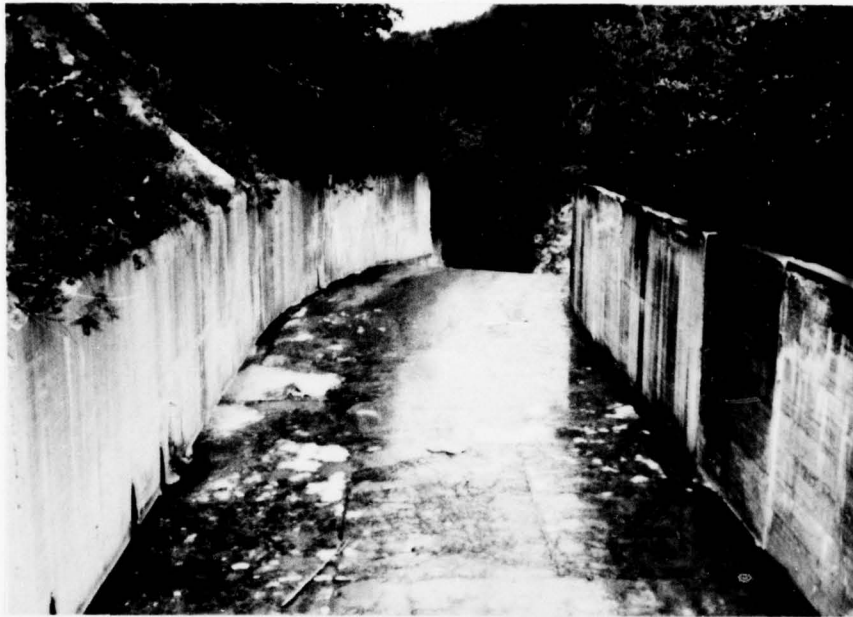
There is substantial erosion on the downstream portion of the sloping chute floor. The flatter floor slab near the abrupt end is also badly eroded. At the downstream end of the high right wall where the chute slab drops sharply there is some local undermining - a chunk of concrete several cubic feet in volume is missing.

SPILLWAY CHANNEL VIEWED FROM GATE BRIDGE

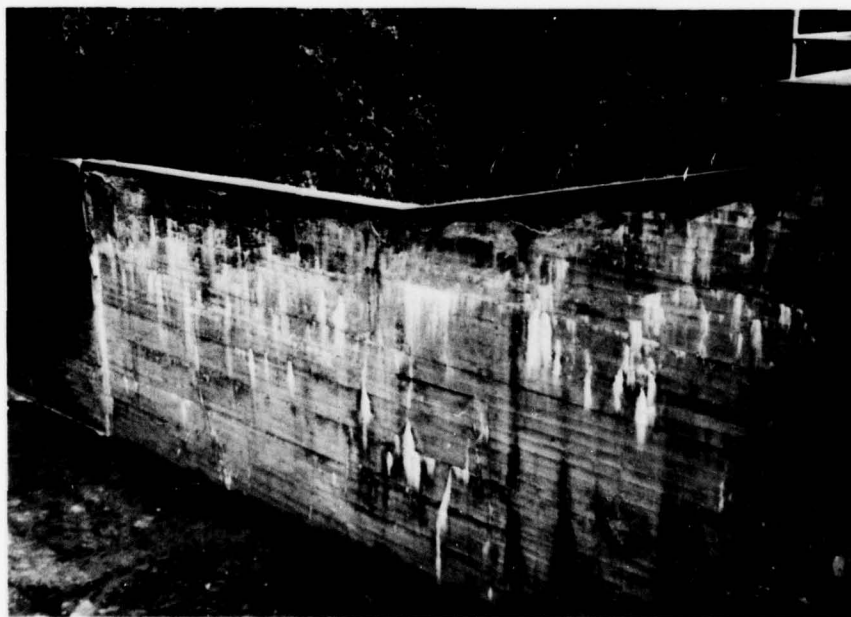
There are exposed rebars and several sizable spalled areas on the exterior face of the right spillway chute wall and carbonate deposits near the vent holes in the spillway chute wall. There is also deterioration of the concrete on both sides of several vertical monolith joints.

RIGHT WALL, SPILLWAY CHANNEL, FROM GATE BRIDGE

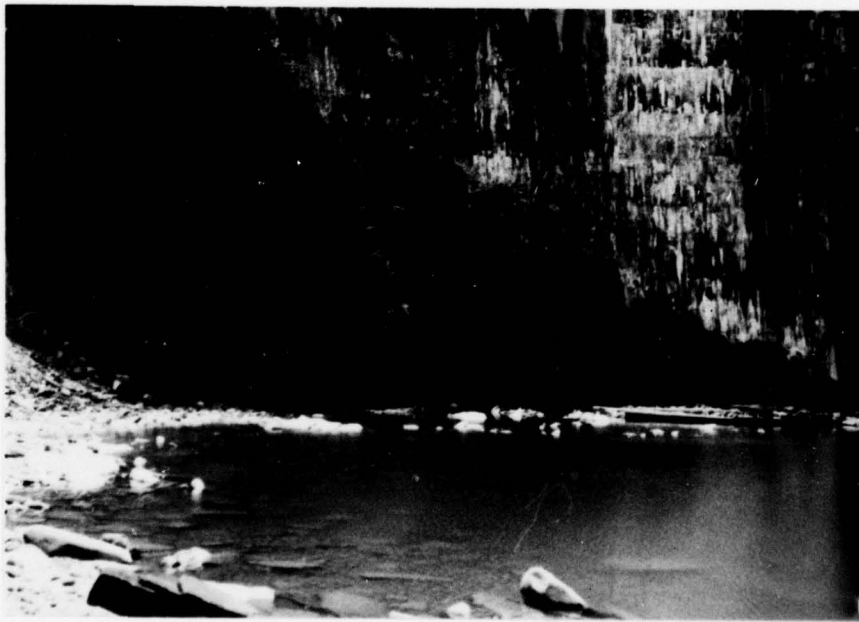
DOWNSTREAM FACE OF DAM, ROCK LEDGE AT BASE OF RIGHT  
ABUTMENT

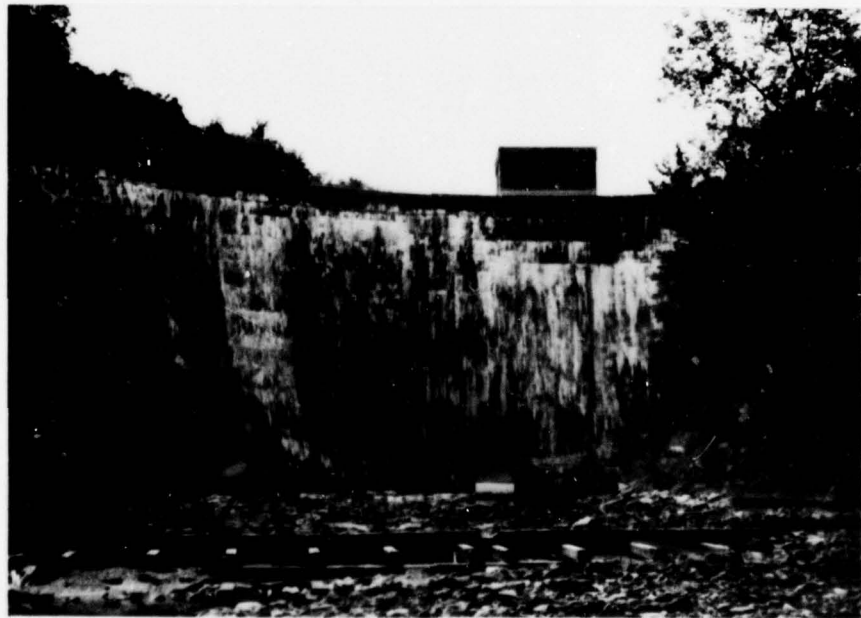
There are numerous areas with white deposits on the downstream face of the dam; deposition of as much as 2 inches thick has been observed. Minor leakage on downstream face of dam appears to be along horizontal and vertical joints of brickwork.

DOWNSTREAM FACE OF DAM FROM DOWNSTREAM WEIR IN  
STREAM BED
