BUCK HORN LAKE DAM

OTSEGO COUNTY  
NEW YORK

INVENTORY NO 362

PHASE I INSPECTION REPORT  
NATIONAL DAM SAFETY PROGRAM

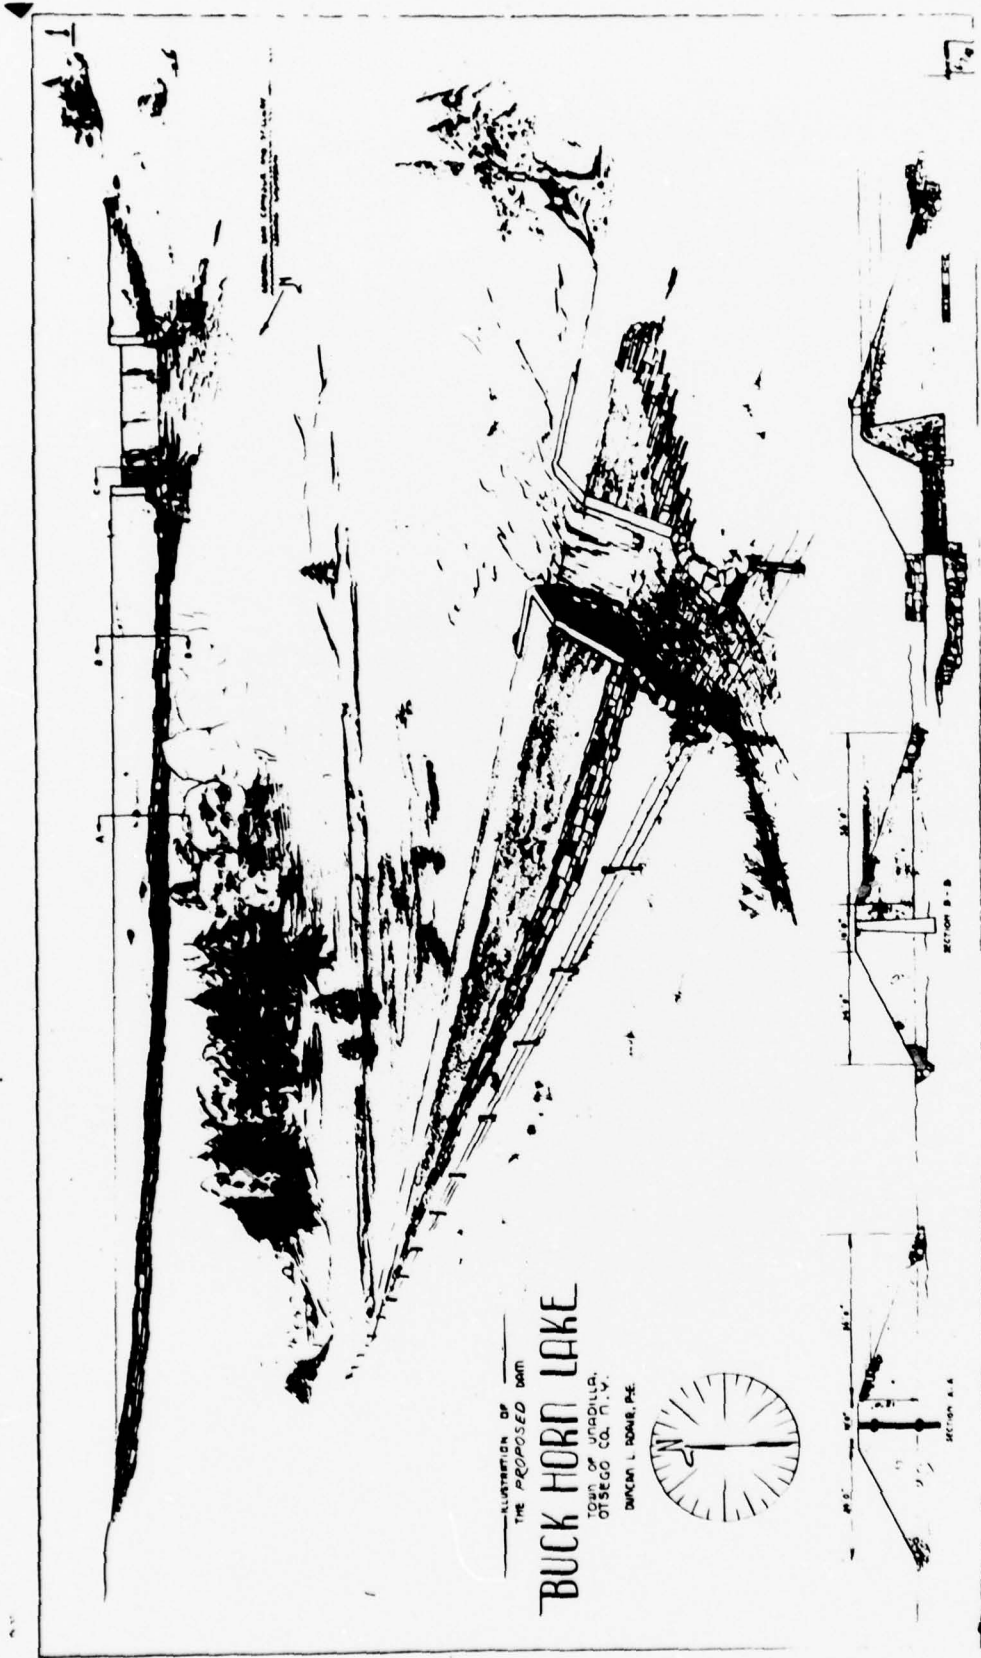
FIGURE 2

ILLUSTRATION OF  
THE PROPOSED DAM  
**BUCK HORN LAKE**  
TOWN OF UNADILLA,  
OTSEGO CO., N. Y.  
DUNCAN L. ROHR, P.E.

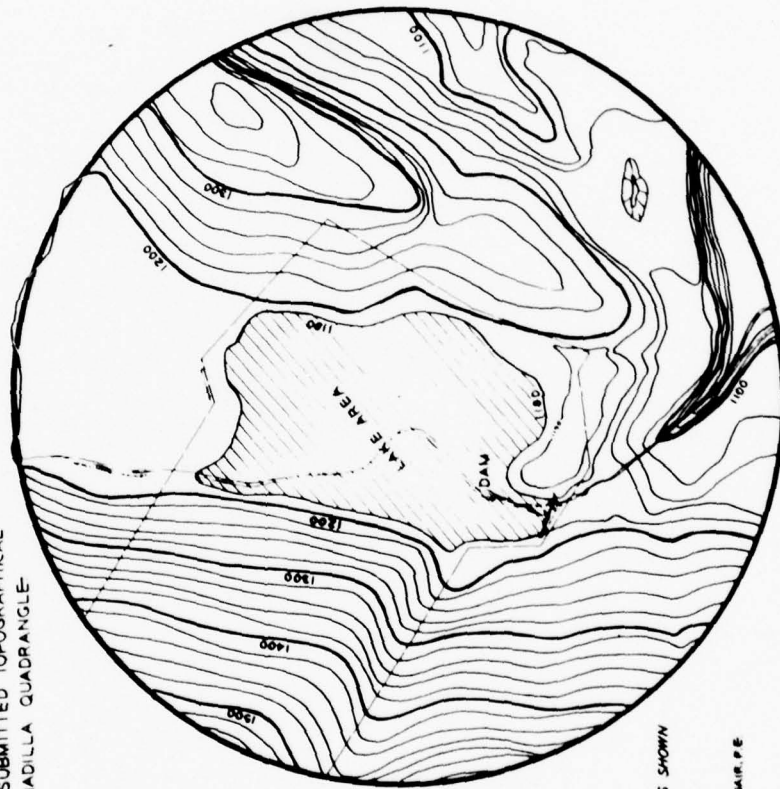
FIGURE 4

ENLARGED VIEW OF CIRCLED AREA  
AS SHOWN ON SUBMITTED TOPOGRAPHICAL  
MAP OF THE UNADILLA QUADRANGLE
