**JEROME PARK RESERVOIR DAM
BRONX COUNTY, NEW YORK**

**PHASE I INSPECTION REPORT
NATIONAL DAM SAFETY PROGRAM**

4. TITLE (and Subtitle)
Phase I Inspection Report
Jerome Park Reservoir Dam
Bronx County, New York
Inventory No. N.Y. 64

12. REPORT DATE
5 September 1978
13. NUMBER OF PAGES

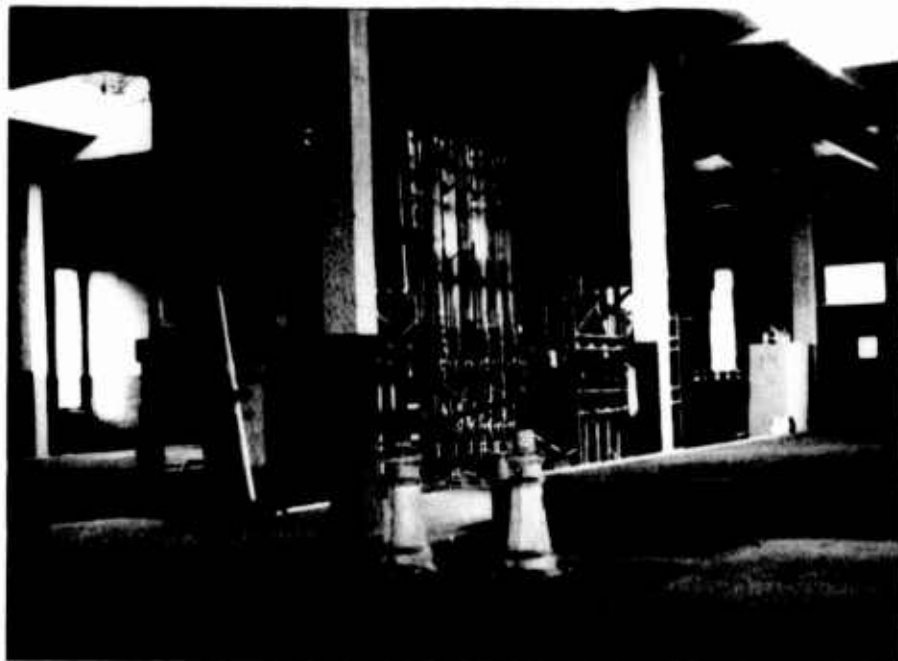
Inspection of Gate House No. 5 revealed that it contains all of the chlorination and flow monitoring equipment currently in use (Fig. 6, Appendix D). It also contains the gates and gate stands by which almost the entire operation of the reservoir can be controlled (Fig. 7, Appendix D). We requested that Mr. Kuse arrange to have all active and relevant gates operated. He informed us that five of the six gates that control flow to the south portal (inlet to the reservoir south of Gate House No. 5) could not be operated since the bronze "lock dogs" had been stolen. We were informed that these gates were ordinarily left in the open position and were in such a position on the day of the inspection. The one gate that was operational was raised and lowered with difficulty by two men working a long lever such as that shown on Figures 6 and 7.

FIGURE 6 GATEHOUSE No. 5 CHLORINATION EQUIPMENT

1. The "lock dogs" observed to be missing on the five gate stems controlling flow to the south portal inlet in Gate House No. 5 should be replaced.
2. Loose or missing bricks on vandalized gate houses, and holes in the chain link fence surrounding the reservoir, should be repaired.
3. The low woody growth on the upstream face of the dam should be removed.
4. Vegetative growth in the concrete apron joints should be removed and the joints recaulked, if necessary.
5. A formal emergency warning procedure should be filed with police at the local precinct house, with the city uniform complaint number, and with the city uniform emergency number.
6. Security measures and their implementation should be re-evaluated and, if needed, a program for tighter security developed and followed.
