⑥ National Dam Inspection Program, Dehart Dam (Inventory Number NDS-PA-561), Susquehanna River Basin, Clarks Creek, Dauphin County, Pennsylvania. Phase I, Inspection Report.

DEHART DAM

## PHASE I INSPECTION REPORT

Name of Dam: DEHART DAM  
 State & State No. PENNSYLVANIA - 22-9  
 County: DAUPHIN  
 Stream: CLARKS CREEK  
 Date of Inspection: July 7, 1978

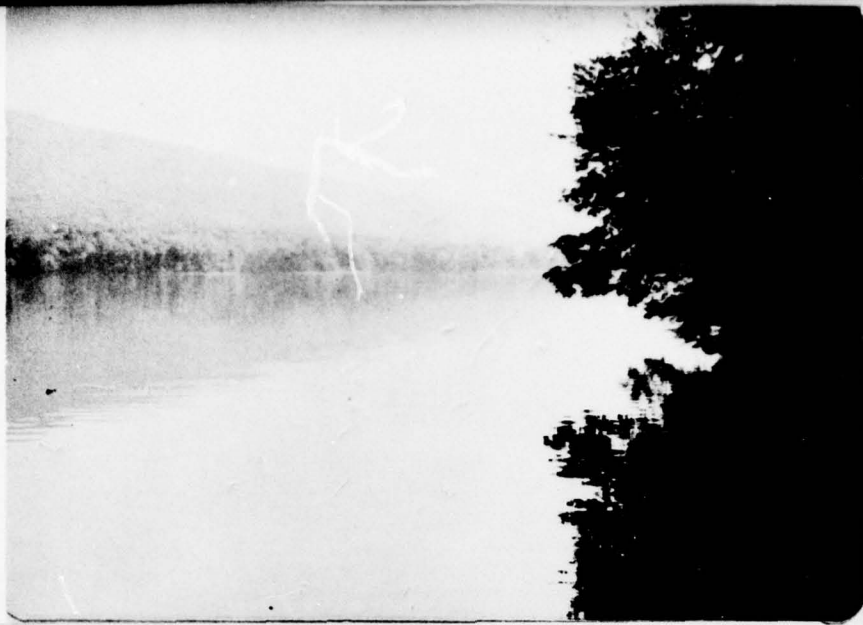
Reservoir

Sedimentation has not been reported as a problem. The reservoir slopes are forested and are not subject to heavy erosion. The general reservoir area is in good condition.

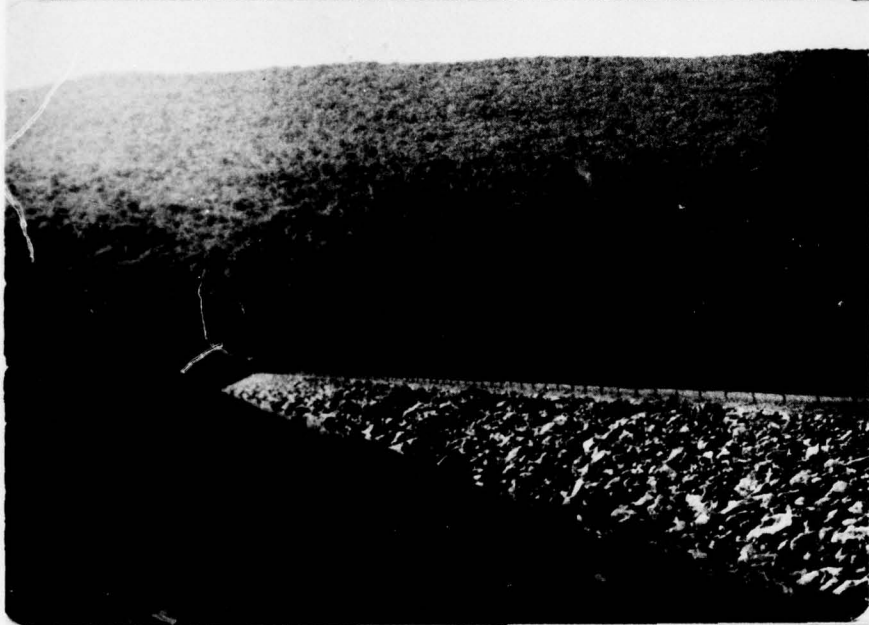
Upstream  
Embankment

The embankment shows no signs of distress. The rock slopes, both upstream and downstream are relatively uniform considering the size of rock (18 to 48 inches) which cover these surfaces. Heavy fern growth is found between the nested rocks on the downstream slope. Some light fern growth is located near the top of the slope on the upstream slope. The presence of this vegetation does not have any influence on the stability of the embankment; however, some trees on the downstream slope should be removed.
