PINE GROVE DAM

INVENTORY NUMBER NDS PA-23

PHASE I INSPECTION REPORT

NATIONAL DAM INSPECTION PROGRAM

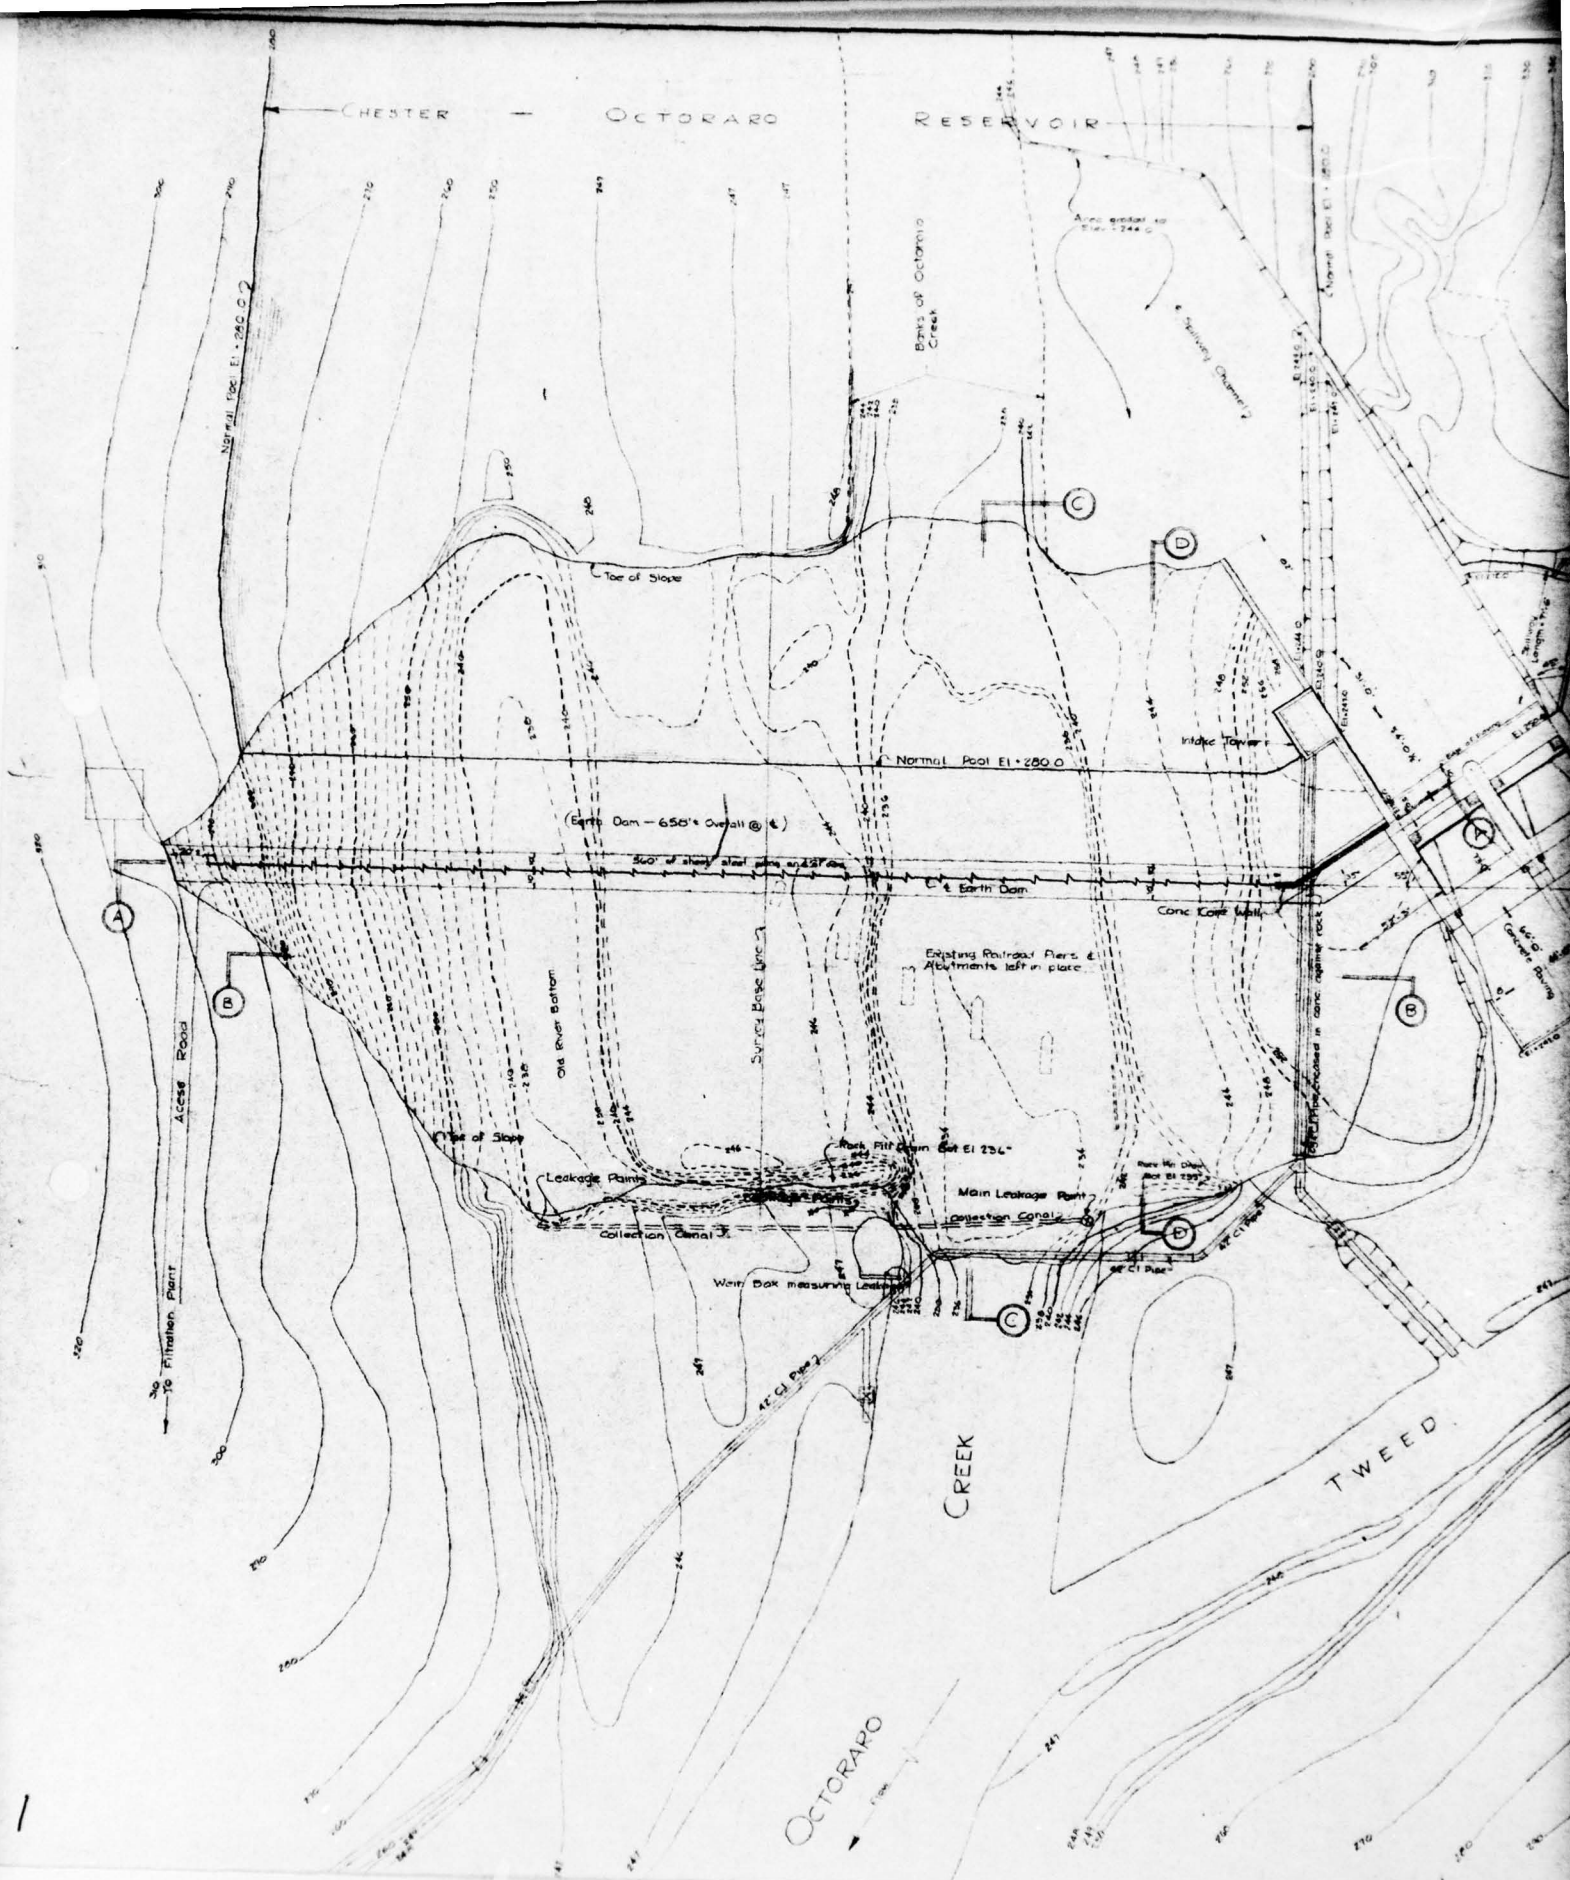
Downstream
Channel

The downstream spillway outlet channel has been heavily eroded as a result of the 1972 tropical storm Agnes and other high discharge storms. Repairs to the dam side of the channel have been made and plans for additional protection of this condition are being considered by the owner.

The water discharging through the spillway has to make a sharp (90°) bend directly below the dam. Heavy erosion has occurred at the opposite hillside as a result of the 1972 tropical storm Agnes and other high runoff storms. Some repairs are being considered to improve this condition. A covered roadway bridge and a low dam cross the stream at a distance of about 1,500 feet below the dam. Aside from the treatment plant there are no residents along or in the flood plain for the next 10 miles. A developing mobile home area is located 10 miles from the dam. This area is adjacent to the stream in its flood plain and is subject to flooding and at the time of this inspection contained five mobile home units. It is expected that the additional loss of life due to dam failure after overtopping would be limited to a few and the additional economical loss would be appreciable. The hazard classification for this dam is considered to be "Significant".
