National Dam Inspection Program,
Little Buffalo Creek Dam, Susquehanna
River Basin, Commonwealth of
Pennsylvania, Perry County (NDS-PA-582),
Phase I Inspection Report.

LITTLE BUFFALO CREEK DAM

PHASE I INSPECTION REPORT

11 Sep 78

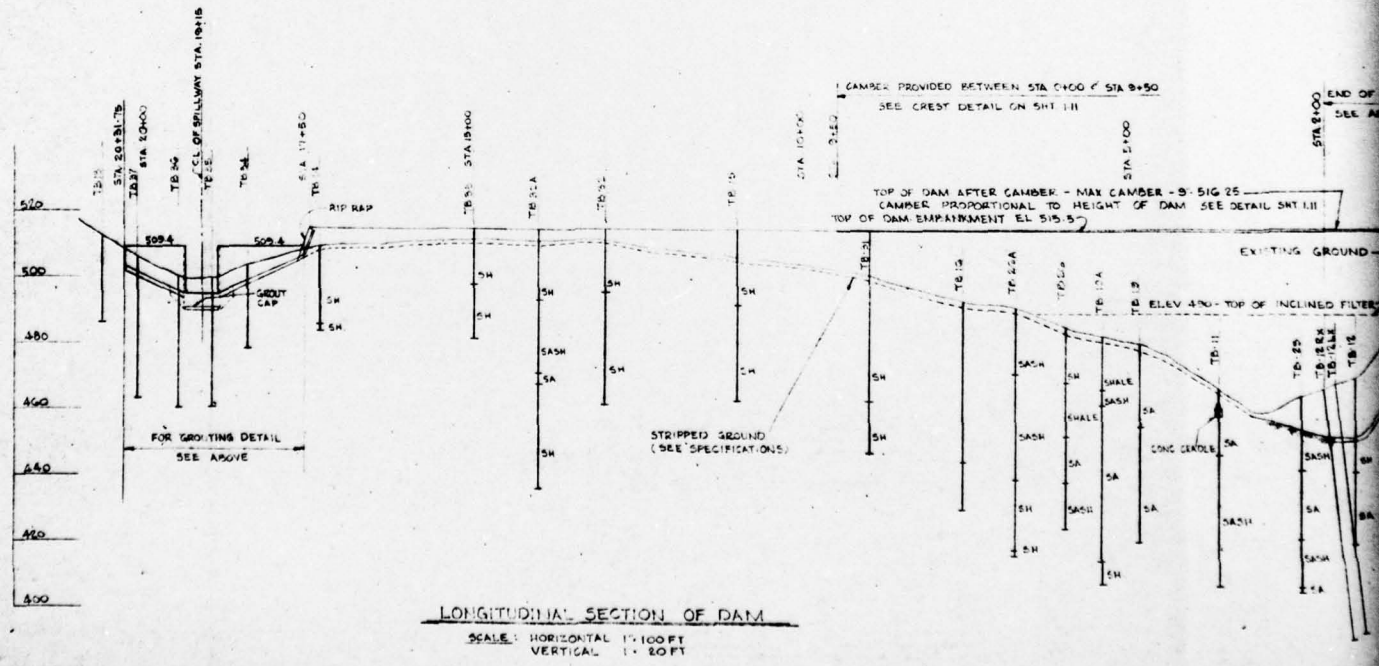
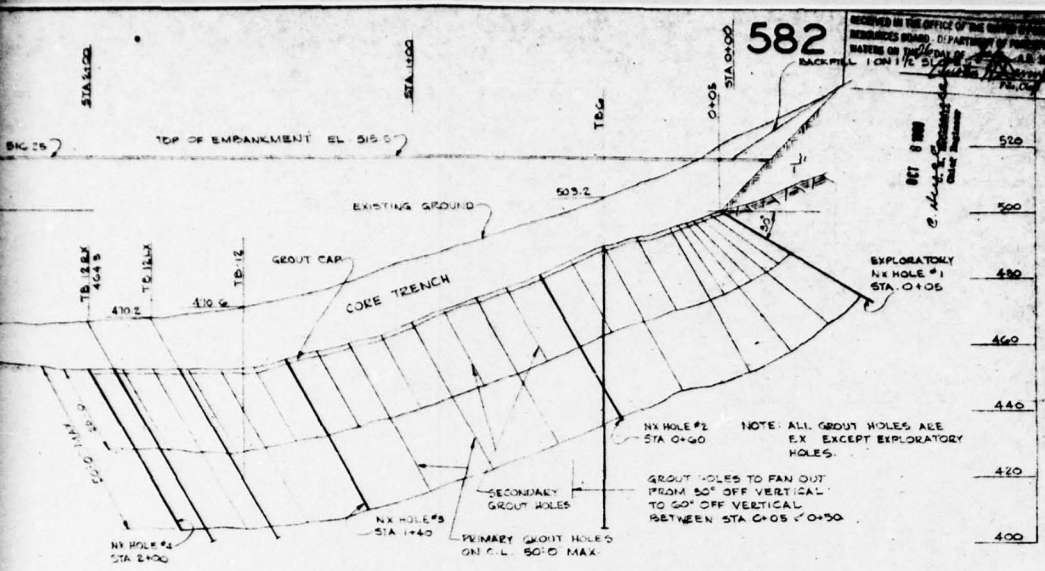
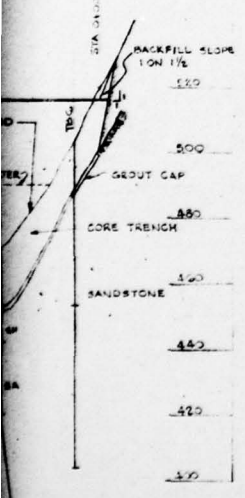
PLATE VII

Foundation grouting was carried out beneath the south abutment of the embankment to Station 2+00, refer to Appendix D, Plate VII.

Examination of the construction drawings, the test boring data and the geologic setting of this dam indicates that the rock formations are subject to leakage along the bedding planes and fractures. Since grouting was carried out in the foundation formations beneath the south abutment and beneath the spillway, the condition was noted and accounted for in these areas. The reason for partial treatment of the foundations is not described in any of the available records. It suggests that the leakage may be coming from the foundation formation which has not been grouted.
