6
National Dam Safety Program,
High Bridge Dam, Susquehanna River Basin,
Commonwealth of Pennsylvania,
Schuylkill County (NDS-PA-679).
Phase I Inspection Report.

HIGH BRIDGE DAM

PHASE I INSPECTION REPORT

Name of Dam: HIGH BRIDGE
 State & State Number: PENNSYLVANIA - 54-157A
 County Located: SCHUYLKILL
 Stream: FISHING CREEK
 Date of Inspection: August 7, 1978

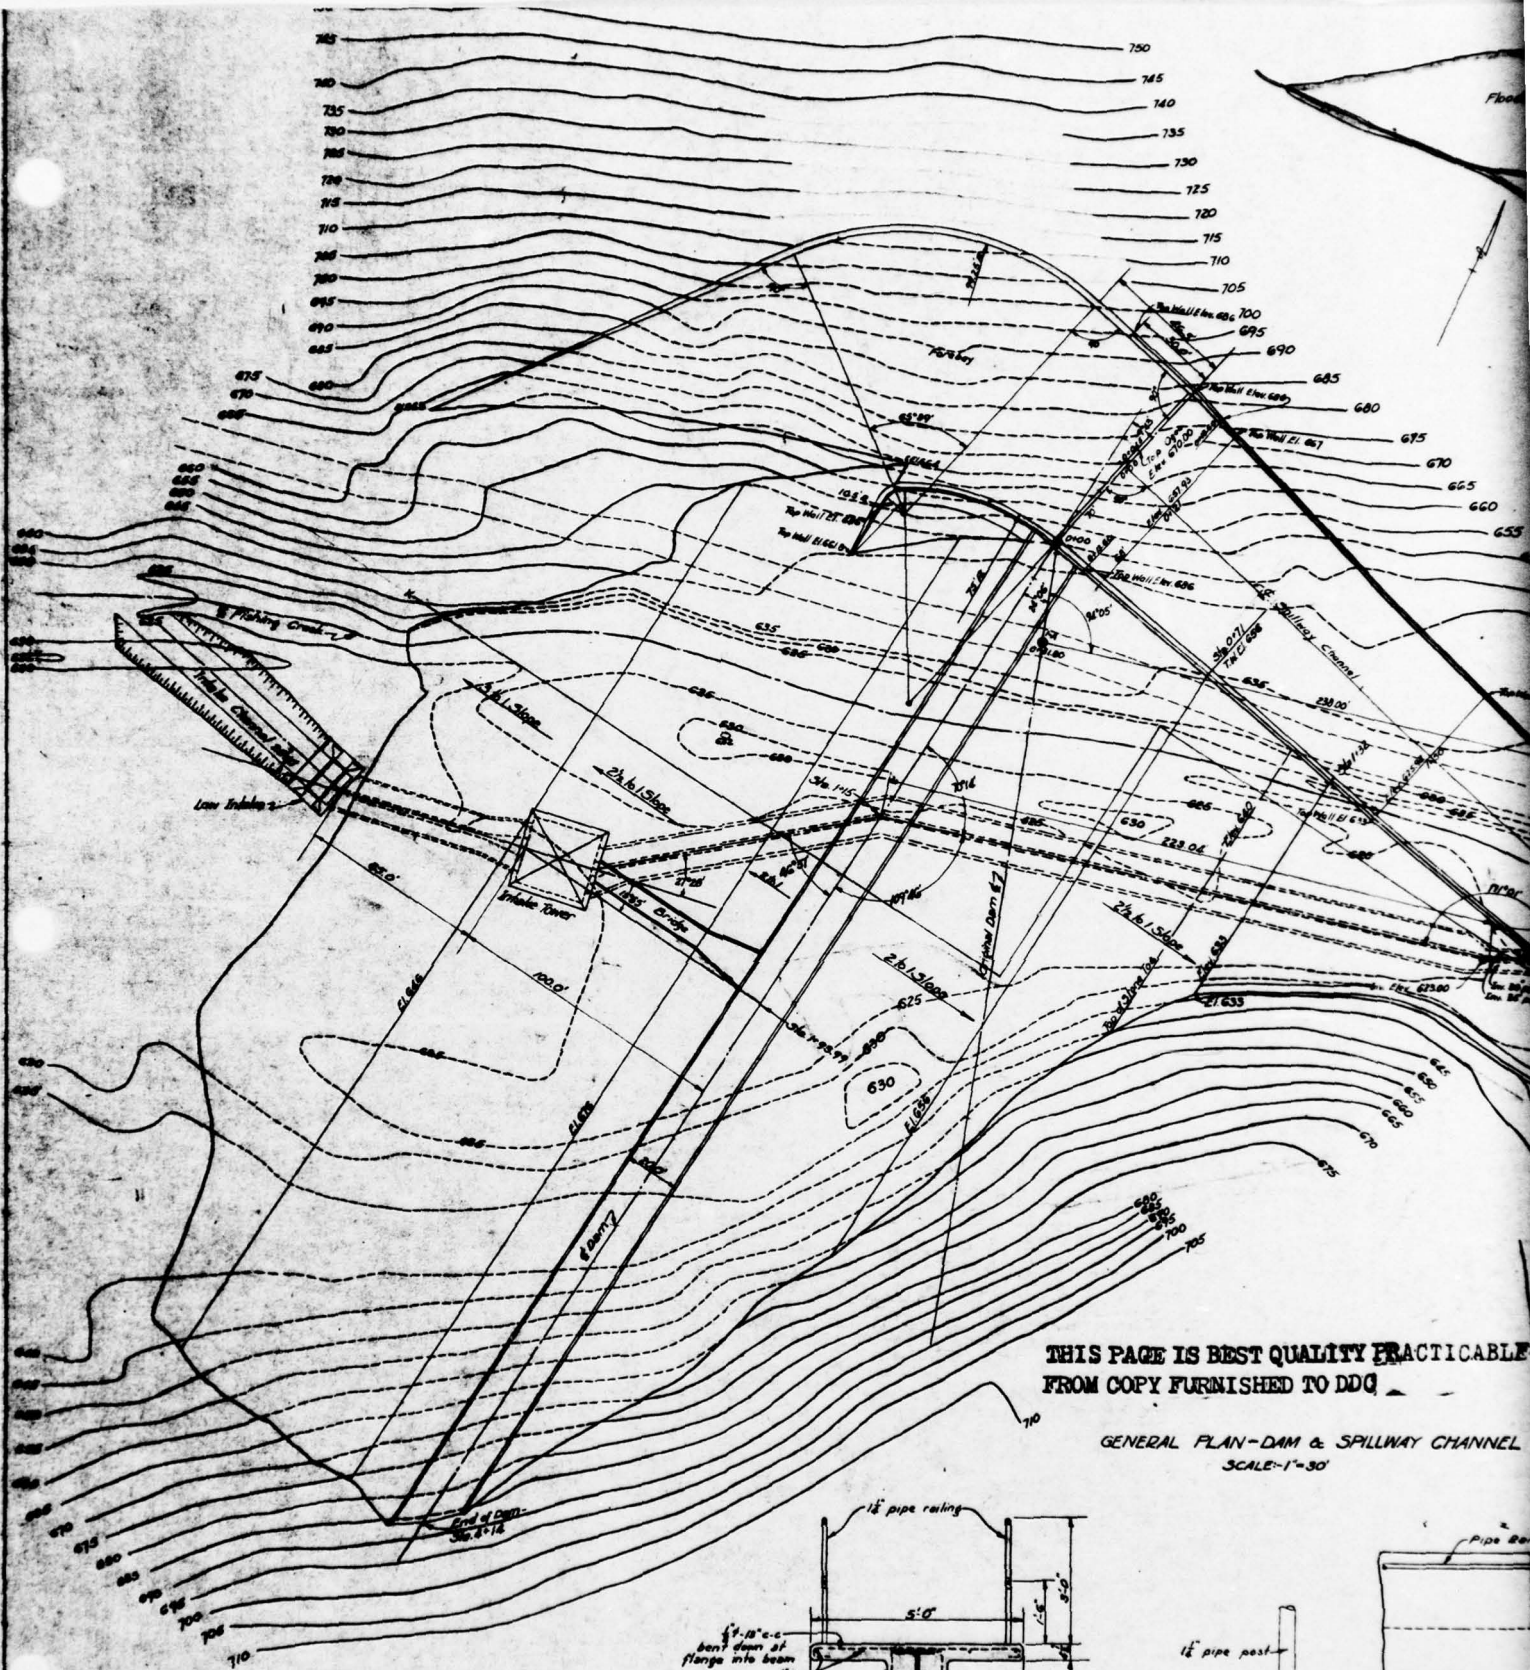
GENERAL PLAN - DAM & SPILLWAY CHANNEL
SCALE: 1" = 30'

The approach channel to the spillway abuts and is excavated into the natural rock formation. It appears to be in sound condition. The right side of the channel is formed by the concrete spillway wall and also is in good condition. The forebay is a curved approach to the spillway. Refer to Appendix D, Plate VII.

The spillway outlet chute is a concrete channel with vertical walls. Considerable cracking and deterioration of the walls was noted. The channel leads to the stilling basin downstream beyond which the discharge returns to the natural stream channel. Refer to Appendix D, Plate VII.
