ANTIETAM DAM

INVENTORY NUMBER NDS PA-332

PHASE I INSPECTION REPORT

6 NATIONAL DAM SAFETY PROGRAM.
Antietam Dam (NDS PA-332). Potomac River Basin, Adams County, Commonwealth of Pennsylvania. Phase I Inspection Report.

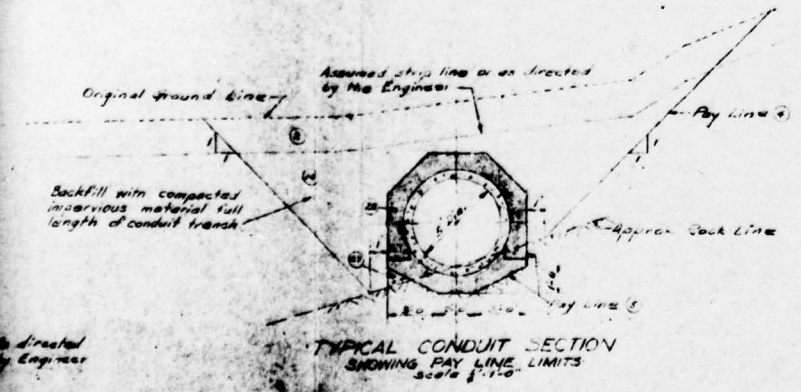
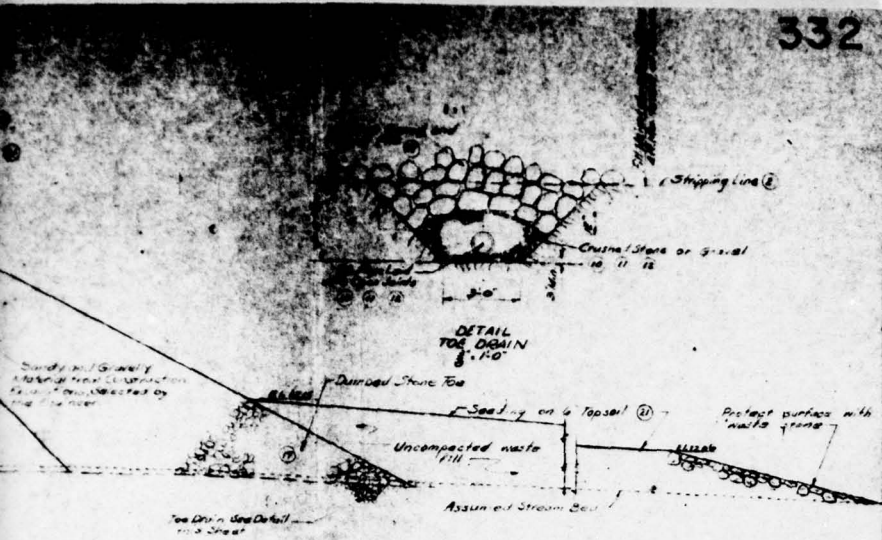
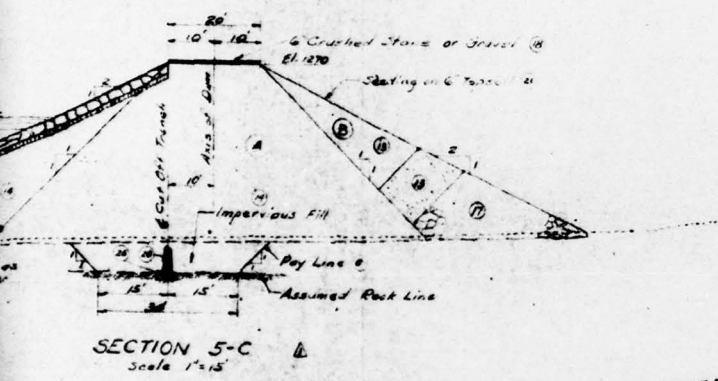
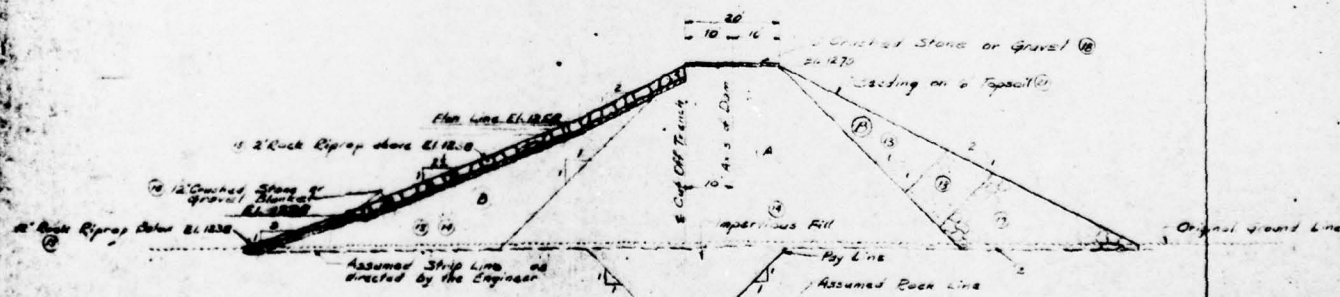
PLATE VII

A cutoff trench is provided and is filled with impervious earth. Drilling and pressure grouting was carried out in the underlying foundation rock formations. Refer to Appendix D, Plate VII.
