**NDI No. Pa.-355
GREENLICK RUN DAM**

**PHASE I INSPECTION REPORT
NATIONAL DAM INSPECTION PROGRAM**

**PREPARED BY
GAI CONSULTANTS, INC.
570 BEATTY ROAD
MONROEVILLE, PENNSYLVANIA 15146
OCTOBER 1978**

PHASE I INSPECTION REPORT
NATIONAL DAM INSPECTION PROGRAM
GREENLICK RUN DAM
NDI# PA-355, PENNDR# 26-97

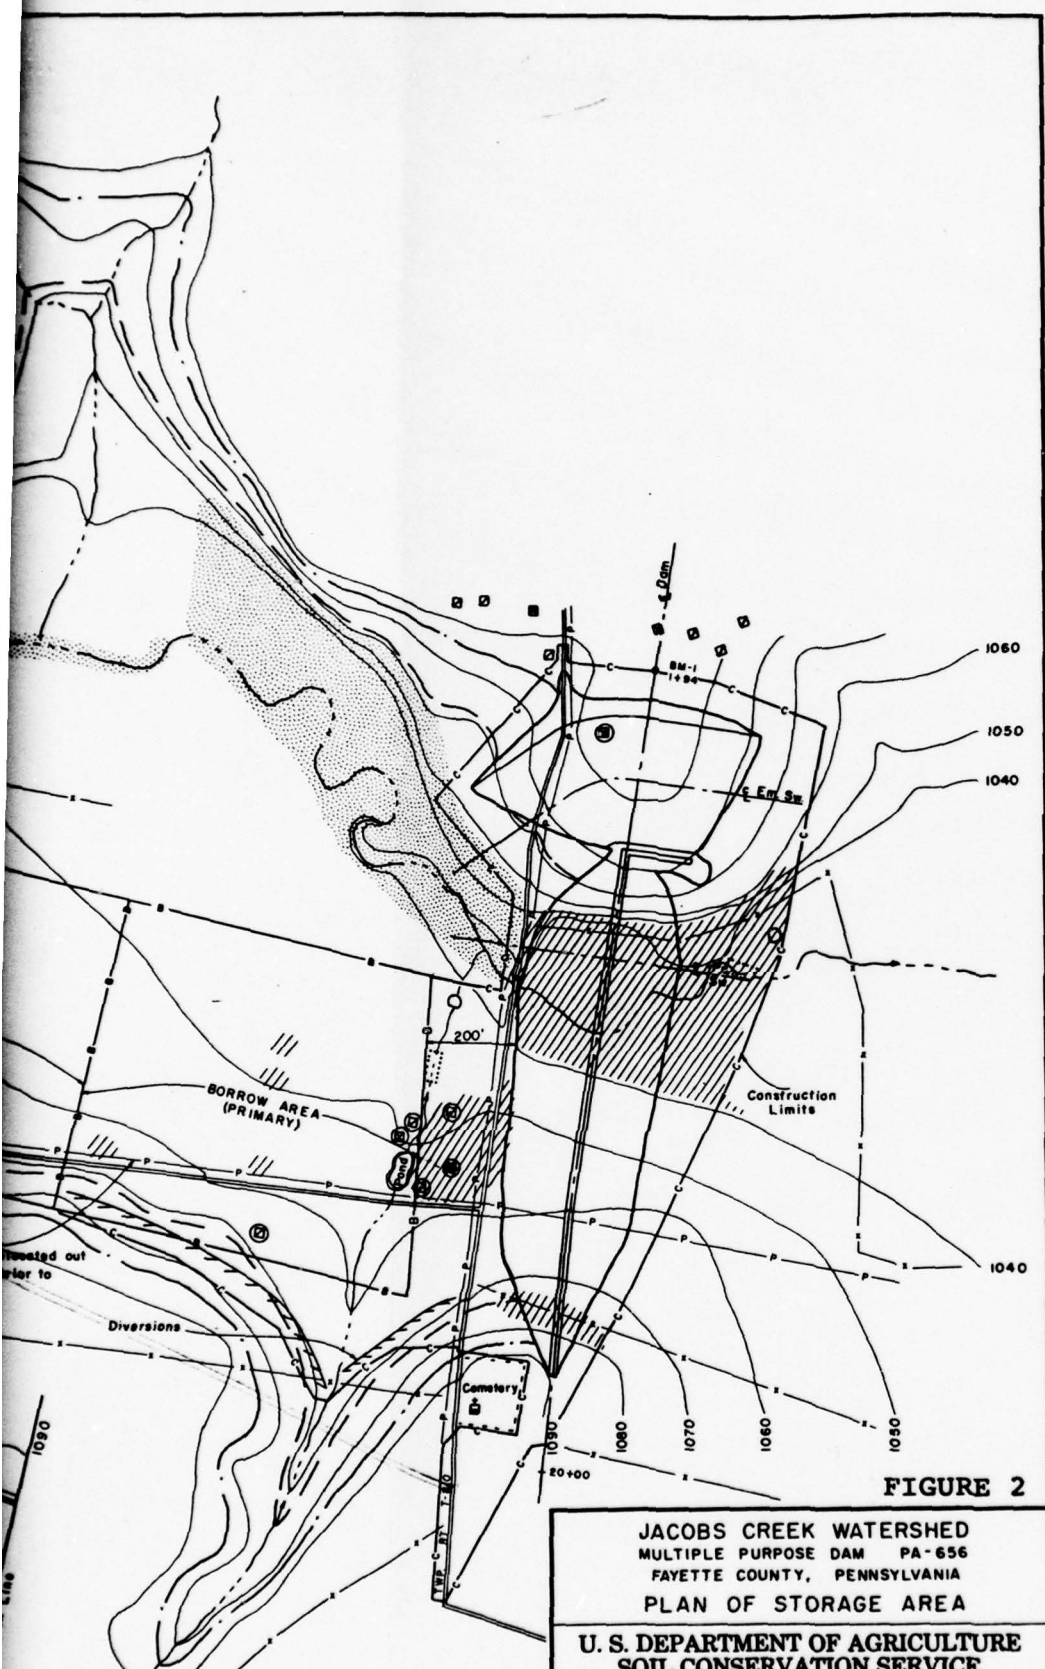
FIGURE 2

JACOBS CREEK WATERSHED MULTIPLE PURPOSE DAM PA - 656 FAYETTE COUNTY, PENNSYLVANIA PLAN OF STORAGE AREA			
U. S. DEPARTMENT OF AGRICULTURE SOIL CONSERVATION SERVICE			
Designed	Date	Approved by	Title
Drawn C. CRISE	5-69		
Traced	Sheet	Drawing No	
Checked <i>John D. ...</i>	2	PA - 656-P	
	of 37

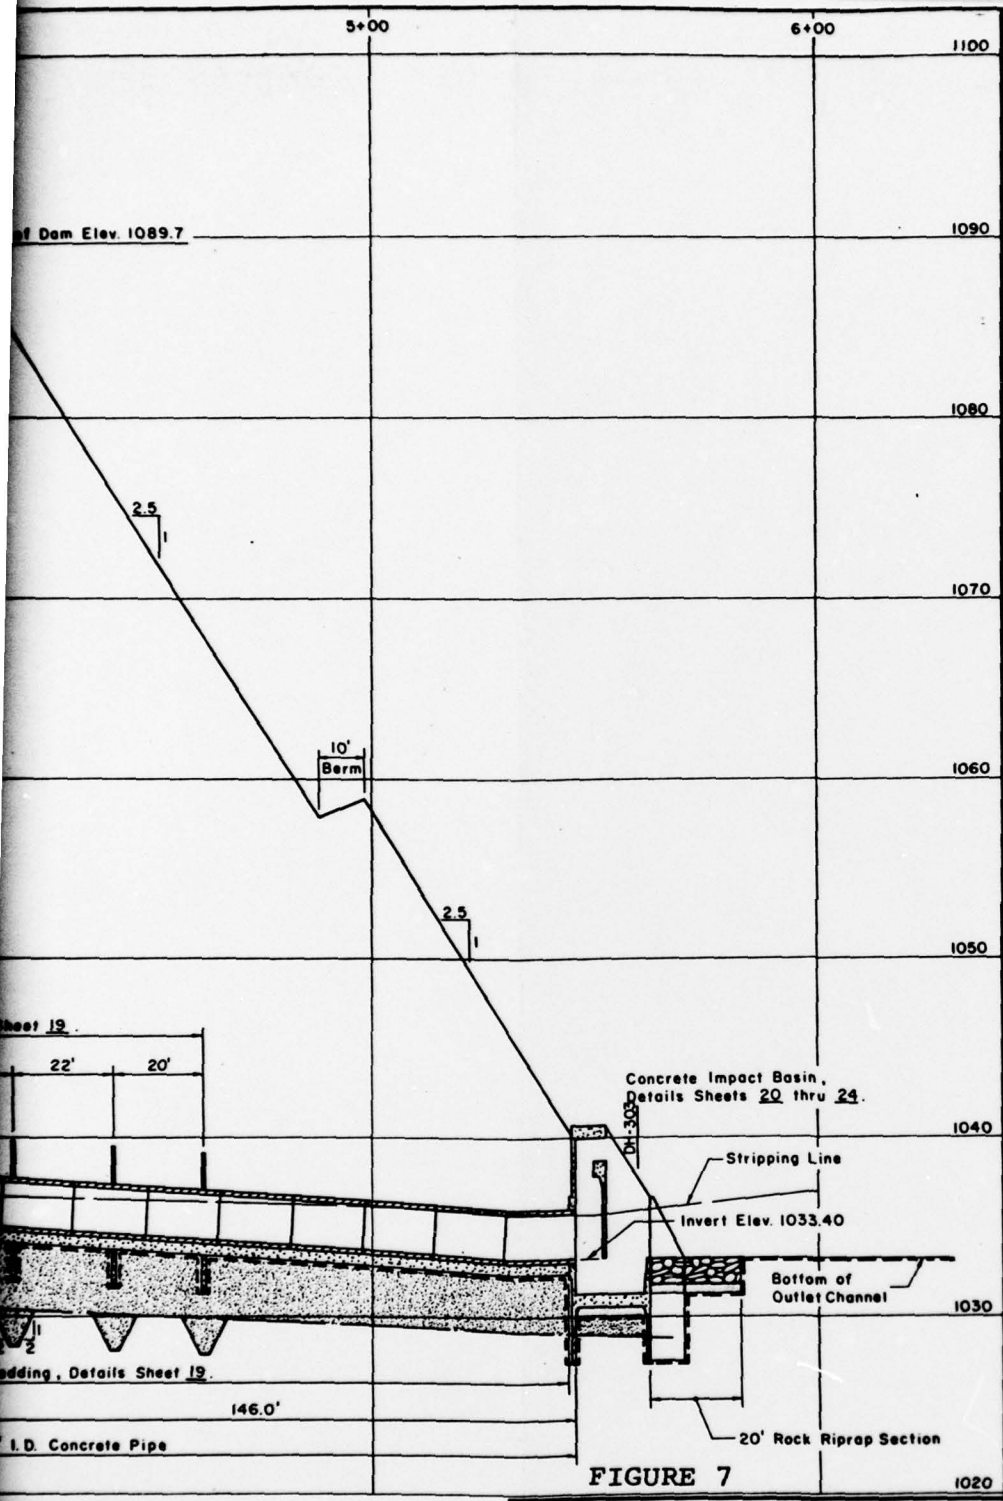
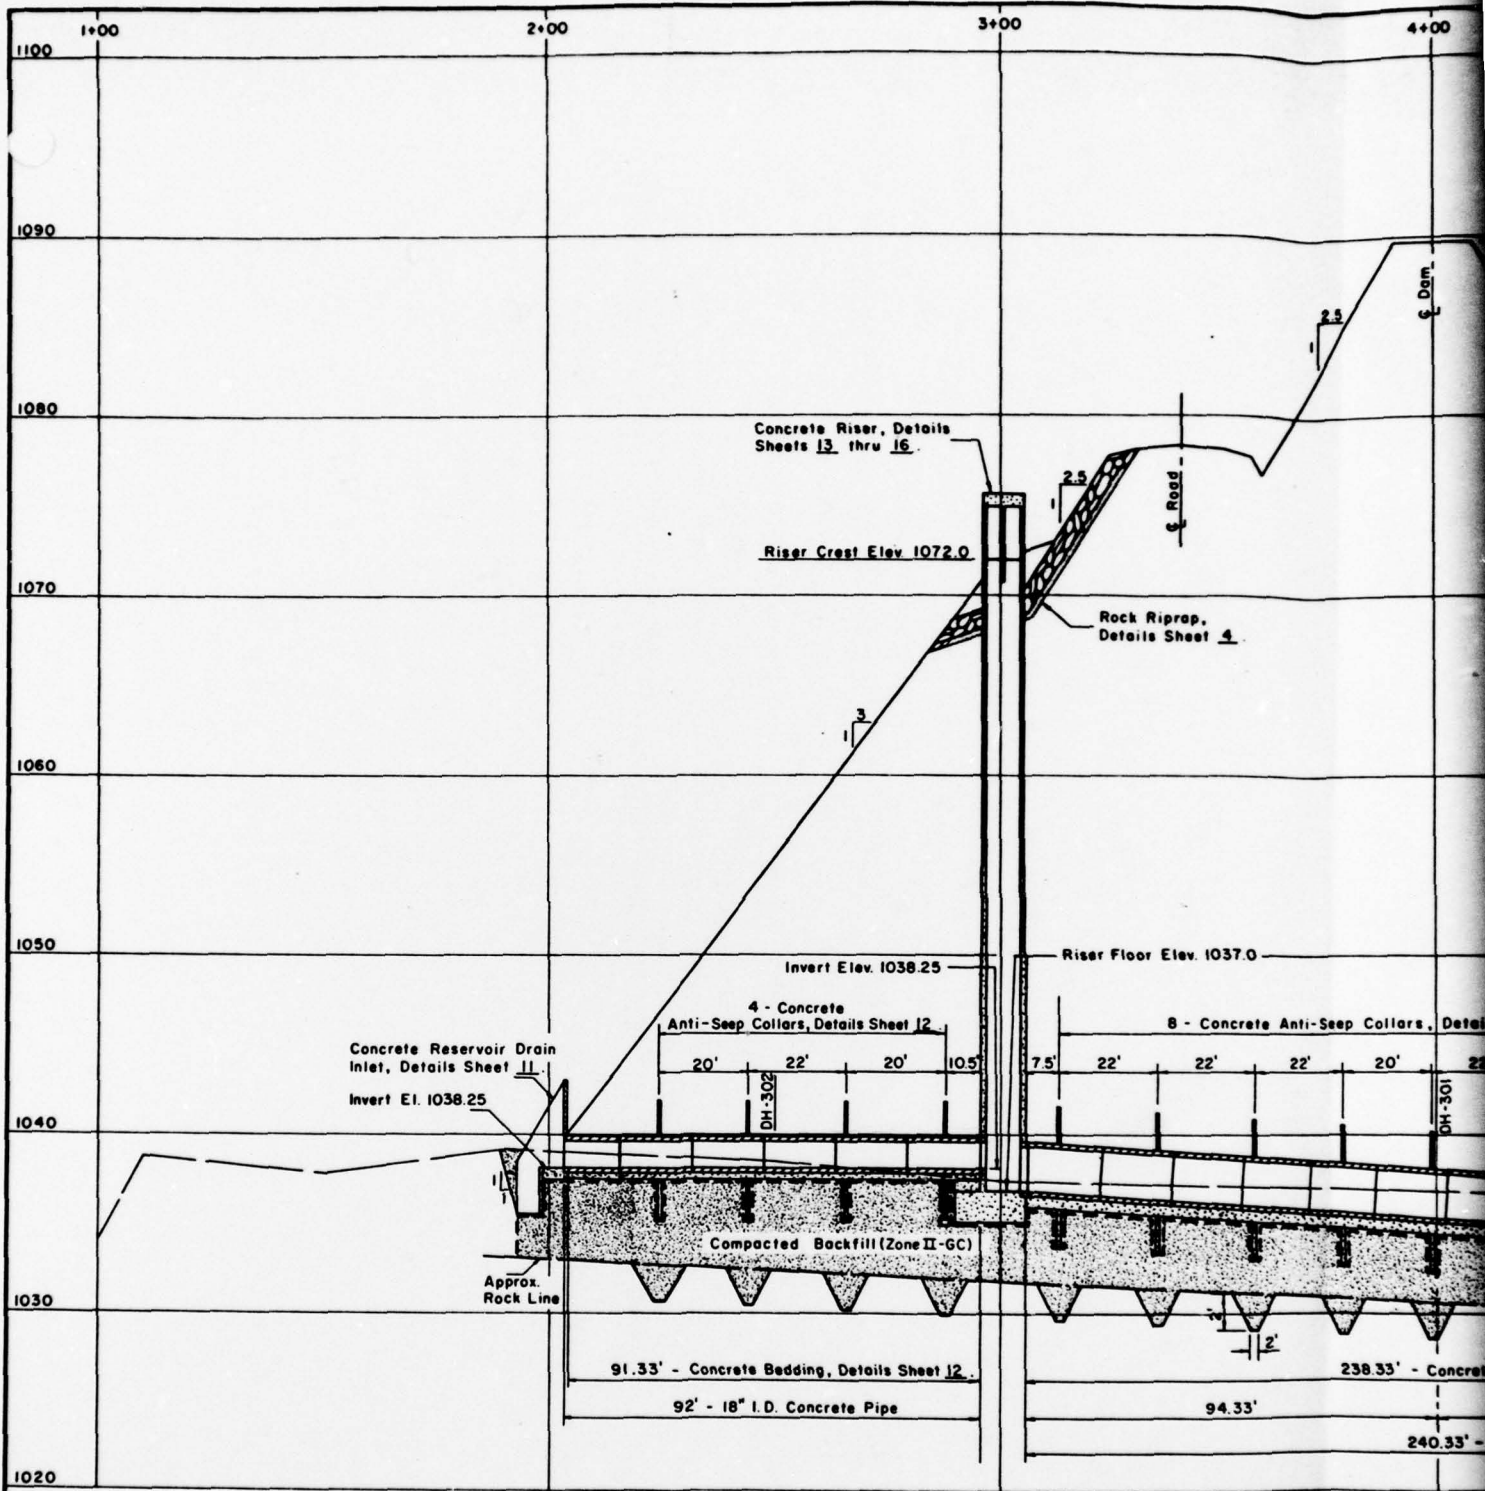
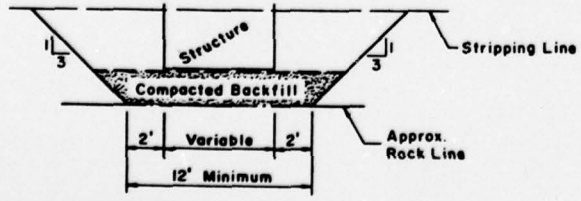
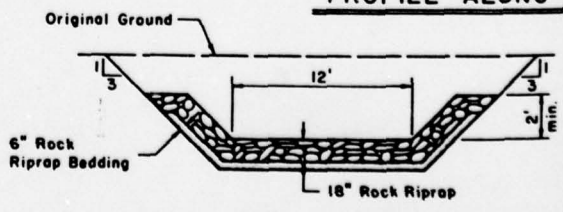
FIGURE 7

c) Outlet Conduit. An 18-inch diameter concrete low level outlet pipe has its intake at the upstream toe of the embankment and discharges into the base of the upstream face of the riser. This conduit is equipped with a slide gate mounted on the inside face of the riser which controls flow through the 30-inch diameter outlet pipe (see Figure 7).

3. Outlet Conduit. The only portion of the low level outlet conduit which could be visually inspected was the discharge end (see Figure 7 and Photograph 7). The concrete portion of the discharge basin is in good condition with only slight evidence of any deterioration. Immediately beyond the basin is a riprap-lined channel approximately 20 feet in length and 20 feet in width. The channel appears to contain an excess of riprap that may obstruct discharge through the outlet channel during high discharges (see Photograph 7).

Finally, it is recommended the excess riprap observed in the outlet channel be removed to eliminate undesirable tailwater conditions and the facility be inspected on an annual basis in order to detect any hazardous conditions which might develop.
