OHIO RIVER BASIN
McCUNE RUN, WESTMORELAND COUNTY
PENNSYLVANIA

NDI No. Pa. - 480
KEYSTONE DAM

PHASE I INSPECTION REPORT
NATIONAL DAM INSPECTION PROGRAM

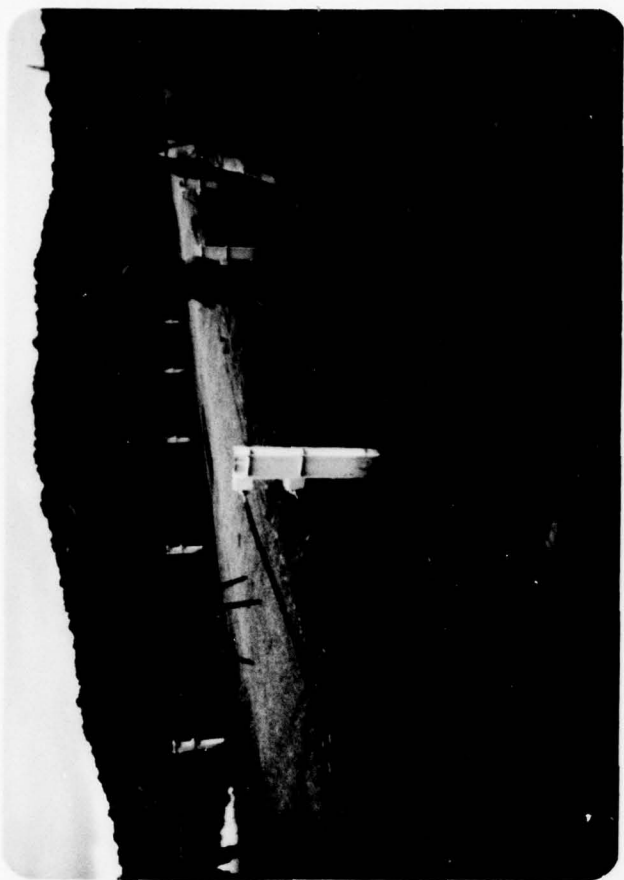
PHOTOGRAPH 8

Closure - An 18-inch bell geared valve and two 12-inch bell valves located in the valve house at downstream toe (see Photograph 8).

Detailed view showing the interior of the valve house.

b. Rehabilitation of the outlet works, including installation of controls at the upstream side of the outlet works to be used for periodic inspection and in the event that emergency conditions develop.

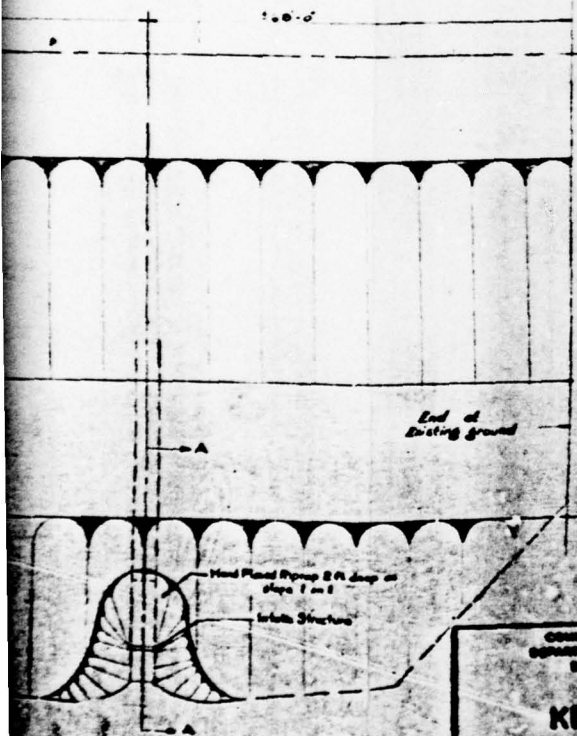
FIGURE 5

Zoning - None indicated. A riprap berm was constructed along the upstream toe in 1957 (see Figure 5, Appendix F).

A major modification of the embankment was made in 1957. A trapezoidal-shaped berm of riprap material was placed along the length of the upstream toe. The general configuration is shown in Figure 5.
