National Dam Safety Program, Pinchot Lake Dam (Inventory Number NDS 335), Susquehanna River Basin, Beaver Creek, York County, Pennsylvania. Phase I Inspection Report.

PINCHOT LAKE DAM

INVENTORY NUMBER NDS 335

PHASE I INSPECTION REPORT

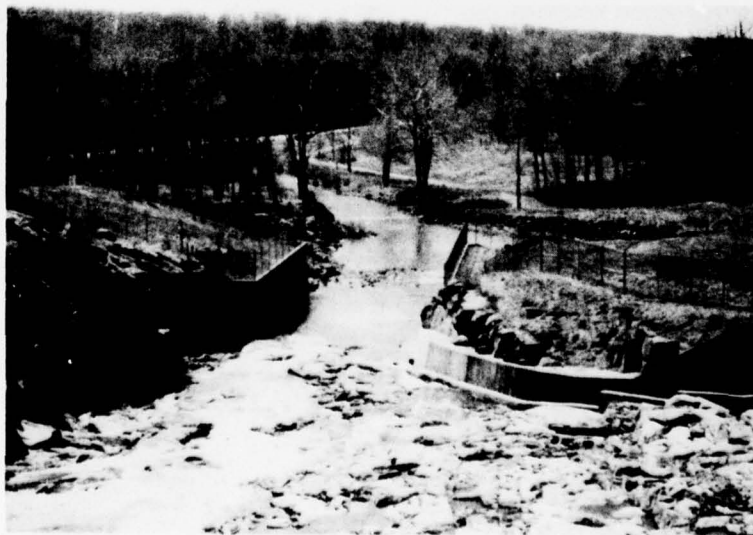
PLATE IV

The spillway crest is in good condition. Some of the joints cause a maintenance problem due to loosening of the sealer. One vertical joint indicated some seepage.

Notched Spillway
Ogee Weir
