REPORT NO. CG-D-02-79

IDENTIFICATION AND EVALUATION OF DEEPWATER PORT HOSE INSPECTION METHODS

U.S. DEPARTMENT OF TRANSPORTATION
RESEARCH AND SPECIAL PROGRAMS ADMINISTRATION
Transportation Systems Center
Cambridge MA 02142

JANUARY 1979

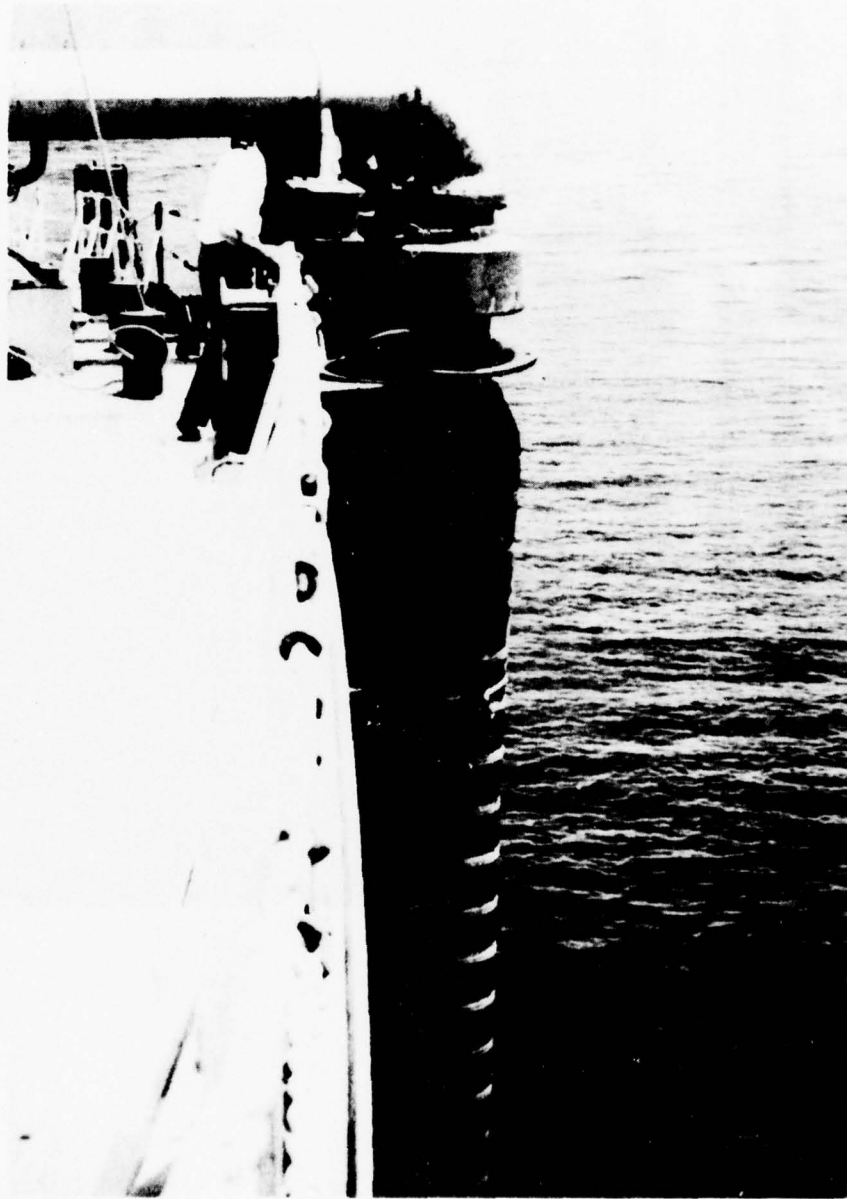
FIGURE 5-1. "OVER-THE-RAIL" STEEL ELBOW AND NIPPLE

that go to a particular terminal do not have sufficient hoist capacity to handle the hoses and therefore, "man handle" the hoses severely. Hose connections are not a standard height or distance from the rail. The Japanese do not use an "over-the-rail" hose; instead they use a steel elbow and nipple as shown in Figure 5-1.

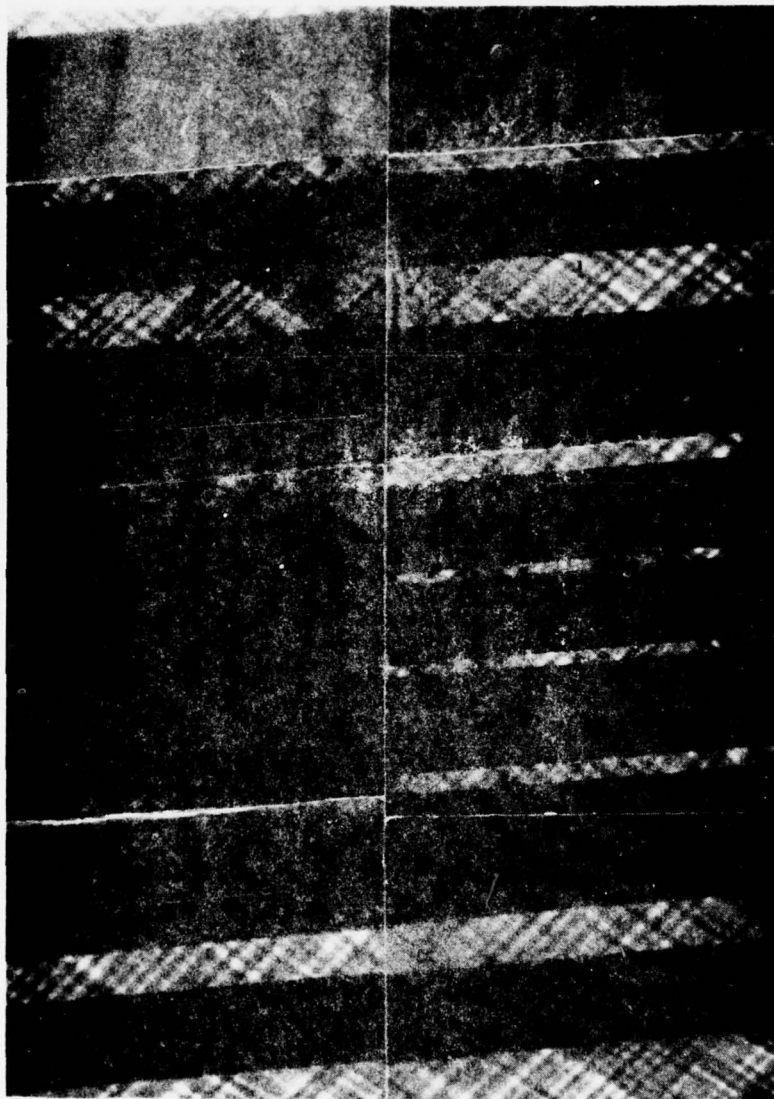
FIGURE 7-1. X-RAY OF HOSE SECTION (COMPOSITE)

Figure 7-1 is an x-ray composite of a section of the 24 inch hose used in this work. It was found that a power level of 70 KV was adequate to penetrate the hose material. In this particular hose, there were two helical wire reinforcements - an inner and outer helix - the inner helix having a bend radius about 1 inch less than that of the outer helix. It can be seen in the figure that the two helices appear to have different wire diameters. The two wires were in fact the same diameter, and the apparent difference is due to the fact that the x-ray source was, in this application, essentially a point source. This resulted in a cross-sectional projection of the wires on the film with dimensions dependent upon the distances among wire, source, and film. The wire of apparent smaller diameter is that nearest the film.

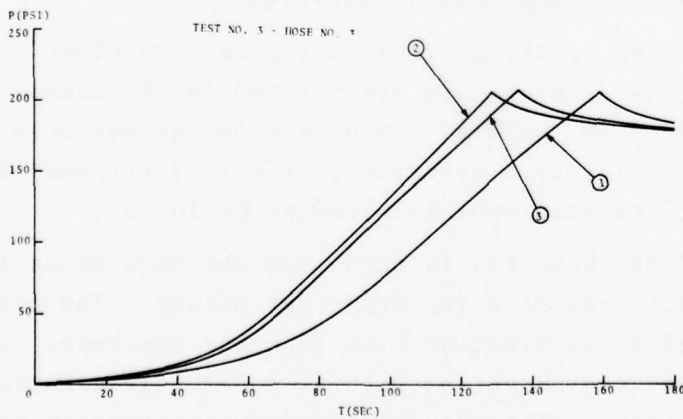
FIGURE 7-4c. DOCK HOSE PRESSURE-VOLUME DATA (HOSE NO. 3)

Figure 7-4c (hose #3) is data from the hose that had been subjected to excessive tensile stress. From cycle (1) to cycle (2) it can be seen that substantial hysteresis effects are present while some recovery is noted in cycle (3). Although this hose also had a steel helix-reinforcement, it was found to be excessively compliant as can be seen from the curves.

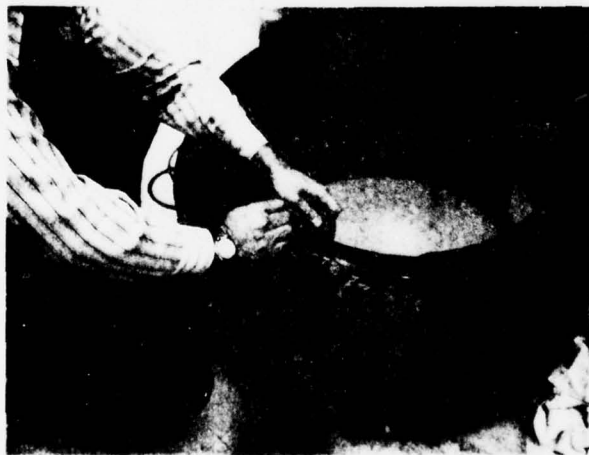
FIGURE 7-6. APPLICATION OF ULTRASONIC PROBE TO HOSE LINER

used, specifically, a Krautkramer-Branson "Sonoray 600", which has available a wide range of parameter adjustment and display options, making it suitable for use in testing rubber products. Figure 7-6 is a photo showing the method of applying the probe to the liner. The couplant used was a commercial water-based product (EXOSIN-2) with the consistency of a semi-fluid gel, but other fluid or semi-fluid materials such as glycerine, grease, motor oil, etc., could be used.

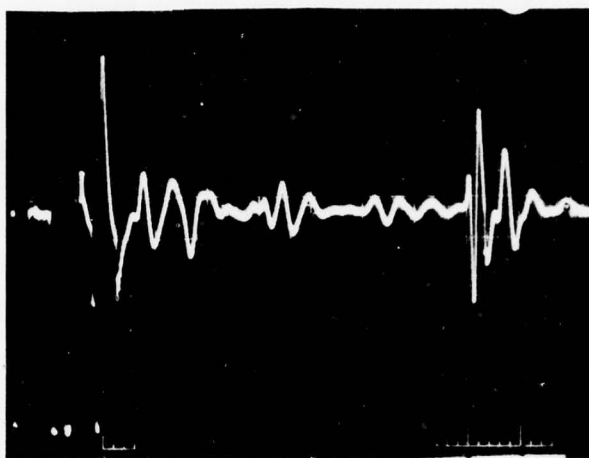
FIGURE 7-7. ULTRASONIC SCAN OF INTACT HOSE

Figures 7-7, and 7-8, show the resulting traces, at well-bonded and separated spots respectively, seen when the transducer and Plexiglas delay buffer assembly is pressed against the liner. A delayed sweep has been used to eliminate the round-trip travel time in the Plexiglas buffer, so that the first interface reflection, i.e., (the first echo from the back face of the Plexiglas) appears at the left edge of the screen. Figure 7-7 is an image of the display when scanning a section of hose having its liner tightly bonded to the hose body. Figure 7-8 is a trace showing a reflection from a separation between the liner and the hose body. It is apparent that ultrasonic detection of liner separation in deepwater port hose is clearly feasible using techniques well within the state-of-the-art.

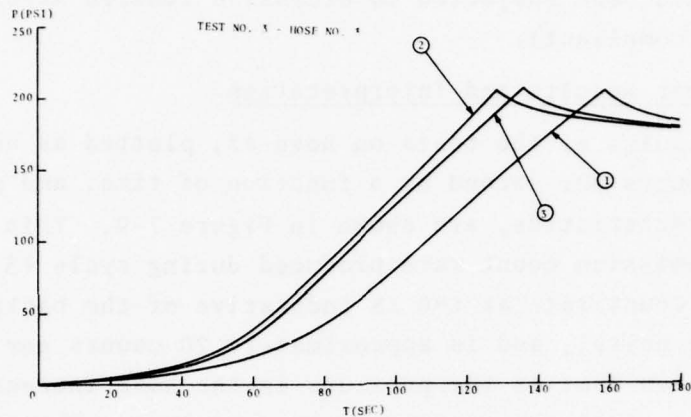
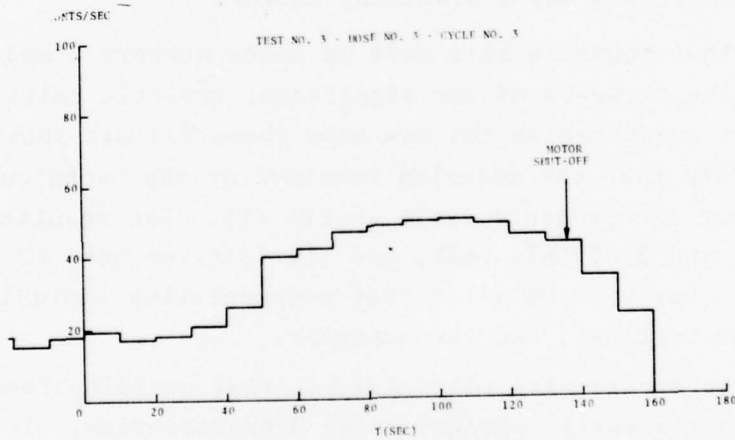
FIGURE 7-9. ACOUSTIC EMISSION AND PRESSURE VOLUME DATA (HOSE #3)

The results of the tests on hose #3, plotted as acoustic emission counts per second as a function of time, and pressure-volume characteristics, are shown in Figure 7-9. This figure shows the emission count rate produced during cycle #3 of this test. The count rate at $t=0$ is indicative of the background noise level (pump noise), and is approximately 20 counts per second. It can be seen that as the pressure in the hose increased to about 130 psi, the count rate increased to a maximum. The rate declined slightly thereafter until the motor was shut off at the maximum pressure. The rate then fell off sharply and went to zero at 160 seconds. It should be noted that the hose continued to emit even after the motor was shut off and the pressure was maintained. As this was the third cycle of the test, it is apparent that the Kaiser effect was not a prominent factor.

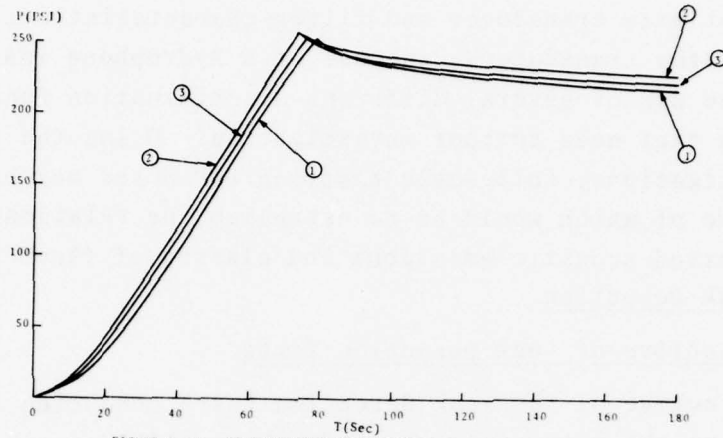
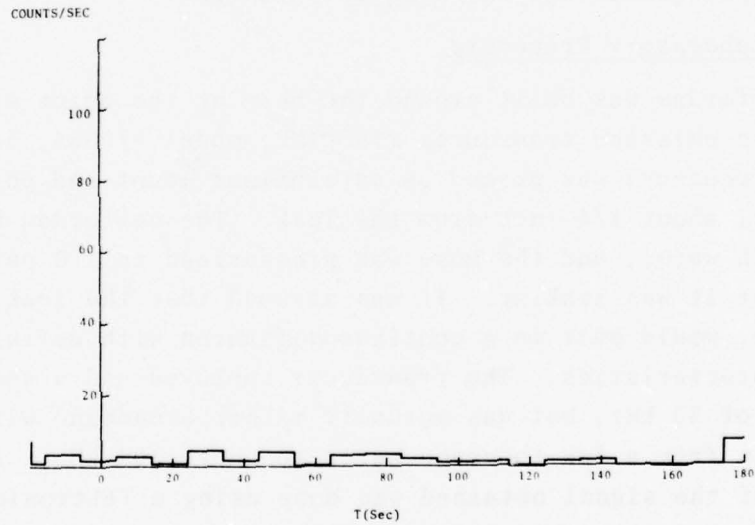
FIGURE 7-10. ACOUSTIC EMISSION AND PRESSURE VOLUME DATA (HOSE #1)

Further tests in this mode on hoses numbers 1 and 2 failed to show the presence of any significant acoustic emissions. Results of a test conducted on the new hose (hose #1) are shown in Figure 7-10. Note that the emission remained at the background level throughout the pressure cycle (cycle #1). The results for cycles numbers 2 and 3 of this test, and the tests on hose #2 were similar. For more detailed test documentation including instrumentation settings, see the Appendix.

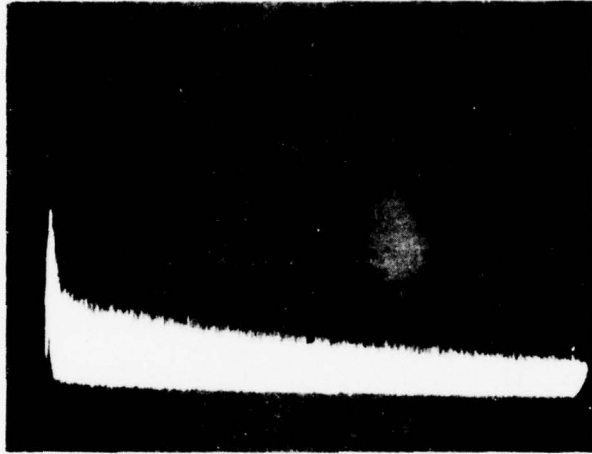
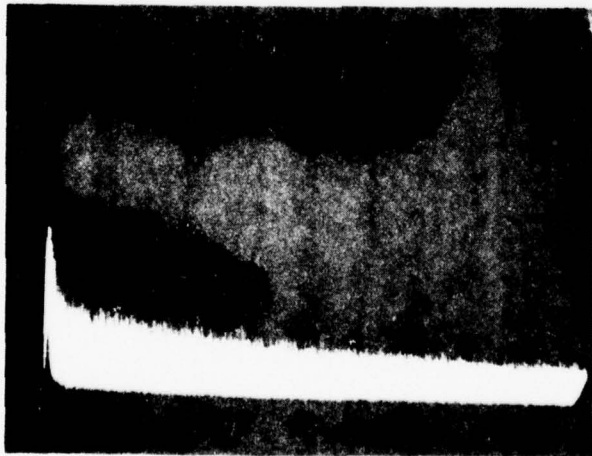
The signal frequency spectrum from 0-100 kHz obtained with the hose at ambient pressure is shown in Figure 7-11a. It is nothing more than a relative measure of system noise. The spike at the far left is a spurious dc signal with no physical meaning. The hose was then pressurized to 170 psi to assure a leak, and the spectrum from 0-100 kHz was again recorded. This is shown in Figure 7-11b; and as can be seen, there is no significant difference between this recording and the one obtained at ambient pressure.

It is recommended that the same experiment (which takes less than a day to perform) be carried out with a low frequency hydrophone. Leaks of various sizes and types (induced in the laboratory) should also be investigated to determine the limitations of the measurement equipment in this application.

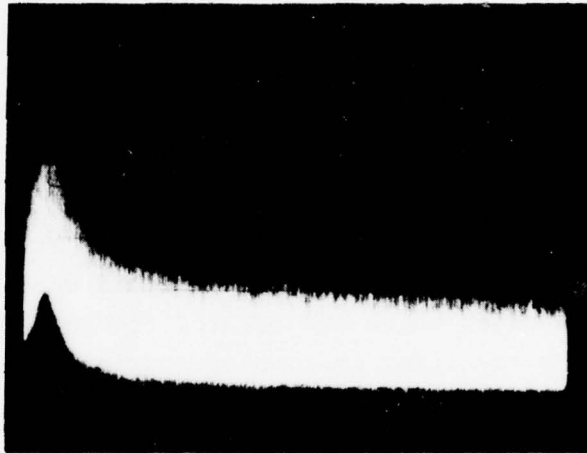
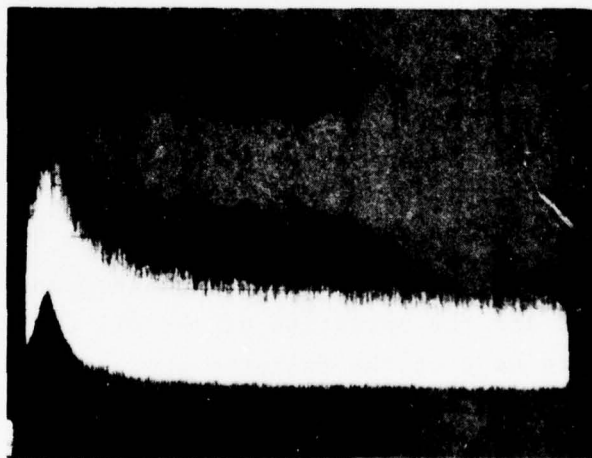
To examine the lower frequencies in more detail, tests were performed again, this time recording spectral information from 0-10 kHz. The result with the hose at ambient pressure is shown in Figure 7-12a, and the result with the hose at 170 psi is shown in Figure 7-12b. Again, there is no discernible difference between these spectral measurements. The whole spectrum was also examined in 1000 Hz increments from 0-100 kHz; and again, no differences could be detected between the spectral content when the hose was at ambient pressure and when it was at 170 psi.
