HUDSON RIVER BASIN
CAMP HARRIMAN DAM
GREENE COUNTY, NEW YORK
INVENTORY NO. 552

PHASE I INSPECTION REPORT
NATIONAL DAM SAFETY PROGRAM

HUDSON RIVER BASIN
CAMP HARRIMAN DAM
INVENTORY NO. 552
PHASE I INSPECTION REPORT

Name of Dam	CAMP HARRIMAN DAM (I.D. NO. 552)
State Located:	NEW YORK
County Located:	GREENE COUNTY
Stream:	EAST KILL, SCHOHARIE CREEK
Date of Inspection:	AUGUST 30, 1978

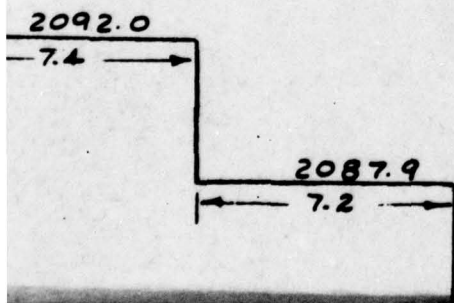
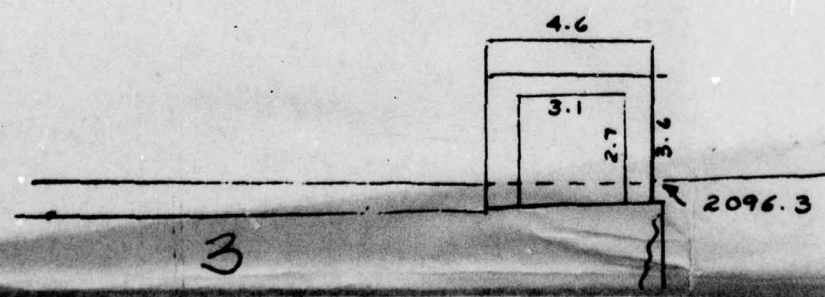
DAM FACE GENERALLY
GOOD

SPILLWAY GATE
365 WIDE x 3.4' HIGH (V. PROBE)
EL. TOP 2190.2 BOT 2186.8

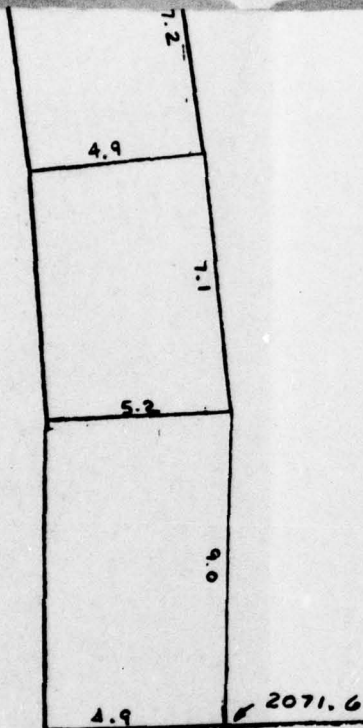
PLAN of MAIN SPILLWAY
SCALE 1" = 5'0"

CONCRETE APRON
BADLY ERODED

- Repair and maintain pavement on the dam crest
- Repair the main spillway
- Fill cavities under the auxiliary spillway
- Maintain the emergency relief channel in a clear and operable condition for a full 100 ft width
