LOWER TUMBLING RUN DAM

**PHASE I INSPECTION REPORT
NATIONAL DAM INSPECTION PROGRAM**

AUGUST 1978

LOWER TUMBLING RUN DAM
SCHUYLKILL COUNTY, PENNSYLVANIA
NATIONAL I.D. NO. PA 00688

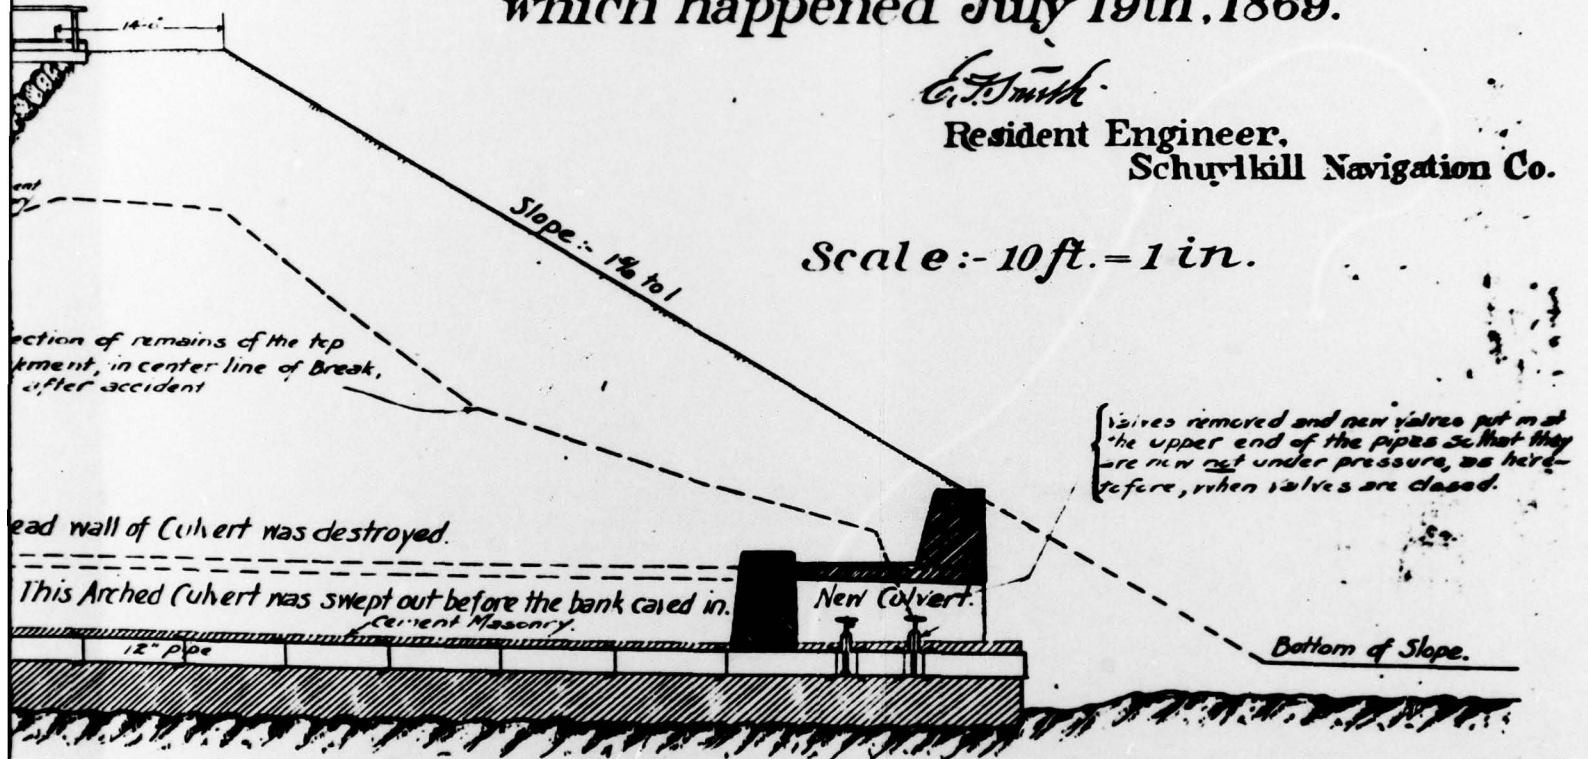
TYPICAL CROSS SECTION OF EMBANKMENT LOWER TUMBLING RUN DAM	
NAT. ID NO. PA.00688	SCHUYLKILL COUNTY
DATA OBTAINED FROM DEPARTMENT OF ENVIRONMENTAL RESOURCES, HARRISBURG, PA.	
	PLATE 4

Before 1869, the water supply pipes were always under full hydrostatic head. These pipes apparently cracked and the resulting leakage was large enough to cause piping and eventual embankment failure in 1869. As shown on Plate 4, the top of the dam dropped 10 feet. The pipes were repaired, encased in concrete for part of their length, and the valves moved to the upstream end of the pipes.

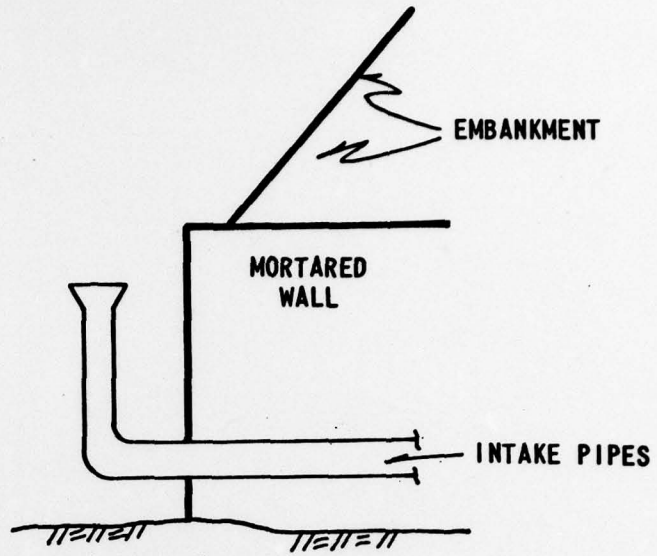
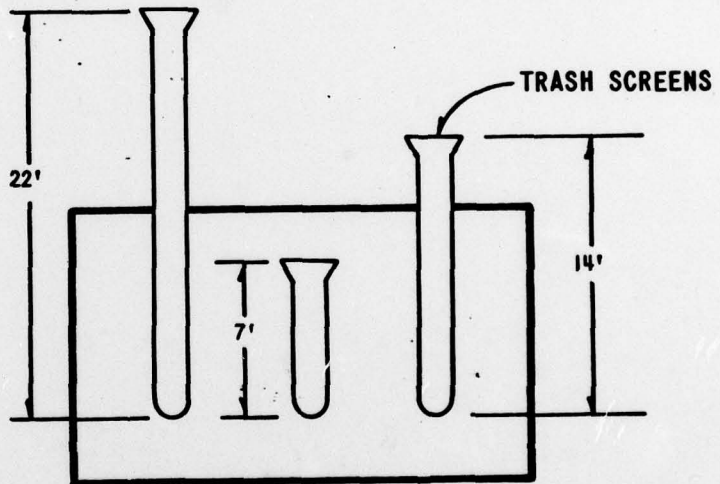
SECTION OF WATER SUPPLY INTAKE STRUCTURE LOWER TUMBLING RUN DAM		
NAT. ID NO. PA.00688		SCHUYLKILL COUNTY
DATA OBTAINED FROM VERBAL REPORTS FROM THE OWNER		
		PLATE 5

1. Outlet Works. The intake structure and cast iron pipes were submerged during the visual inspection and could not be inspected. The access bridge to the intake valves consists of a steel frame structure with wood planking. The concrete supports of the bridge were noted to have a number of cracks, but appeared to be stable. It was reported by Mr. Charles Feindler, Borough Manager, that the intakes for the vertical riser pipes are approximately 7, 14 and 22 feet above the base of the intake structure. They are connected to three 12-inch diameter cast iron pipes. See Plate 5 for details.

1. The spillway system should be reconstructed to meet current hydrologic/hydraulic criteria.
2. Prepare As-Built drawings in conjunction with a geotechnical investigation and stability analysis performed under the direction of a registered professional engineer. See Section 7 for details.
3. The outlet works should be inspected and repaired as necessary.
