**PENNSYLVANIA
ID NO. PA.00059**

ROCK RUN DAM

PHASE I INSPECTION REPORT NATIONAL DAM INSPECTION PROGRAM

AUGUST 1978

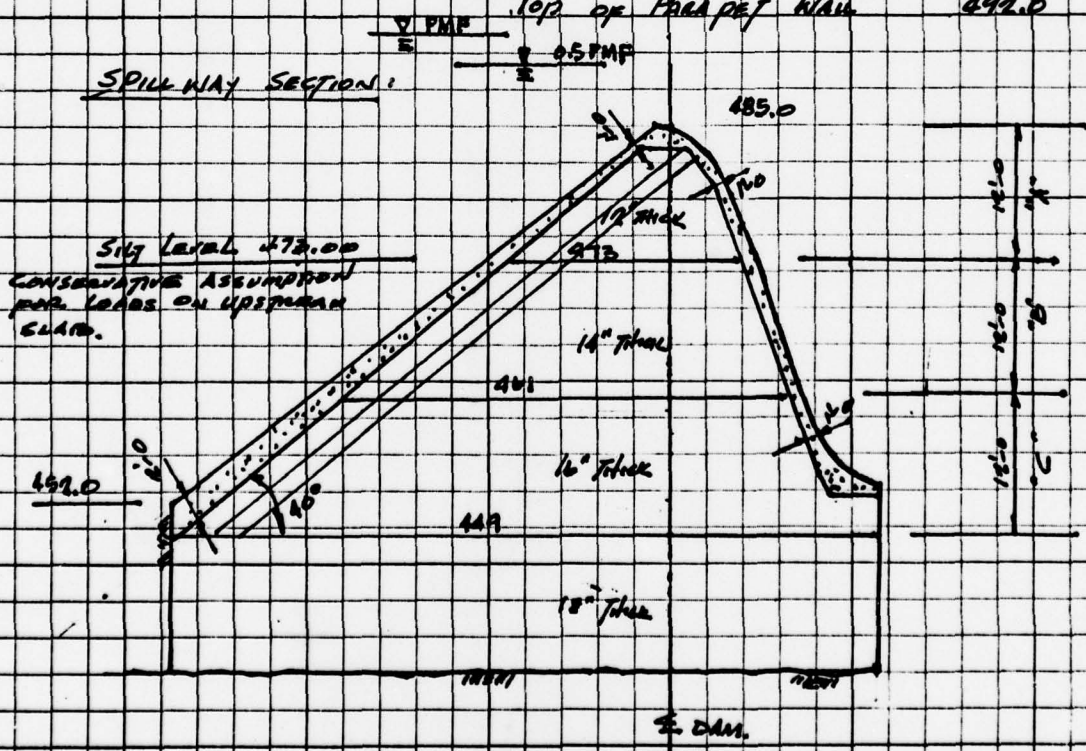
TYPICAL BUTTRESS AT SPILLWAY - BAY SIZE 15'-0"

NOTE: THIS IS THE SMALLEST SECTION OF DAM. THIS SECTION GOVERNS STABILITY OF THE DAM.

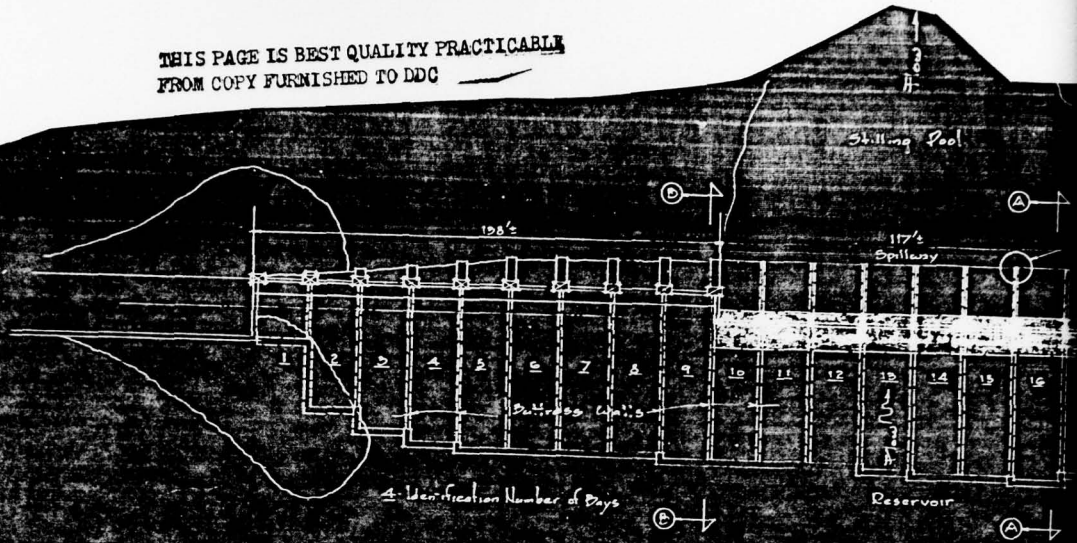
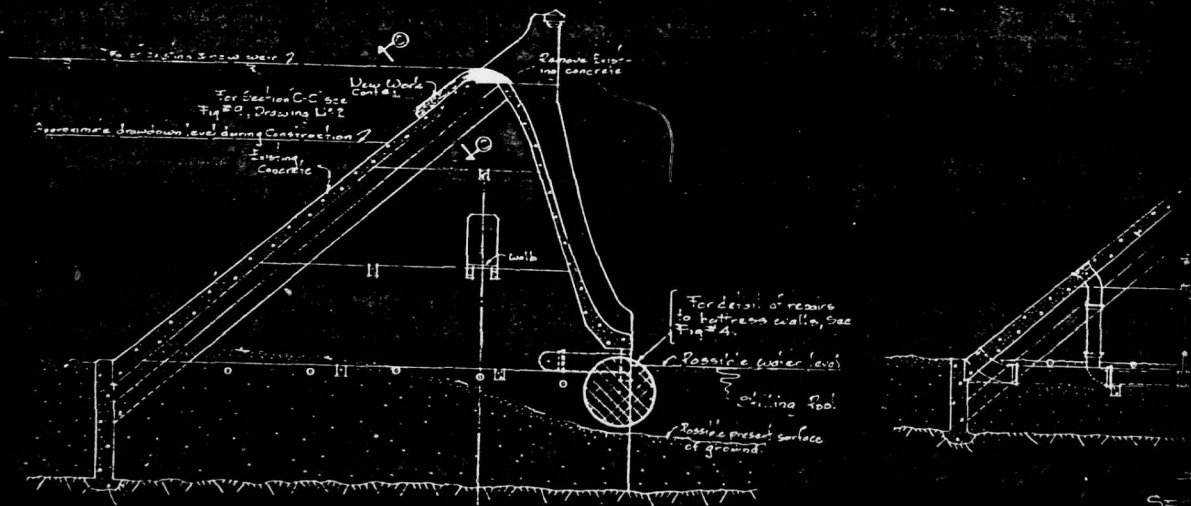
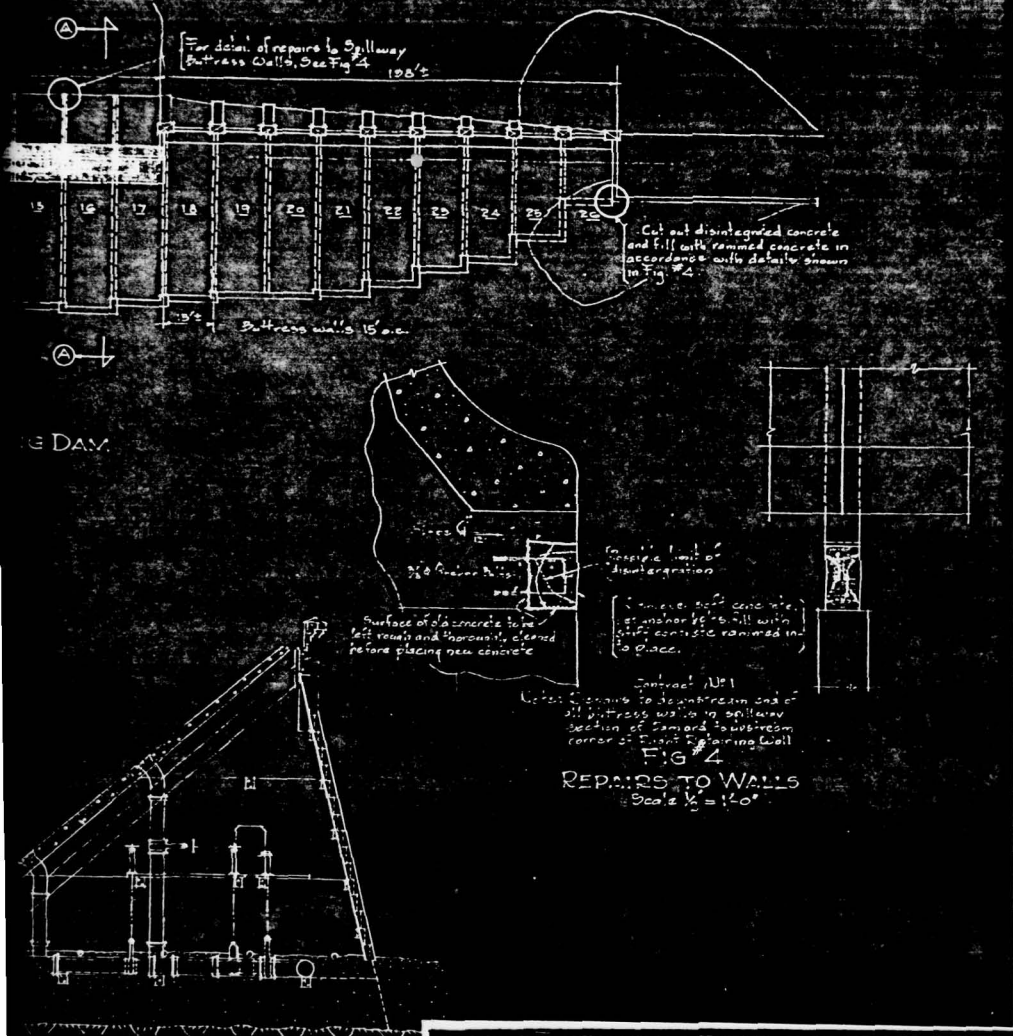
PLAN OF DAM & APPURTENANCES ROCK RUN DAM	
NAT. ID NO. PA.00059	CHESTER COUNTY
DATA OBTAINED FROM ALBRIGHT & FRIEL, INC., CONSULTING ENGINEERS, PHILA., PA., PLAN NO. 48060-1, DATED SEPT., 1949	
2	PLATE 2

As shown on Plate 2, Appendix E, the dam is a concrete slab and buttress structure with the upstream slab inclined at an angle of 40° from the horizontal. The downstream batter is 1H:4V. The dam contains 27 buttress walls forming 26 bays supported directly on decomposed or intact rock. Each bay is 15 feet on center for a total length of 513 feet. Wing walls extend beyond the buttress walls, increasing the length of the dam to approximately 583 feet. The spillway is located between bays 10 through 17 with a notched section between bays 13 and 14, as shown on Plate 2. The crest elevation is 485 feet (MSL) at the notch and the remainder of the spillway is 2 inches above the notch. The parapet walls extend to elevation 492.

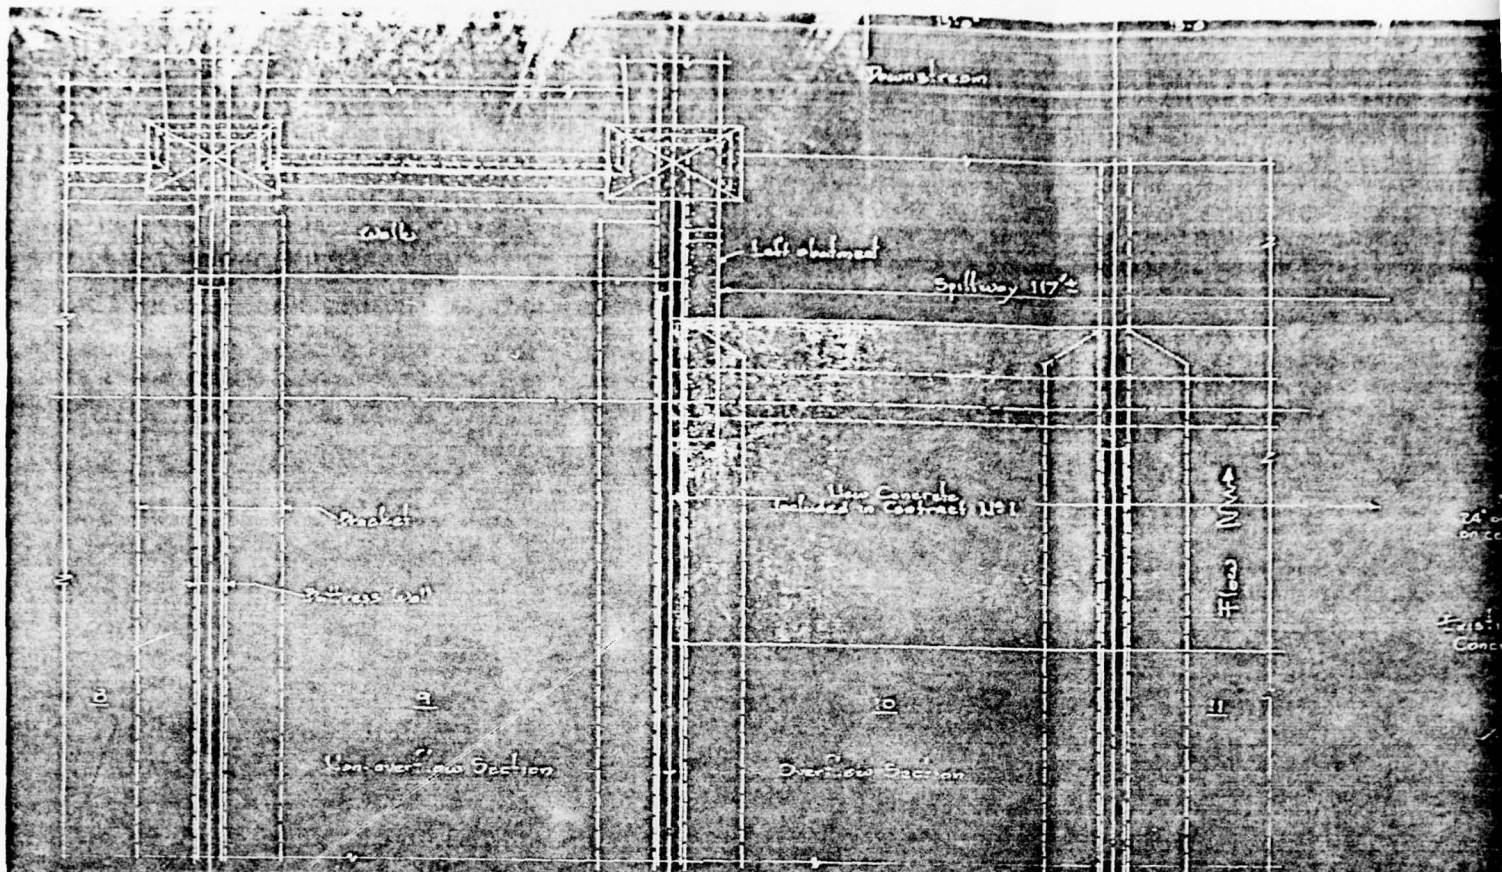
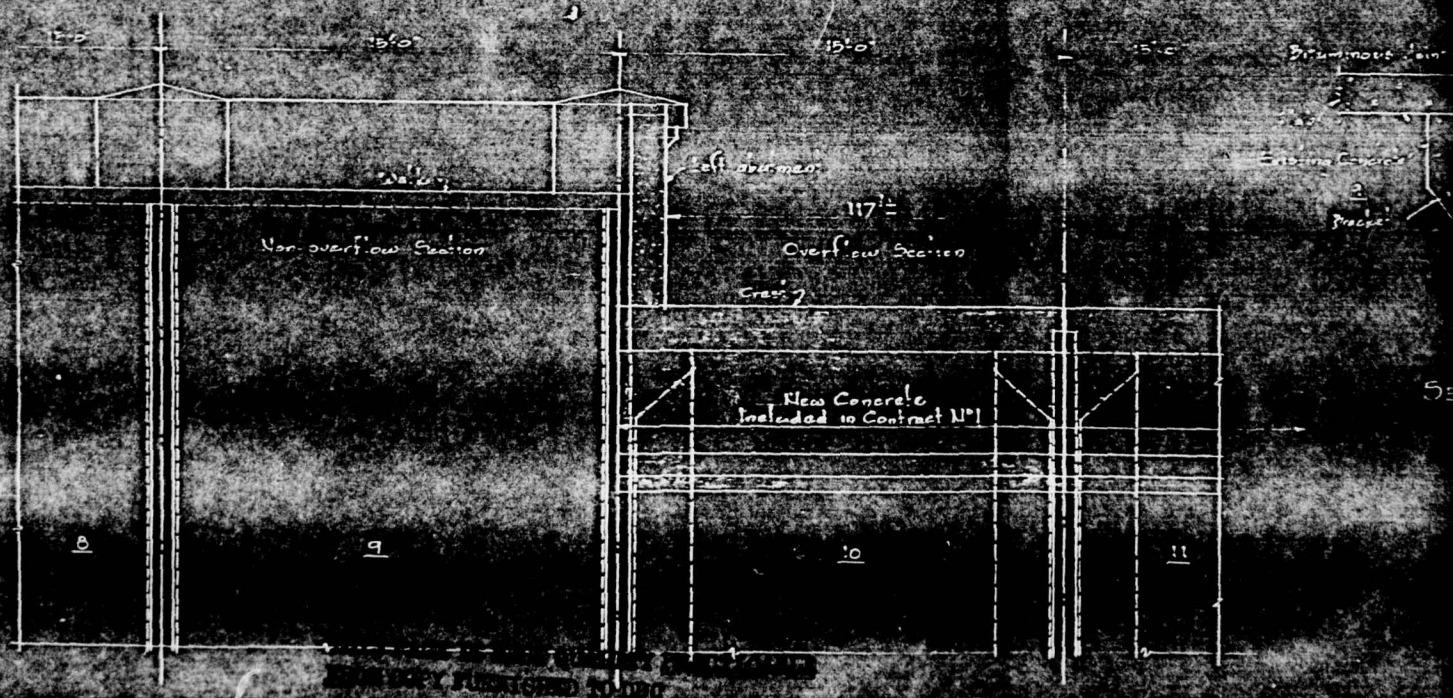
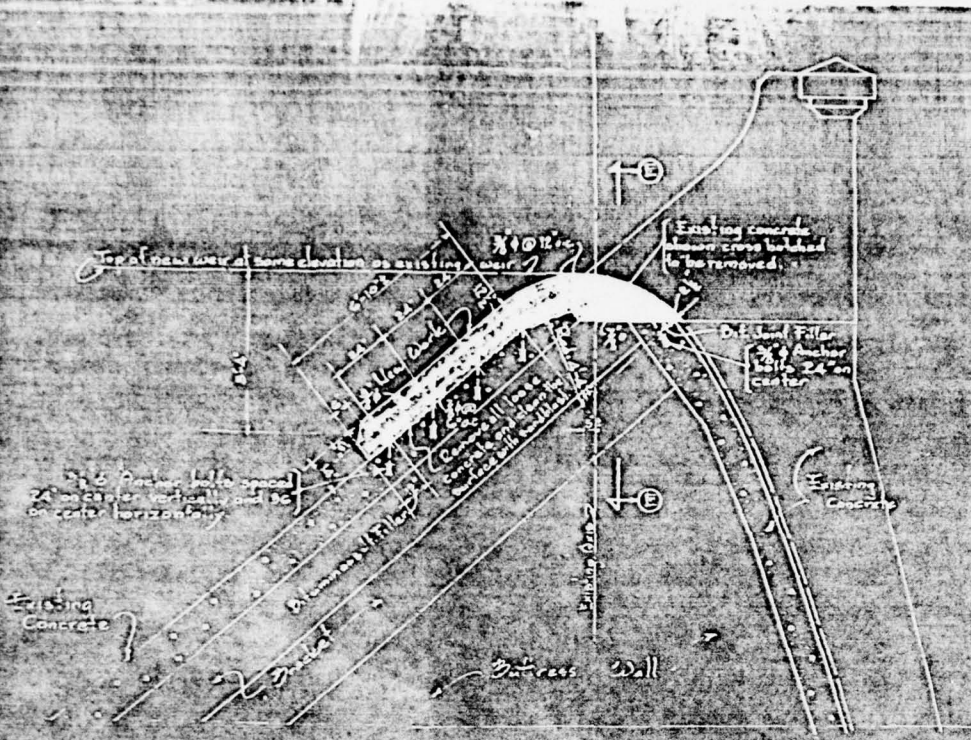
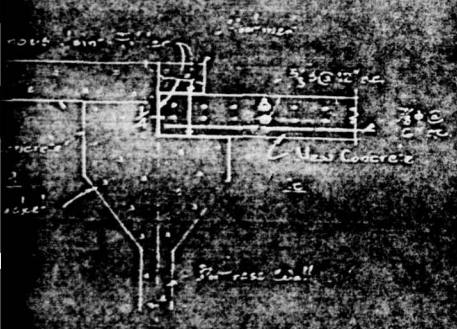
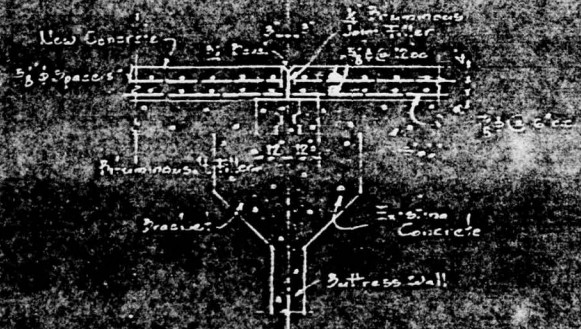
<p>DETAILS OF REPAIRS ROCK RUN DAM</p>		
<p>NAT. ID NO. PA.00059</p>		<p>CHESTER COUNTY</p>
<p>DATA OBTAINED FROM ALBRIGHT & FRIEL, INC., CONSULTING ENGINEERS, PHILA., PA., PLAN NO. 48060-2, DATED SEPT., 1949</p>		
		<p>PLATE 4</p>

The dam was designed for water supply and contains three intake pipes as shown on Plate 3. The two upper pipes are 18 inches in diameter with elevations at 473.0 and 463.1, respectively. The lower 24-inch cast iron pipe is at elevation 452.8 and serves as a pond drain. All three pipes feed into a common 24-inch cast iron pipe and pass through the downstream toe. At the present time the two lower pipes are inoperable; the valves are rusted closed and silt has accumulated to an elevation above 465. Currently, water is supplied by demand through the upper intake pipe and to the water treatment plant immediately downstream. A second pond drain pipe is located in Bay No. 11, but it is not known how and when this pipe

h. Normal Operating Procedure. Under normal operating conditions, the upper intake pipe, as shown on Plate 3, is left open and water is supplied by gravity to the treatment plant, approximately 400 feet downstream. It is reported by the Owner's representative that the lower and middle pipes are rusted and the valves are inoperable. In addition, the Owner believes that silt has accumulated to some elevation above the middle intake pipe. Excess water passes over the spillway into the downstream channel and subsequently into Brandywine Creek. There are no minimum downstream flow requirements.
