WILLIAMS RUN DAM

NDI I.D. NO: 432

National Dam Inspection Program, Williams Run Dam (NDI ID 432), Ohio River Basin, Williams Run, Cambria, Pennsylvania.

PHASE I INSPECTION REPORT.

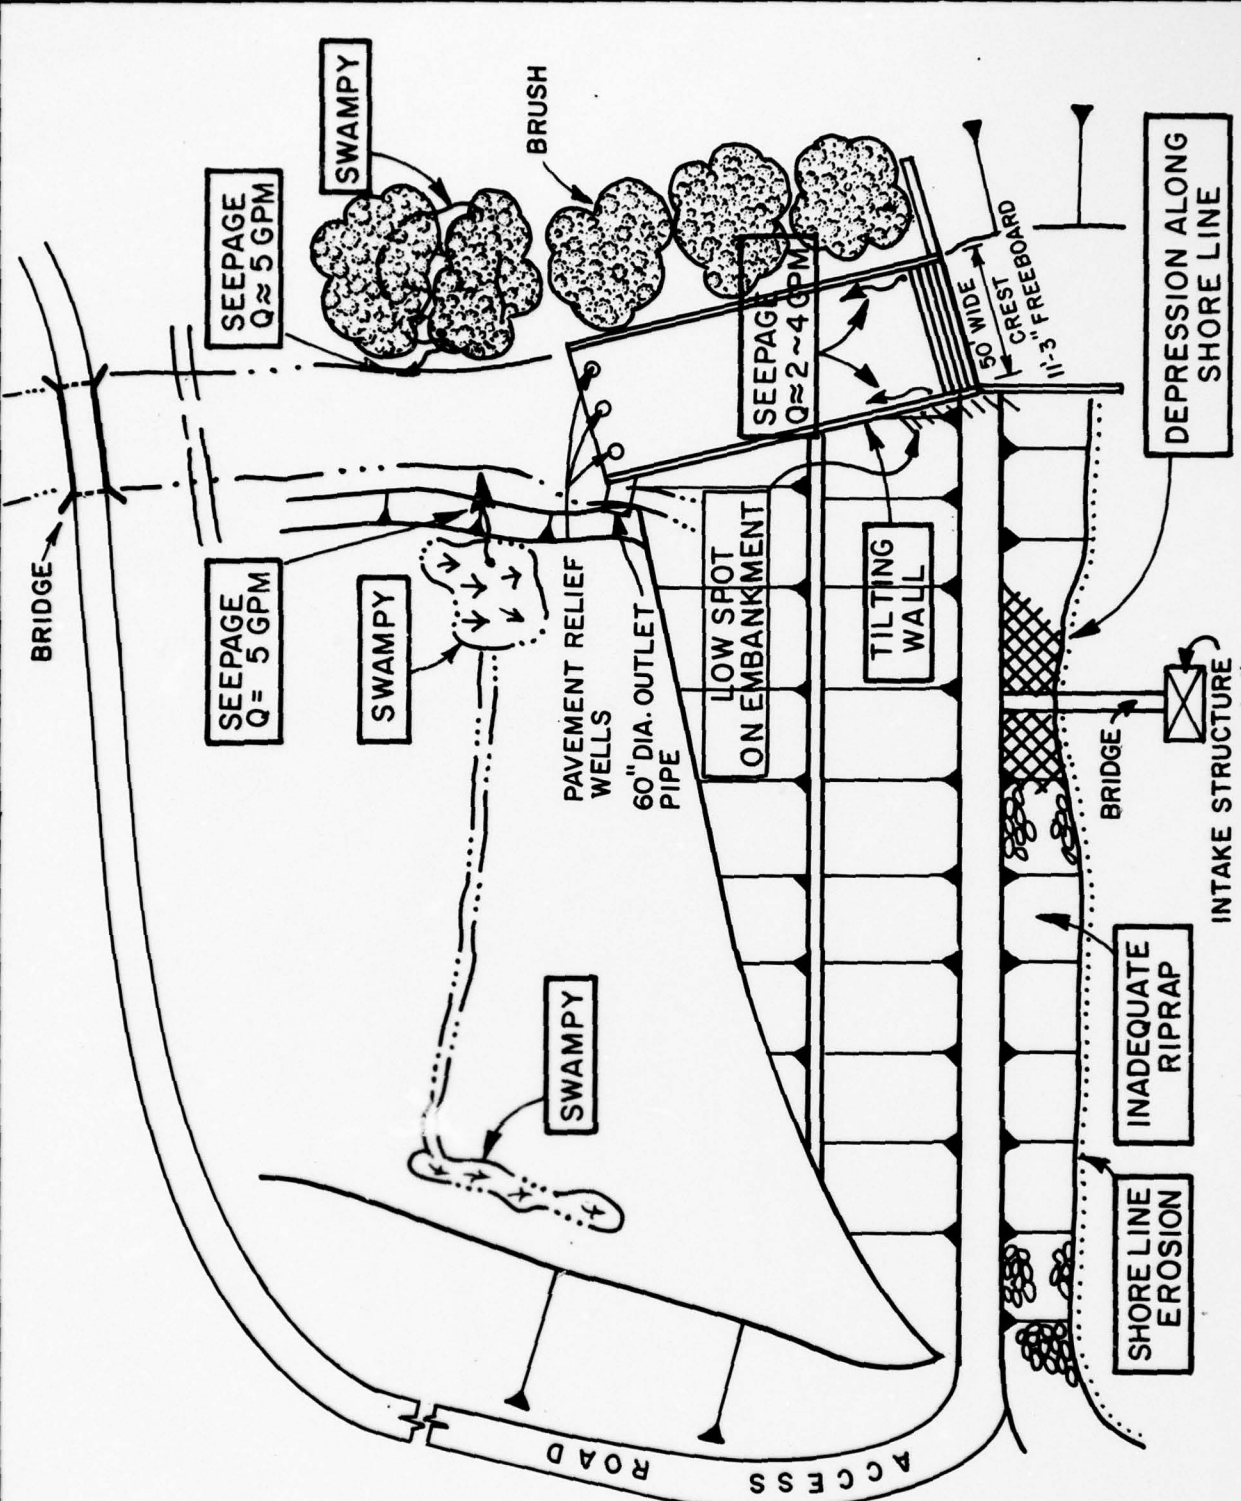
PLATE 10

Specific observations are illustrated in Plate 10 and in the photographs in Appendix C.

POOL LEVEL DATE OF INSPECTION: 11' 9" BELOW DAM CREST
