National Dam Inspection Program. Mill Run Dam (NDI ID 533), Susquehanna River Basin, Mill Run, Blair County, Pennsylvania. Phase I Inspection Report.

MILL RUN DAM

NDI I.D. NO: 533

PHASE I INSPECTION REPORT  
NATIONAL DAM INSPECTION PROGRAM

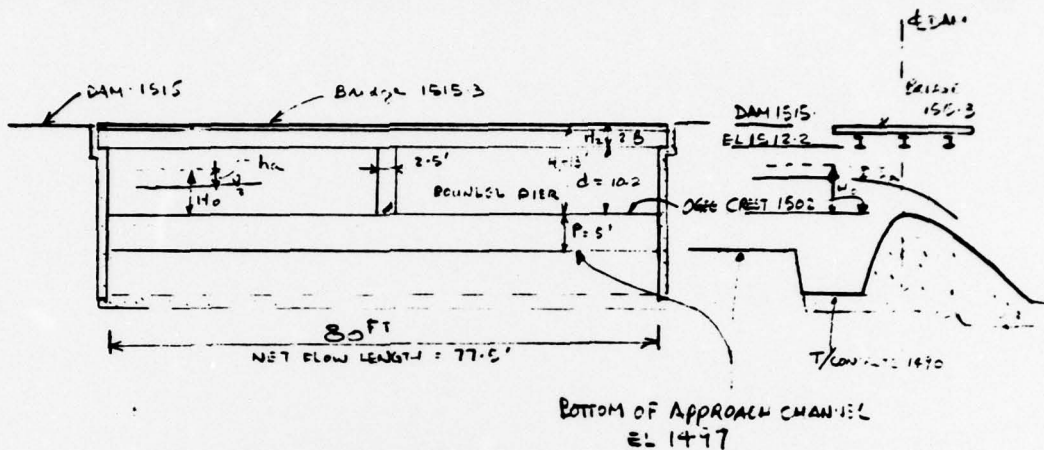
By WTC Date 7-14-78 Subject MILL RUN DAM Sheet No. 2 of 3  
Chkd. By BE Date 8-24-78 HYDROLOGY & HYDRAULIC Proj. No. 78-114-10

DUE TO THE OBSTACLE OF BRIDGE, THE SPILLWAY CAPACITY HAS REDUCED  
BY THE CLEAR OPENING OF 10.2' X 77.5'
