DELaware RIVER BASIN
CROSSWICKS CREEK, OCEAN COUNTY
NEW JERSEY

LEVEL ^{II}
**OAKFORD LAKE DAM
NJ 00544**

PHASE 1 INSPECTION REPORT
NATIONAL DAM SAFETY PROGRAM

January, 1979

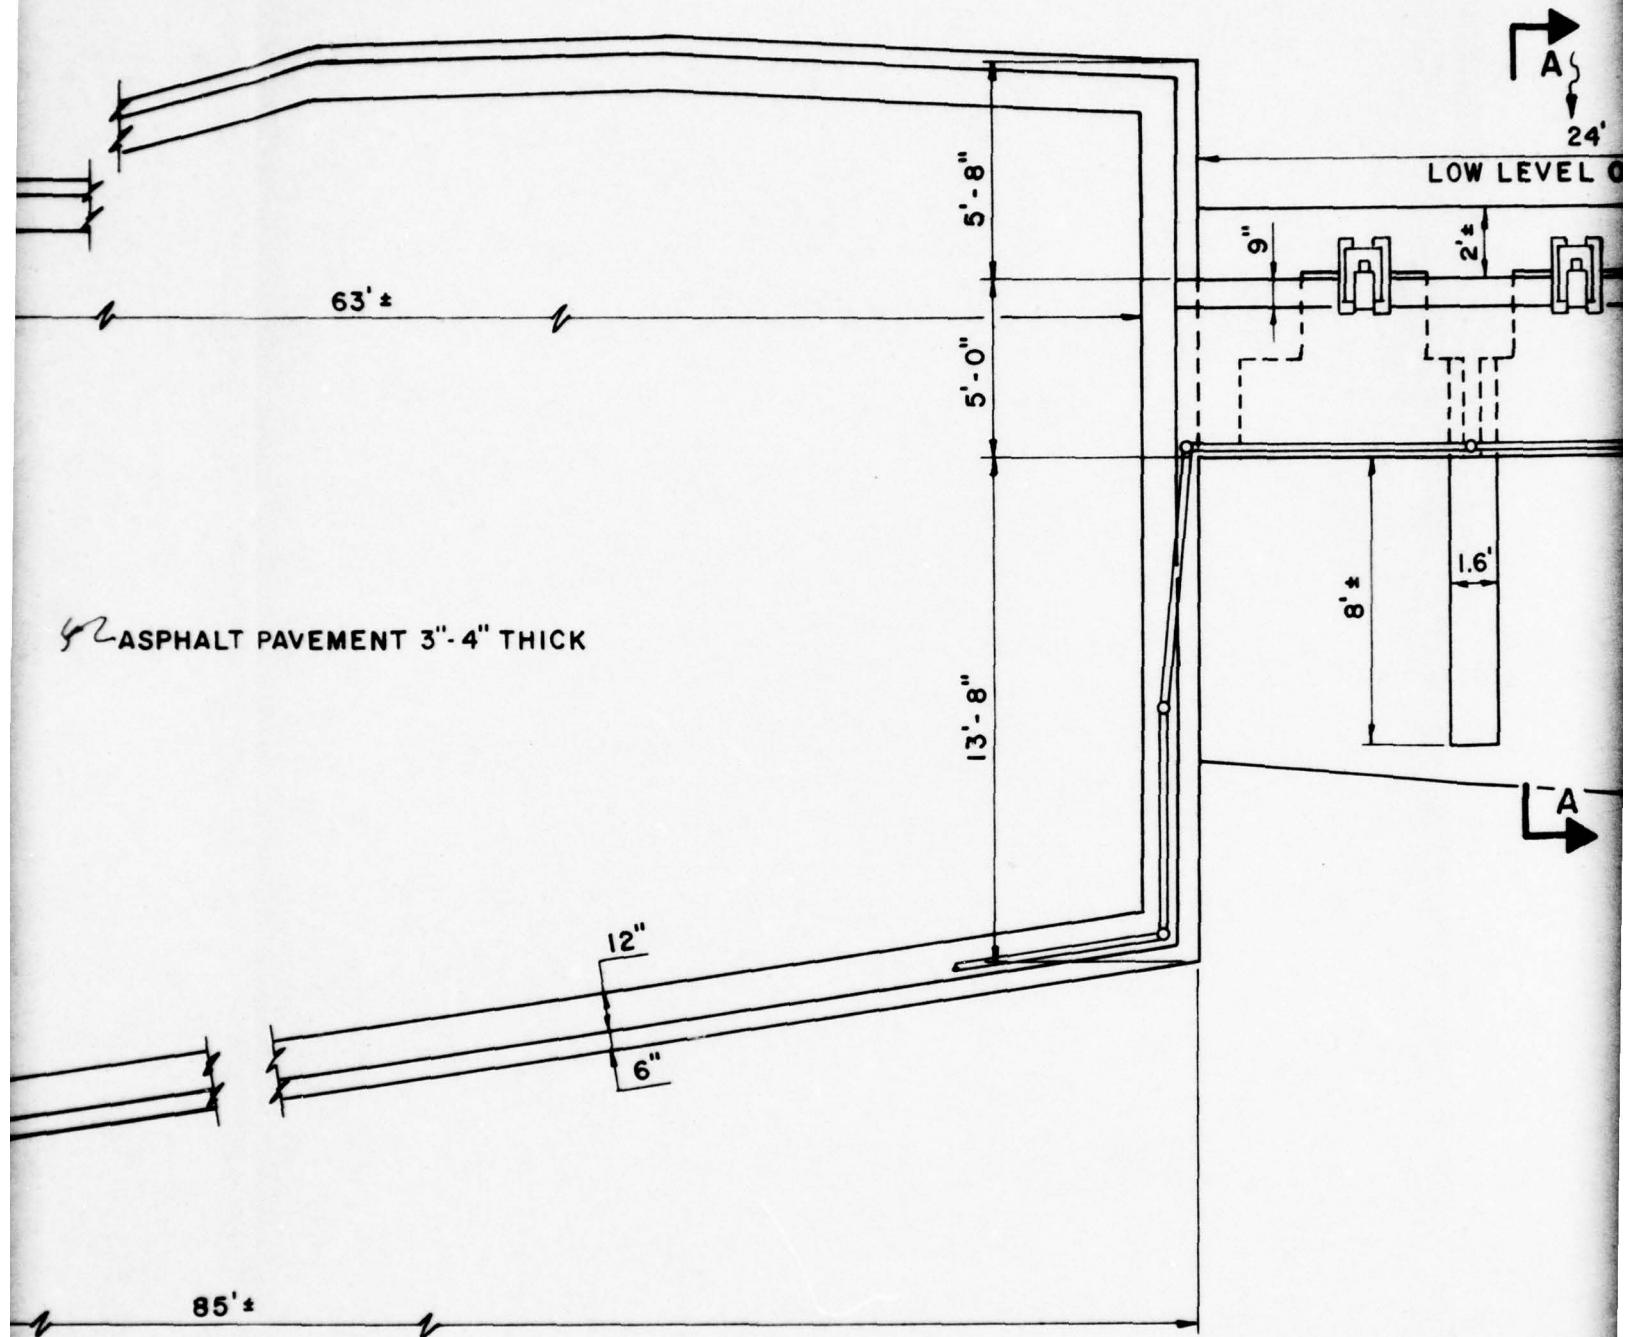
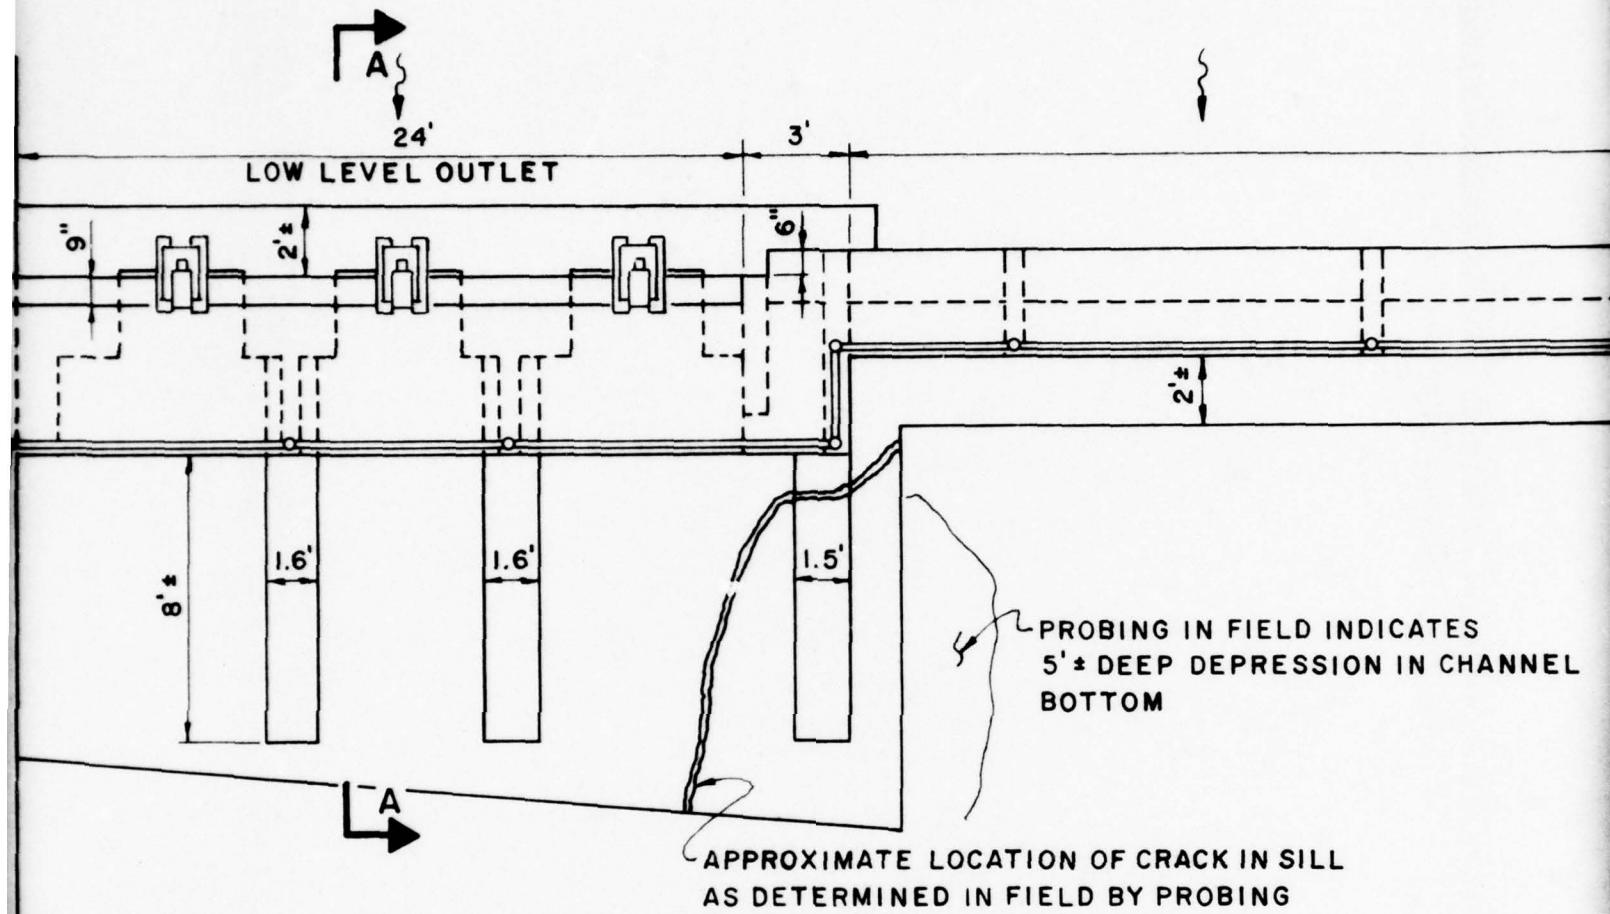
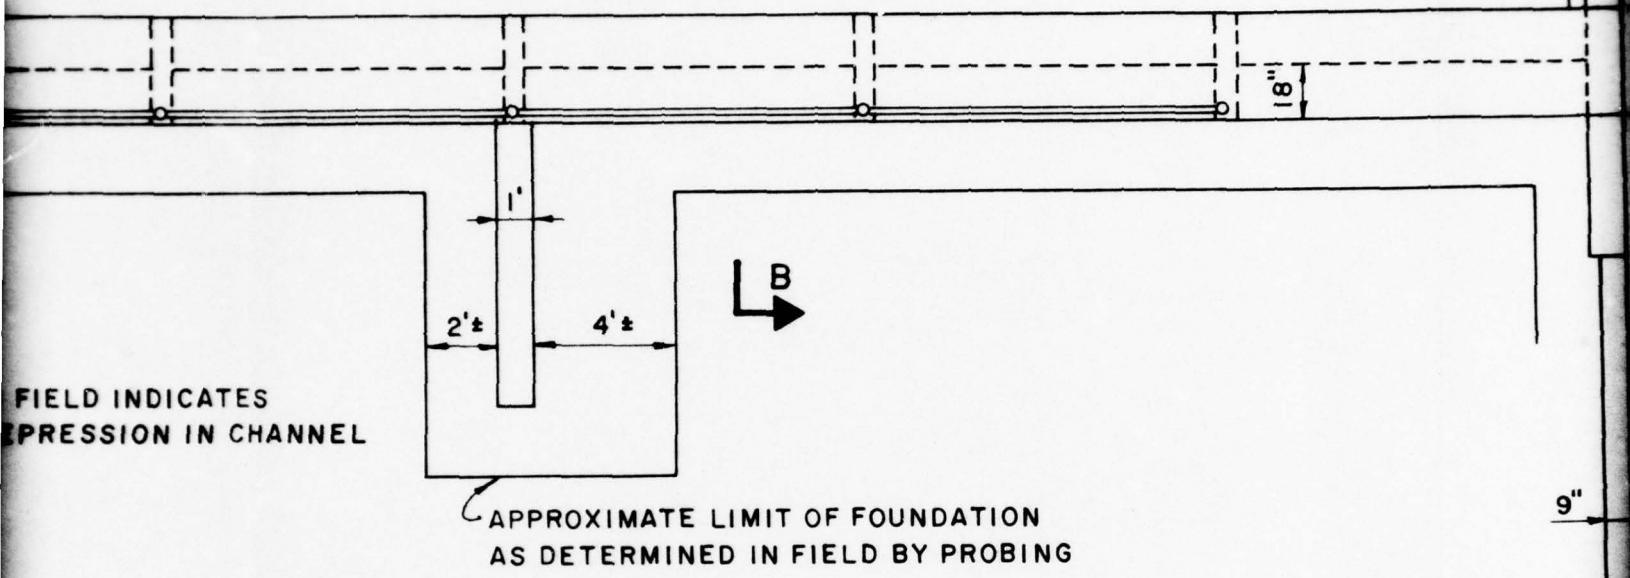
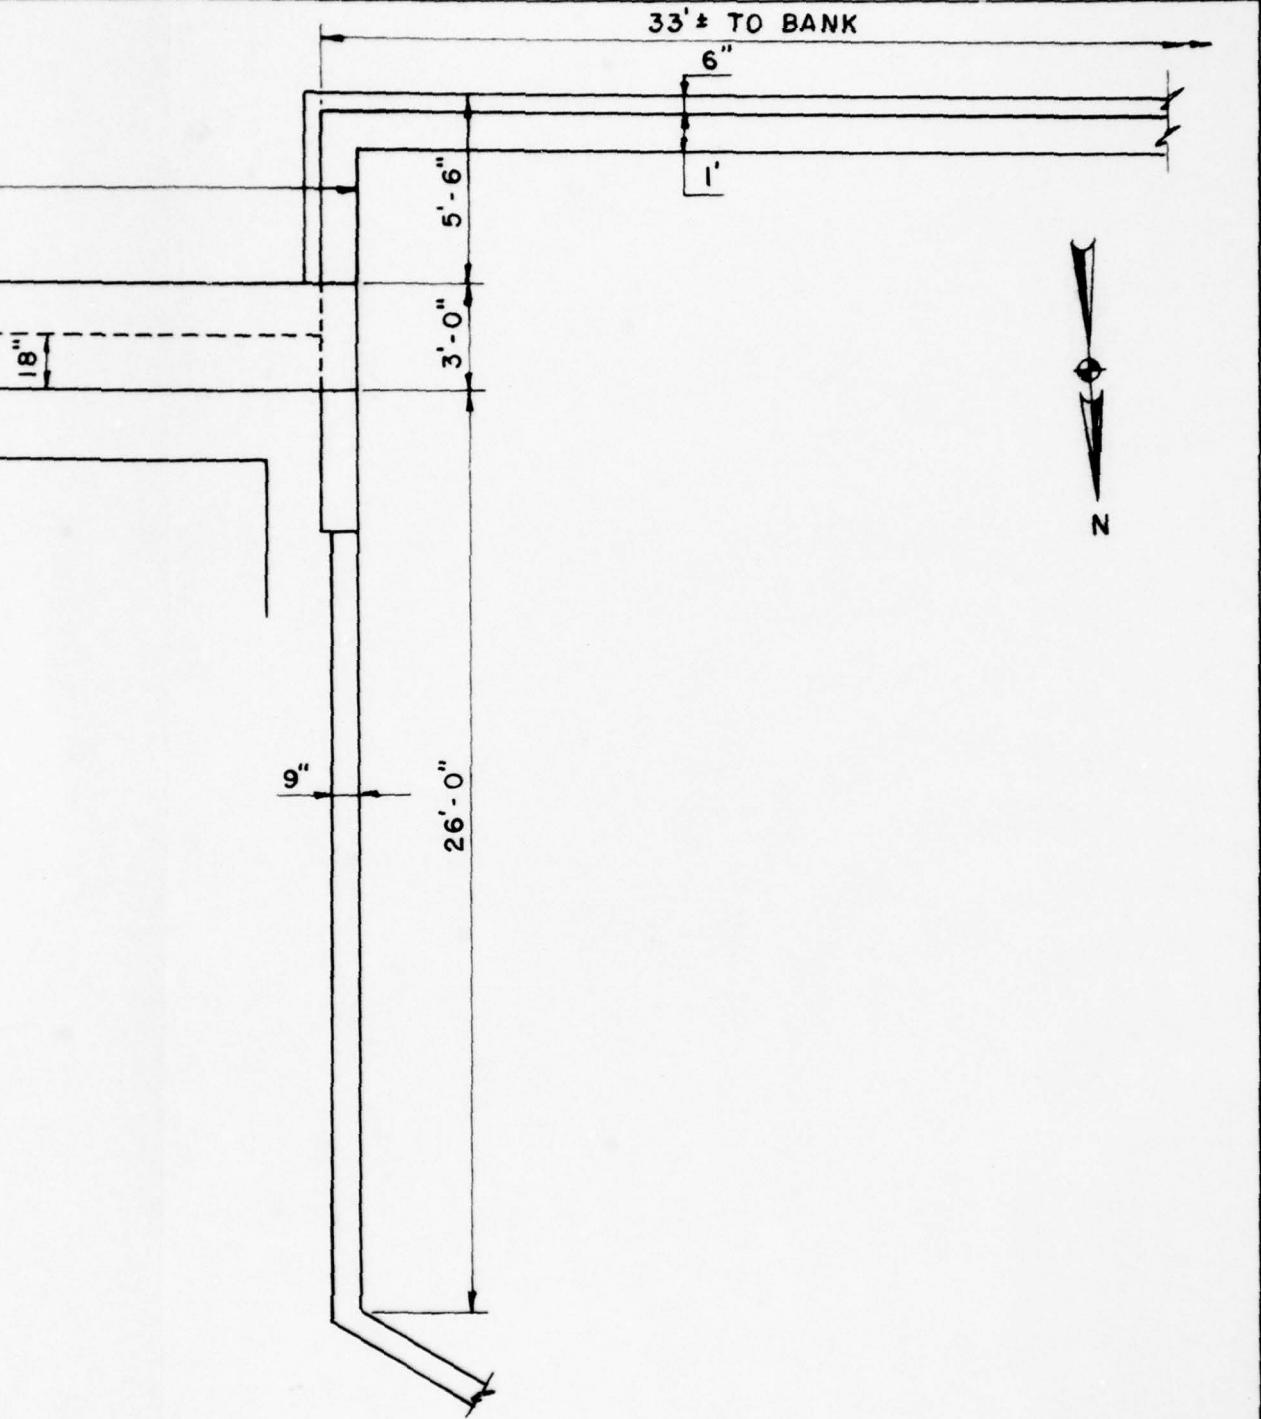
DWG. NO. 2

The concrete facing on the right abutment is severely cracked with sections missing while the entire facing on the left abutment is missing. The left buttress of the low level outlet section has a three-inch wide crack extending through the stilling basin. This has been apparently caused by undercutting of the toe.

- b. Within eighteen months repair the cracked buttress and stilling basin at the low level outlet sections.
- c. Within eighteen months fill in the area downstream of the concrete weir with heavy riprap stone to prevent scouring.
