UPPER HUDSON RIVER WATERSHED
SACANDAGA RIVER BASIN

**LAKE ALGONQUIN DAM
HAMILTON COUNTY, NEW YORK**

**PHASE I INSPECTION REPORT
NATIONAL DAM SAFETY PROGRAM**

CONVERSE WARD DAVIS DIXON
CONSULTING ENGINEERS
91 ROSELAND AVENUE, P.O. BOX 91
CALDWELL, NEW JERSEY 07006

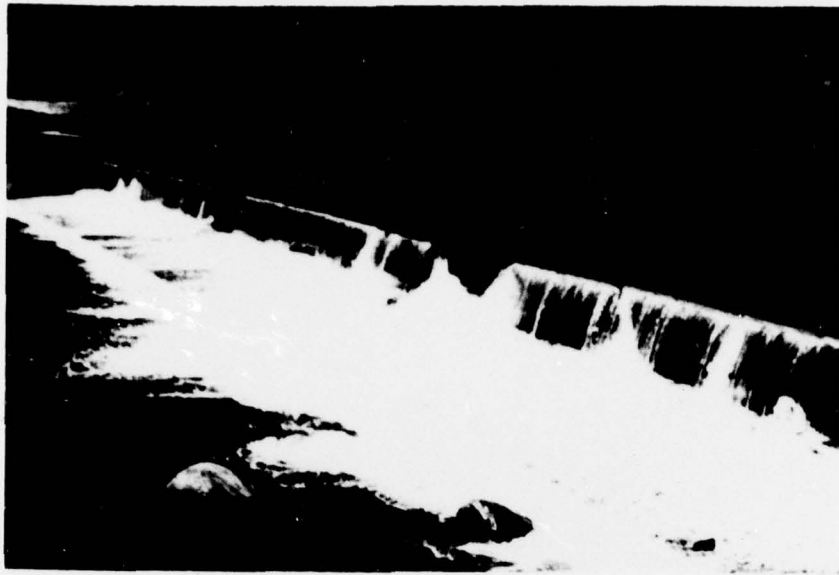
FIGURE 19 TEMPORARY IMPOUNDMENT DAM AT STATE CAMPSITE
