# INFRARED THERMOGRAPHY OF BUILDINGS

## Qualitative Analysis of Five Buildings at Rickenbacker Air Force Base, Columbus, Ohio

Richard H. Munis  
Stephen J. Marshall

September 1977

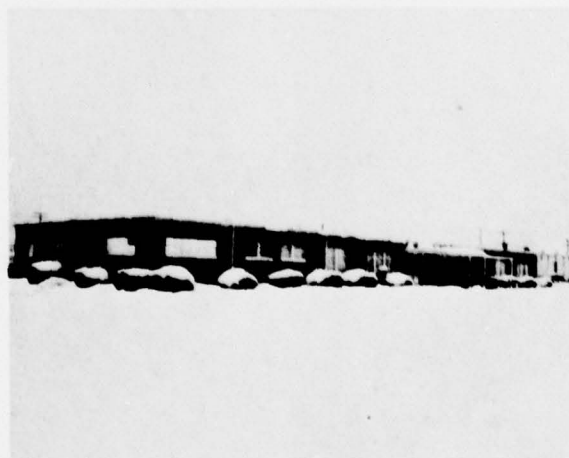
Figure 12 shows more heat loss from the single-pane glass above the two doors on the east face than from the single-pane glass in the two doors. Figures 13 and 14 show the same effect as shown in Figures 6 and 7 at the door on the north side of the building. Figures 15 and 16 show leakage around individual sash units. Figure 17 is a photograph of the south and east sides of this building.

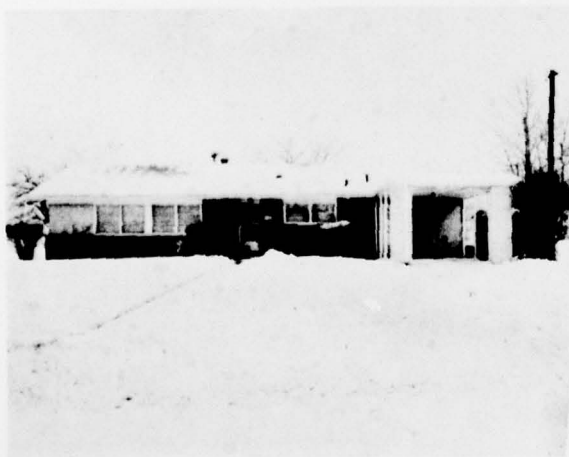
Figure 4b

The Capehart Housing Unit is a combination of face brick and stucco exterior finish (Fig. 4b). It is a one-story building with subgrade insulation and attic insulation, but according to the drawings there is no wall insulation. Exterior wall materials are either stucco or face brick followed by sheathing 25/32 in. thick and on the inside aluminum foil-backed dry wall. The Capehart structure is built on a concrete slab. This particular Capehart unit has storm sashes on all windows except the south-facing picture window which is fitted with insulating glass.

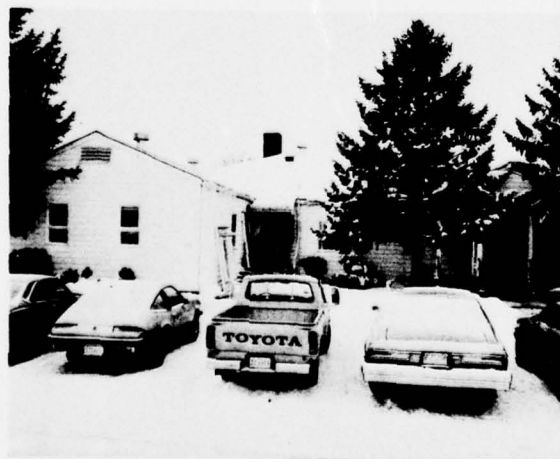
Building S-1 is a one-story frame building with aluminum siding (Fig. 5). A typical wall section in this building consists of aluminum siding with 1/2-in. foam backing, frame siding, 1-in. sheathing, no insulation in the wall cavity, and finally, 1/2-in. insulation board.

Note in Figure 2 the infiltration loss around the top and sides of the window (arrows). Infiltration losses can also be seen in Figures 3 and 4. Those losses, however, are located where the glass meets the frame of the window, whereas in Figure 2, the losses that have been described are around the framing space of the window. Figure 5 is a photograph of the east section of the north face.
