LAKE SEBAGO DAM  
ROCKLAND COUNTY  
NEW YORK  
INVENTORY NO 772

PHASE I INSPECTION REPORT  
NATIONAL DAM SAFETY PROGRAM

National Dam Safety Program. Lake Sebago  
Dam (772), Lower Hudson River Basin,  
Rockland County, New York. Phase I  
Inspection Report.

11 19 SEPTEMBER 1978

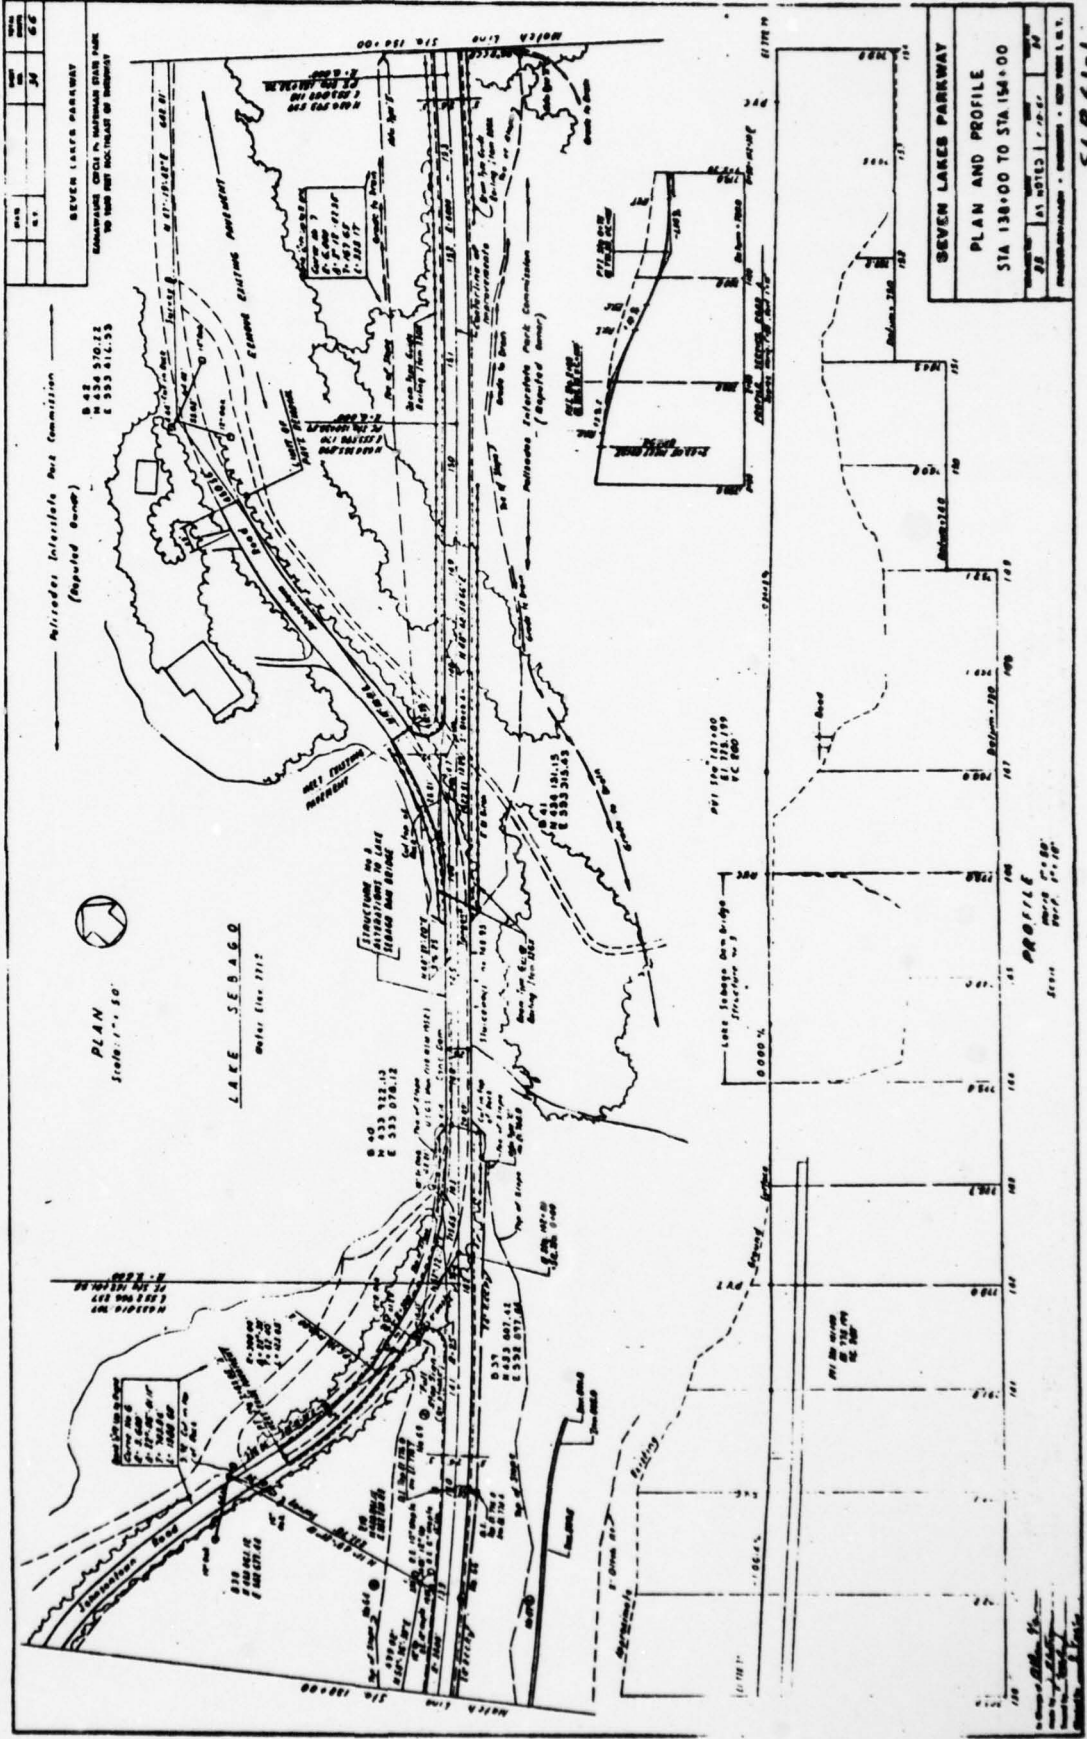
FIGURE 10

Figures 10 and 11 show plans for the new Seven Lakes Parkway (old Seven Lakes Parkway noted as Johnstown Road). The profile shows the depressed terrain between the old and new roadway. Currently, a large swamp exists in the area partly from runoff and partly from seepage of the dam's embankment. Overtopping of the dam would flood this area. A drain pipe (36" R.C.C.P.) at Station 154 + 00 could drain this area, but it is suspected it may not be able to sustain the 18 feet of head it would receive and could blowout causing a breach or failure in the road embankment. The adequacy of the road embankment is also unknown. Stations below 154 + 00 have a higher grade indicating that the road would not be overtopped.
