USARTL-TR-78-48

ICING TESTS OF A UH-IH HELICOPTER WITH AN ELECTROTHERMAL ICE PROTECTION SYSTEM UNDER SIMULATED AND NATURAL ICING CONDITIONS

R. H. Cotton LOCKHEED-CALIFORNIA CO. P.O. Box 551 Burbank, Calif. 91520

April 1979

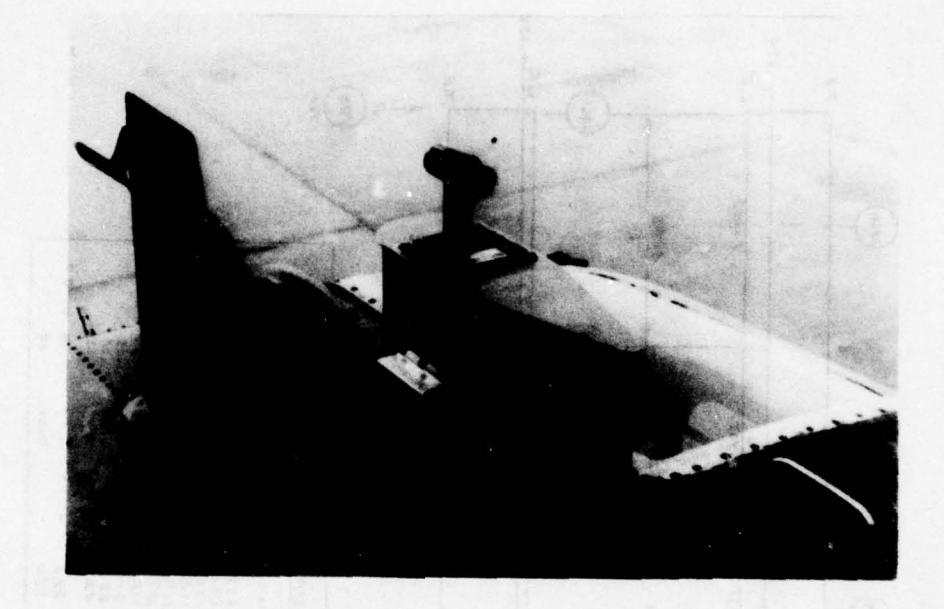
No changes were made to this system. Figure 3 shows the probe installation on the RH pylon located on the cabin roof. Excellent operation was obtained during the 1977 Ottawa program and verified further by the additional data on system capability and accuracy obtained during the confirmatory calibration runs made in the icing tunnel at the conclusion of the flight program. These results were included in Reference 4 as Appendix B.

Figure 3. Infrared-Type Ice Detector Installation on the R.H. Pylon on the Top of the Cabin Roof.

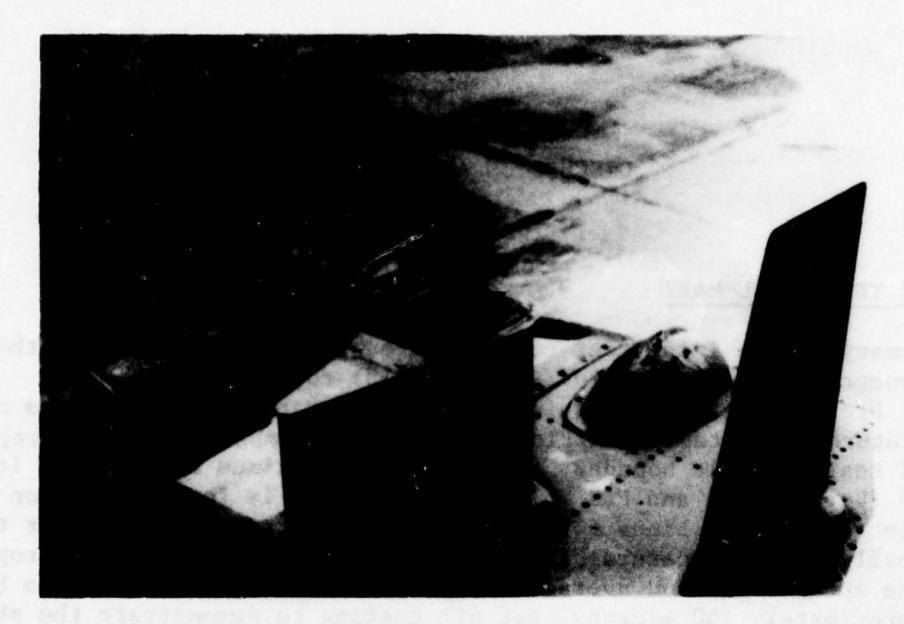
The model of the ultrasonic ice detector head was changed to a prototype of the aspirated version of the ultrasonic-type sensor to be used on the UH-60A Black Hawk helicopter. The previous installation incorporated an engine bleed air-operated aspirator that was installed separately around the ice detector sensor and used the bleed air to anti-ice the aspirator duct as well as to operate the jet pump. The model used this year was an all-new unit with the aspirator duct as an integral part of the head. The forward portion of the aspirator duct was anti-iced by a built-in electric heater similar to an airspeed system pitot head. This change was made to eliminate the need for a minimum temperature requirement for the bleed air. In addition, the electronics that previously were below the mounting plate and an integral part of the detector assembly were packaged in a separate component that could be installed anywhere reasonably close to the detector location. Also, the accreted ice thickness at which the detector probe is deiced was reduced from 0.080 inch to 0.040 inch to provide more probe deice cycles (counts) per blade deice cycle. Figure 4 shows the external configuration of the new ultrasonic-type detector.

Figure 4. Ultrasonic-Type Ice Detector Installation on the L.H. Pylon on Top of the Cabin Roof.

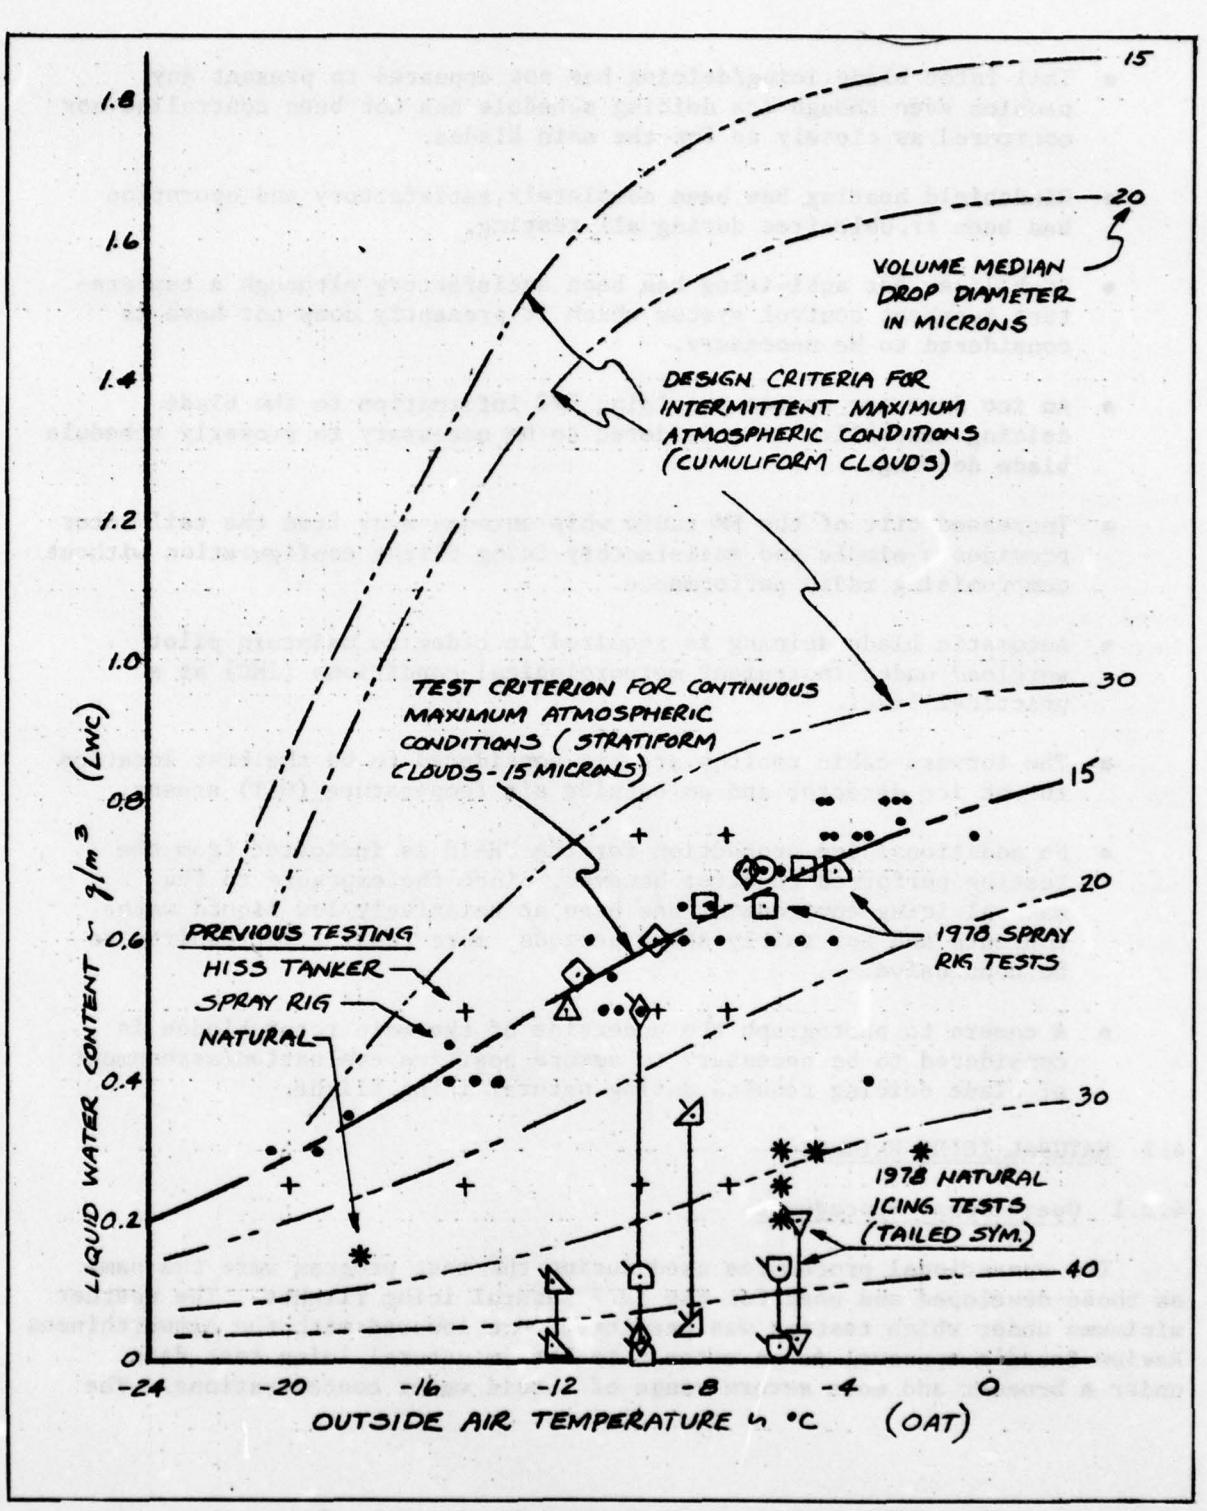
A summary of the icing test conditions evaluated during all of the testing conducted with the UH-1H (S/N 70-16318) to date is shown in Figure 5. Presented are the liquid water concentrations (LWC) versus outside air temperature (OAT) test conditions. These are compared to the accepted LWC versus OAT test criteria boundary for continuous maximum atmospheric icing conditions (Reference 1 and FAR 25). This boundary is for a 15-micron volume mean droplet diameter. Lines for 20, 30, and 40 microns, which cover the range normally found in natural icing clouds, are shown also. The droplet size of the spray rig cloud averages approximately 30 microns and the HISS tanker approximately 150 microns, but all testing to demonstrate the ability to operate continuously in an icing environment is generally conducted to the 15-micron line.

The ice protection system is designed to operate under intermittent maximum conditions (15 minutes maximum) which, as shown also in Figure 5, can have liquid water concentrations approaching 2.0 grams per cubic meter  $(g/m^3)$  near 0°C and is approximately double the LWC for continuous maximum at all OATS. It was hoped to encounter intermittent maximum conditions under natural icing and thus demonstrate satisfactory ice protection system operation under all expected conditions. Unfortunately, LWC conditions in this range were not encountered although experience to date indicates that no problem should be expected.

Figure 5. Summary of Icing Conditions Under Which the Ice Protected UH-1H Has Been Tested to Date.

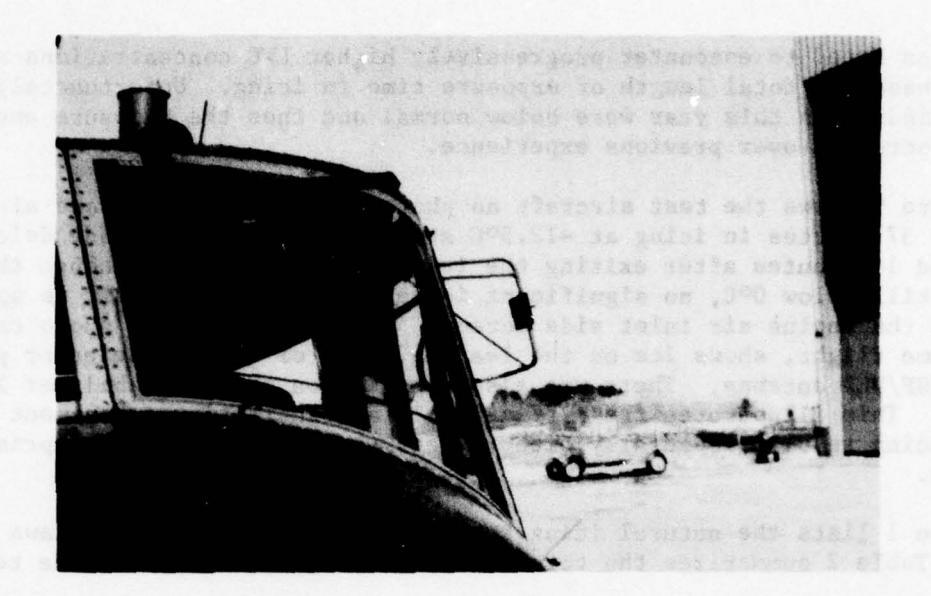
- c. The thickness of ice buildup on the leading edge of a miniature airfoil section of the same aerodynamic shape and percent thickness as the main rotor blade. A visual ice detector of this type was installed outside of the copilot's side window and could be manually deiced by the copilot using a stick after each blade deice. Figures 7 and 8 show the test aircraft's installation. Note that the ice has been removed from the lower half of the airfoil and the probe is ready for another accretion. The upper half is left untouched as an indication of total ice buildup, thickness and shape, for each icing encounter (a measure of total exposure). It is assumed that the ice on the main rotor blade at the mid-span point is approximately three times the thickness on the visual indicator based on the ratio of the rotational speed of the blade at the 50-percent span point to aircraft flight speed.

Figure 7. Miniature Airfoil Section Mounted Outside of the Copilot's Window for Visual Indication of Ice Accretion.

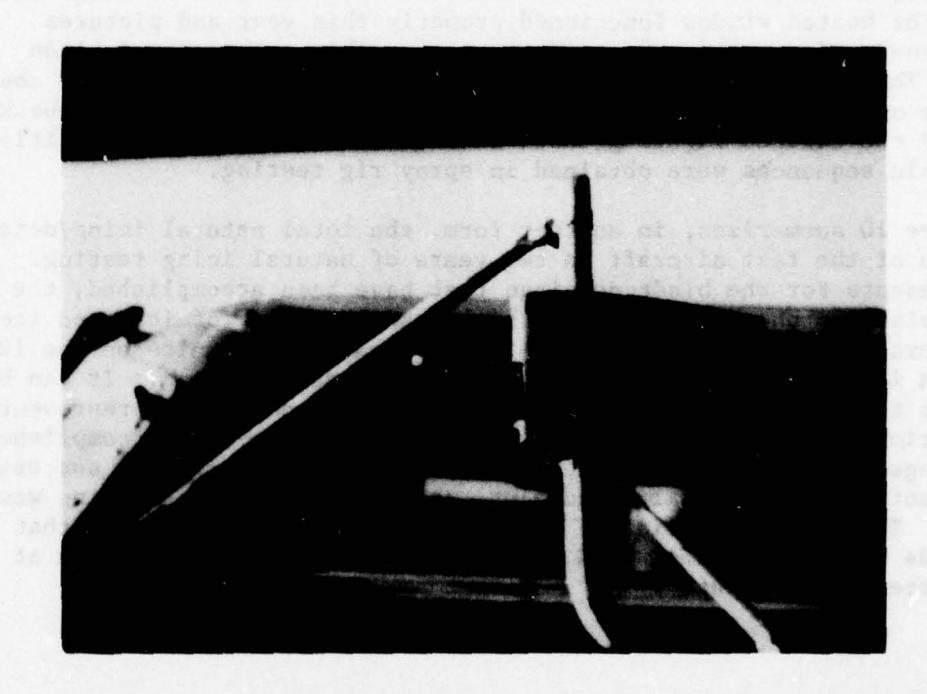
Figure 8. Close-up of Visual Icing Indication After a Natural Icing Flight With 0.2 Inch of Ice Accretion Above Thickness Measuring Probe and With Ice Removed From Leading Edge Below the Probe (Test  $OAT = -12.5^{\circ}C$ ).

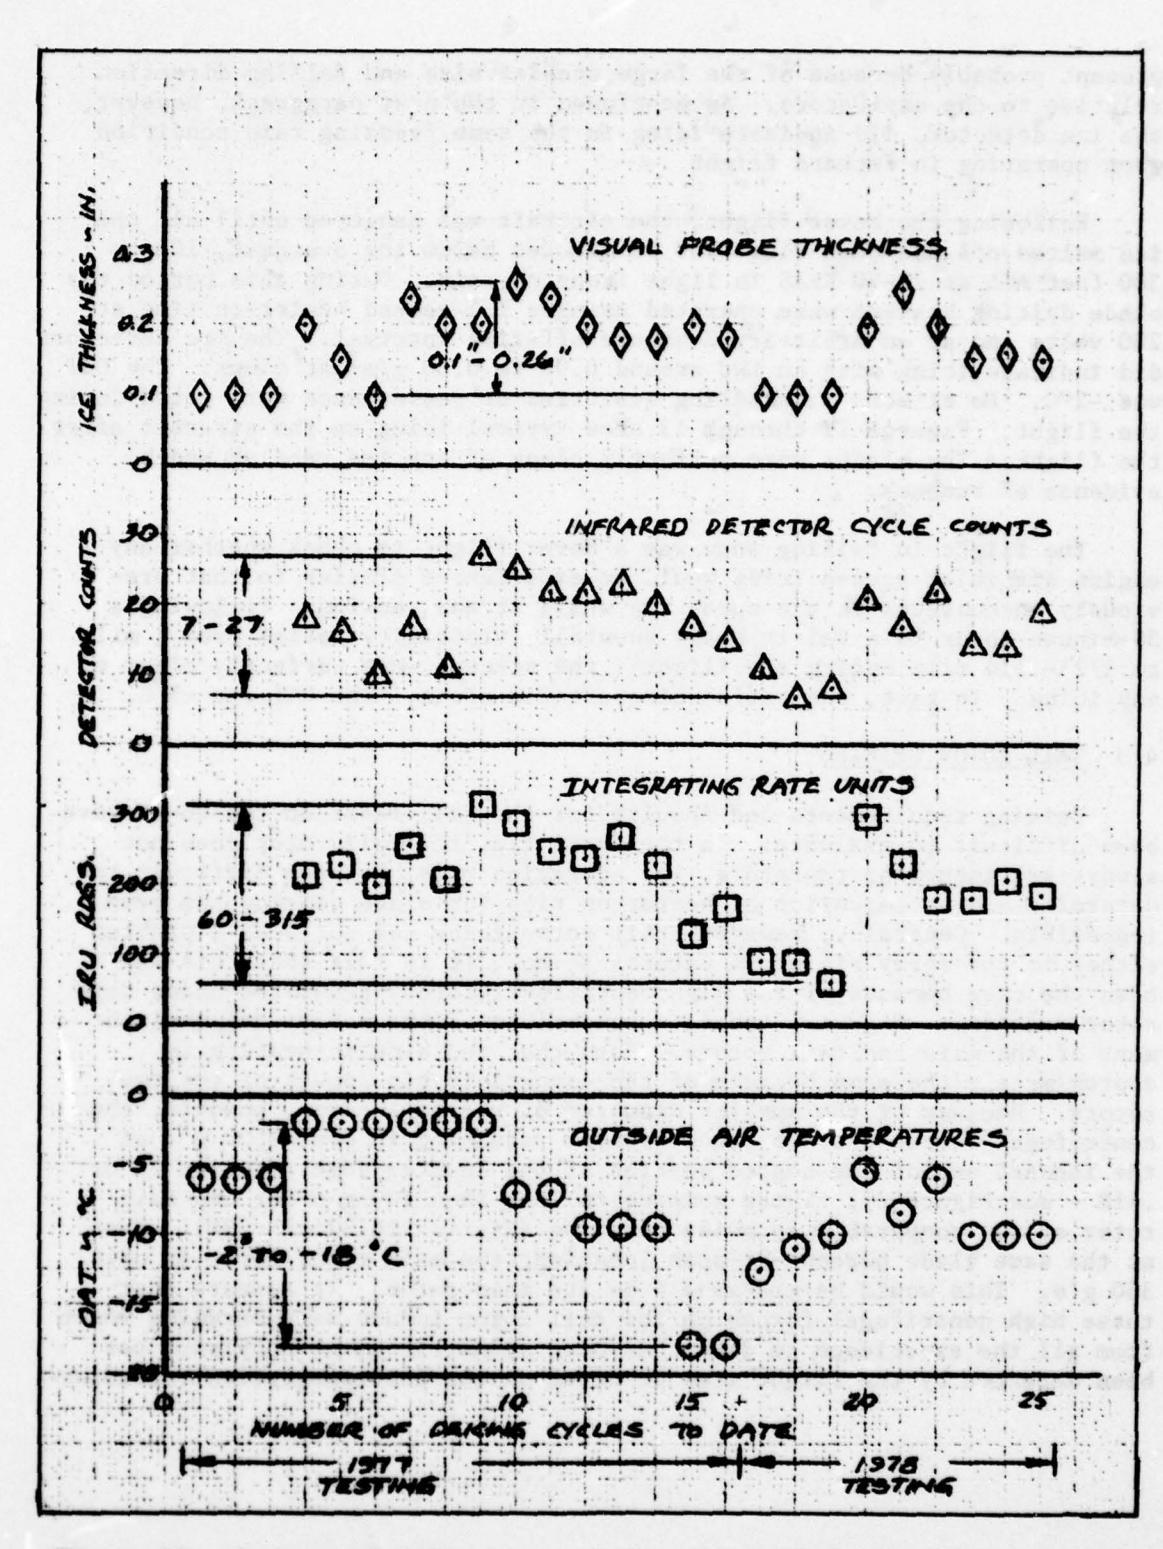
Figure 10. Summary of Indications of Main Rotor Blade Ice Accretion at which Deicings have been Accomplished Under Natural Icing Conditions to Date.

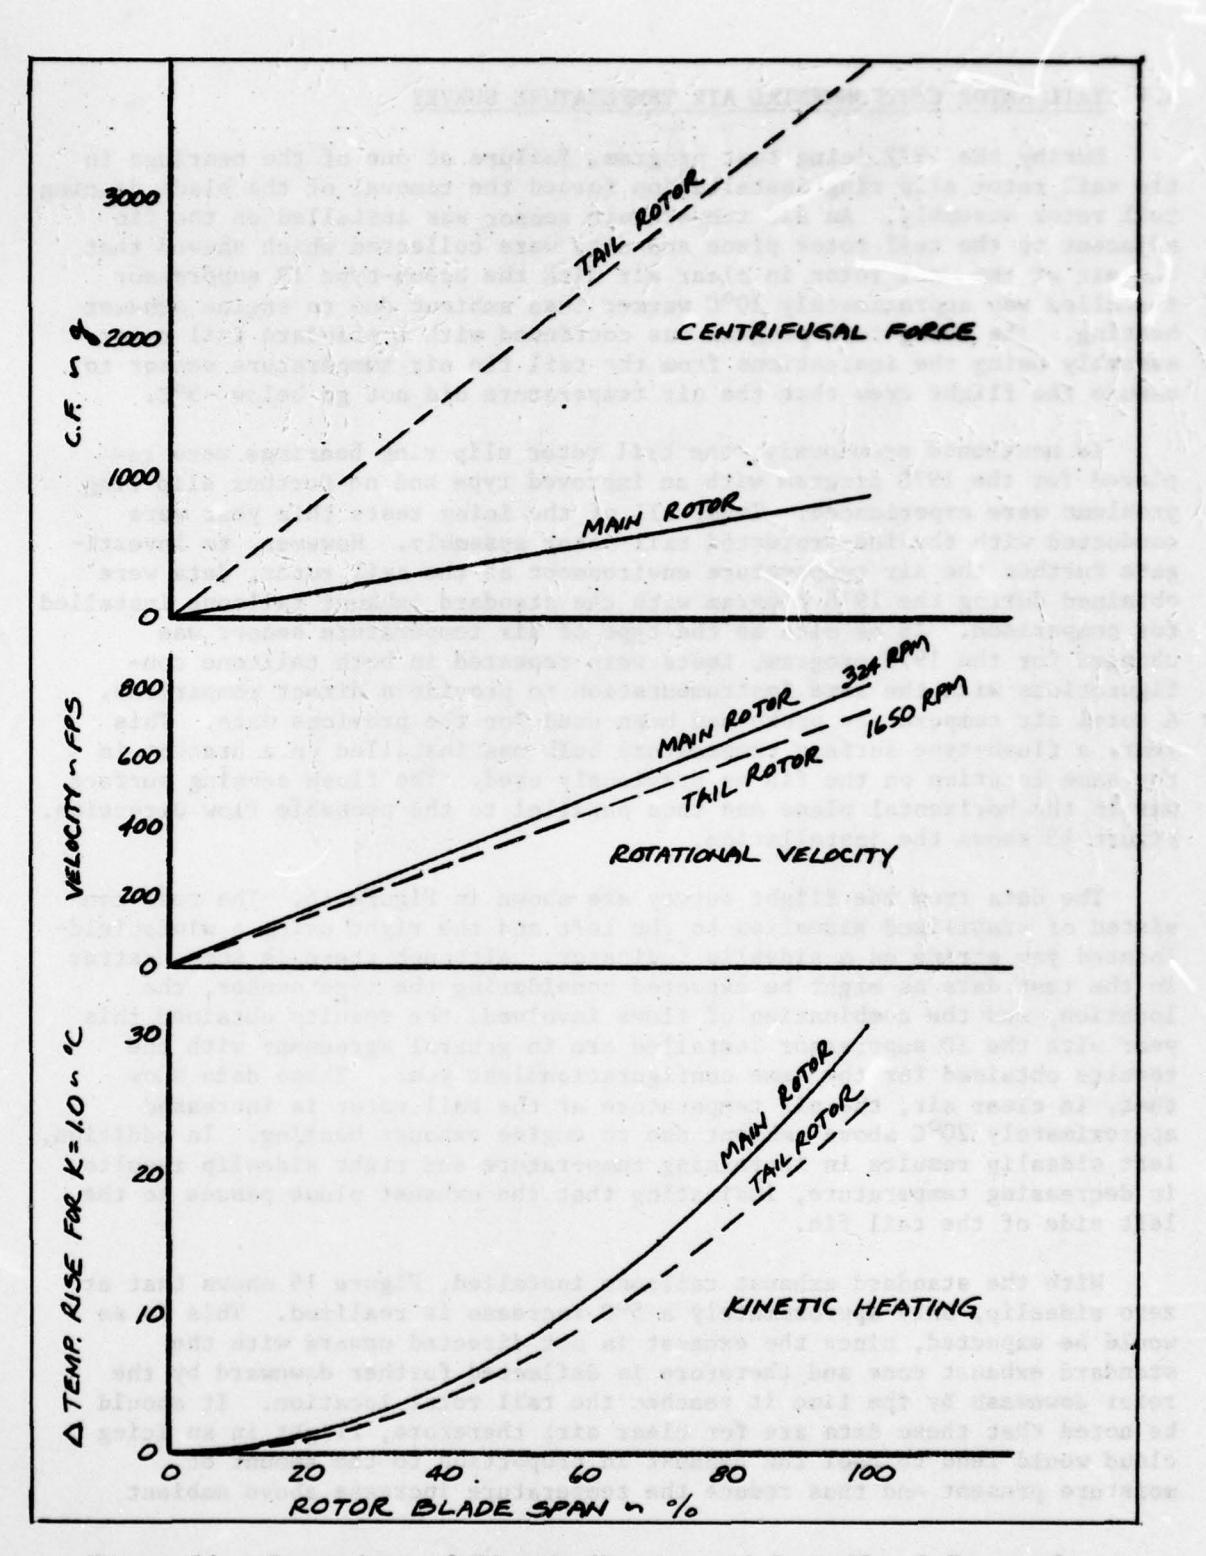
Figure 14. Comparison of Kinetic Heating and Centrifugal Force of the Main and Tail Rotor of UH-1H.

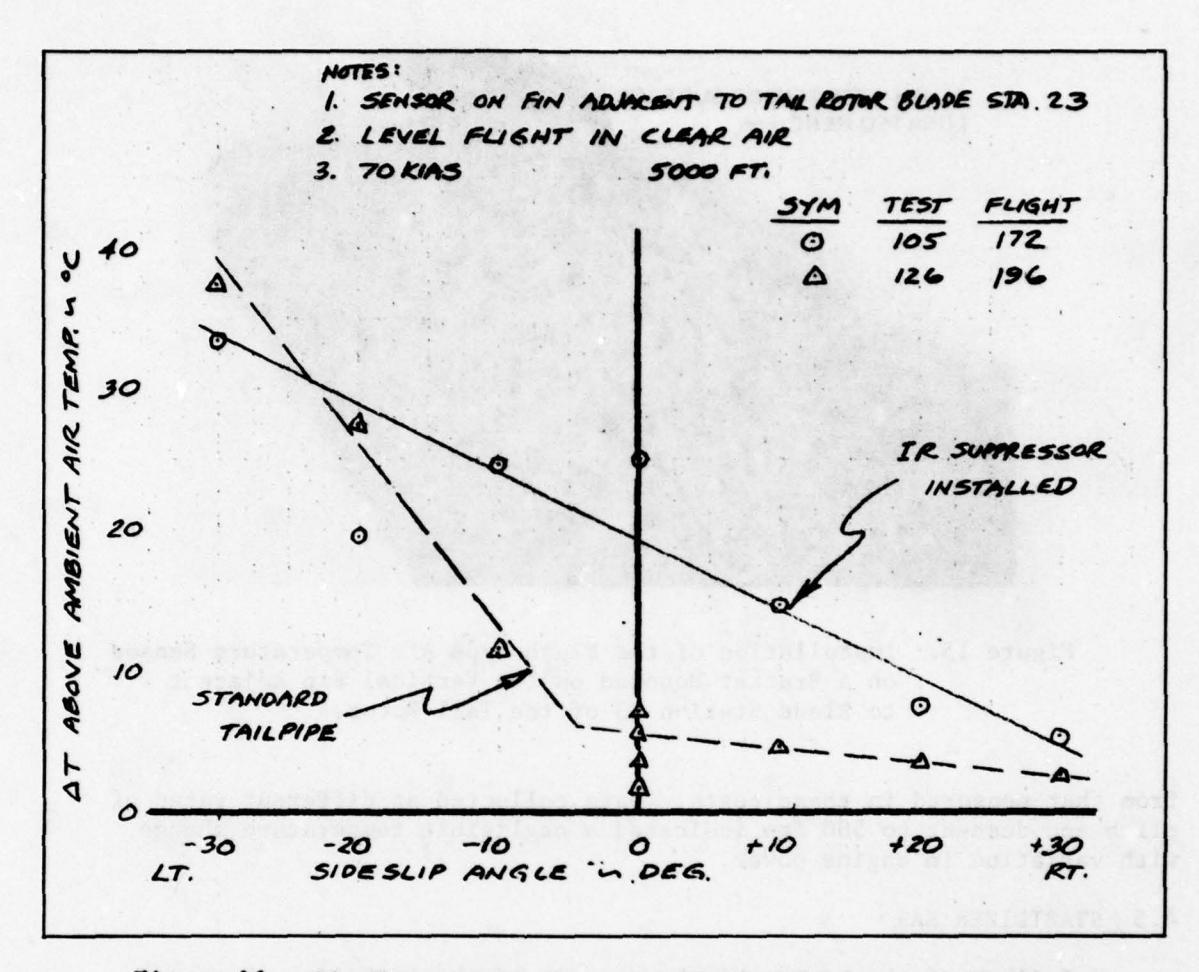
The data from the flight survey are shown in Figure 16. The test consisted of stabilized sideslips to the left and the right using a windshieldlocated yaw string as a sideslip indicator. Although there is some scatter in the test data as might be expected considering the type sensor, the location, and the combination of flows involved, the results obtained this year with the IR suppressor installed are in general agreement with the results obtained for the same configuration last year. These data show that, in clear air, the air temperature at the tail rotor is increased approximately 20°C above ambient due to engine exhaust heating. In addition, left sideslip results in increasing temperature and right sideslip results in decreasing temperature, indicating that the exhaust plume passes to the left side of the tail fin.

With the standard exhaust tailcone installed, Figure 16 shows that at zero sideslip, only approximately a 5°C increase is realized. This is as would be expected, since the exhaust is not directed upward with the standard exhaust cone and therefore is deflected further downward by the rotor downwash by the time it reaches the tail rotor location. It should be noted that these data are for clear air; therefore, flight in an icing cloud would tend to cool the exhaust in proportion to the amount of moisture present and thus reduce the temperature increase above ambient

Figure 16. Air Temperature Increase Above Ambient at Tail Rotor With and Without the Infrared Suppressor Installed.

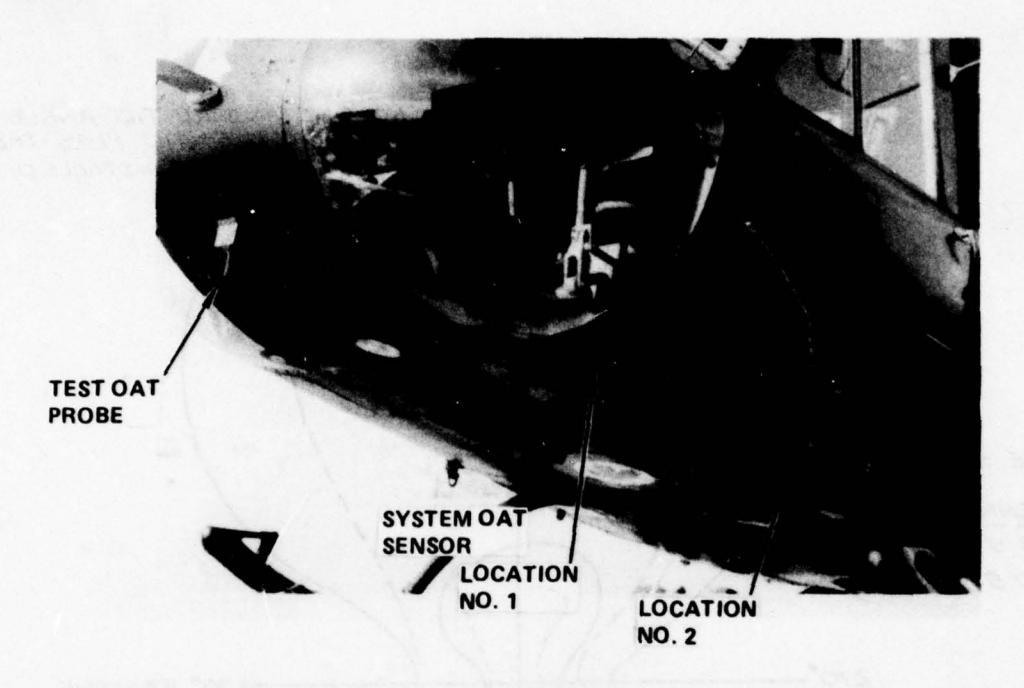
Flight results during this year's testing showed that the underside of the nose was an unsatisfactory location because it measured 5° to 10°C warmer than the actual temperature and was not consistent. The basis for determination of the actual outside air temperature was a shielded-type resistance-element total air temperature probe normally accepted as a standard and used extensively in aircraft performance testing. This type is relatively expensive and incorporates a probe deicing feature. The LH sensor was relocated to the fuselage side just below the copilot's door. This resulted in considerable performance improvement in forward flight, but was now sensitive to sunlight and still gave inconsistent readings in hover. Figure 18 shows the two locations that were tried for the flush-type system OAT sensor and also the test OAT probe installation.

Figure 18. Two Locations Evaluated for the Deicing "SYSTEM OAT" Flush-Type Sensor and the Location of the "TEST OAT" Probe.

and hover. (This is not true for all UH-lH standard probe/indicators, however, because cross checks with the chase UH-lH used last year showed that the Chase had a  $6^{\circ}$ C error.) In any case, this close agreement led to the experimental relocation of the flush-type deicing system OAT sensor to the inboard vertical side of the RH ice detector pylon. A sun shade was provided in the form of a stand-off sheet metal shield. Figures 19 and 20 show the installation. Subsequent evaluation showed that this installation provided an excellent deicing system OAT measurement as its readings agreed exactly with the TEST OAT and the standard windshield probe in forward flight and in hover. The signals from this sensor installation were used on all the remaining natural icing flights to permit automatic operation of the blade heater on-time scheduling.

Based on this experience, it appears that a satisfactory OAT signal to a deicing controller can be obtained with a cabin roof top sensor location on the UH-1H. One possibility would be to change the standard ship's probe to an electrical resistance type rather than the present bimetallic mechanical indicator type. Another possibility would be to supplement the present mechanical indicator with a second probe in the same location but through the LH windshield. The second sensor would deliver an electrical signal to the deicing controller and the mechanical cockpit readout would be retained.

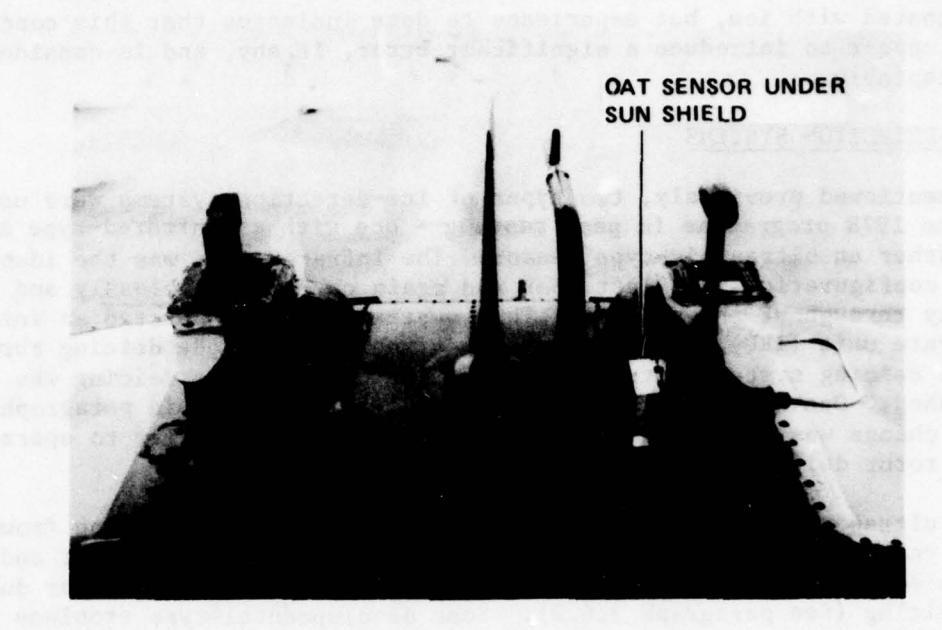
Figure 19. OAT Sensor for the Deicing System Controller Located on the Side of the RH Ice Detector Pylon.

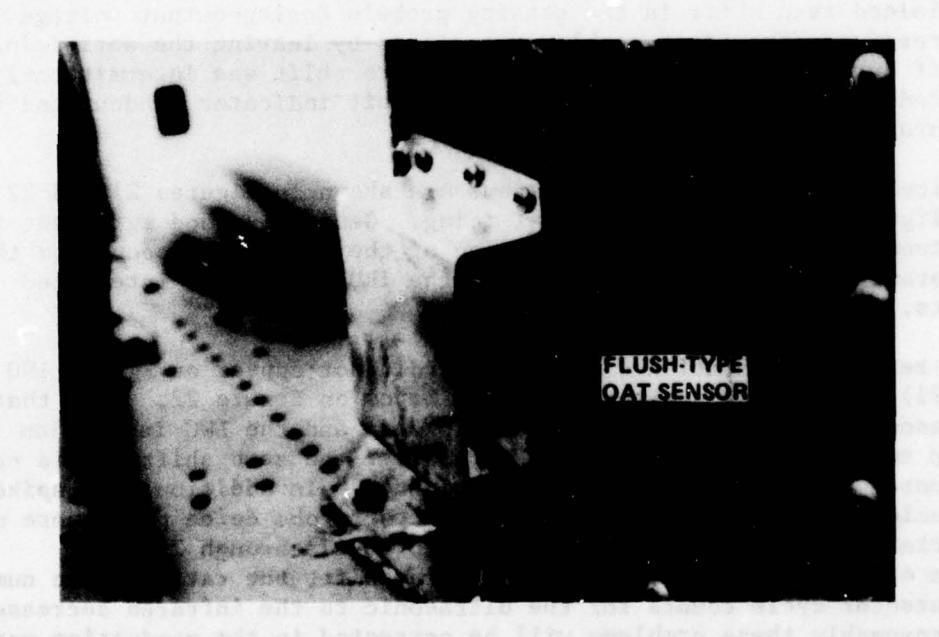
Figure 20. Close-up of Deicing "SYSTEM OAT" Sensor Installation.

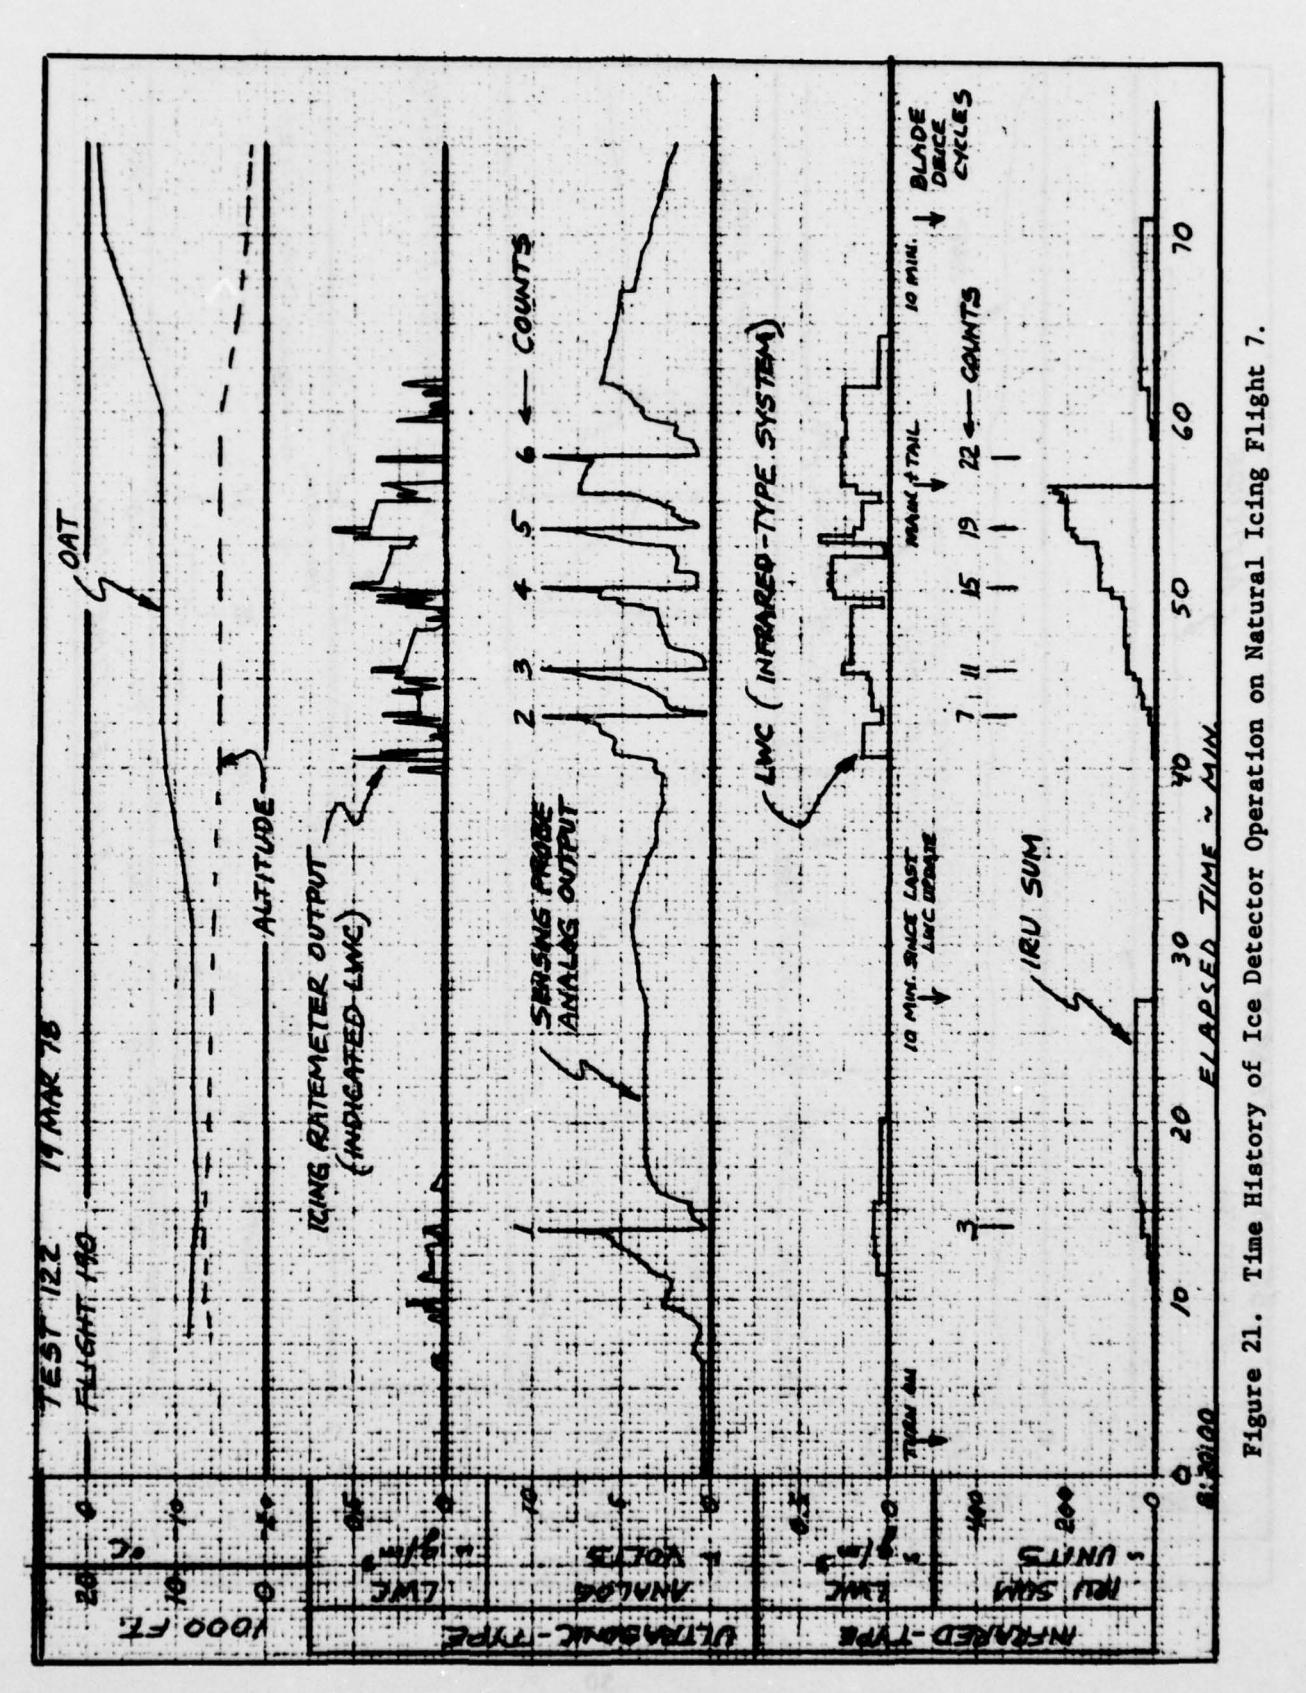
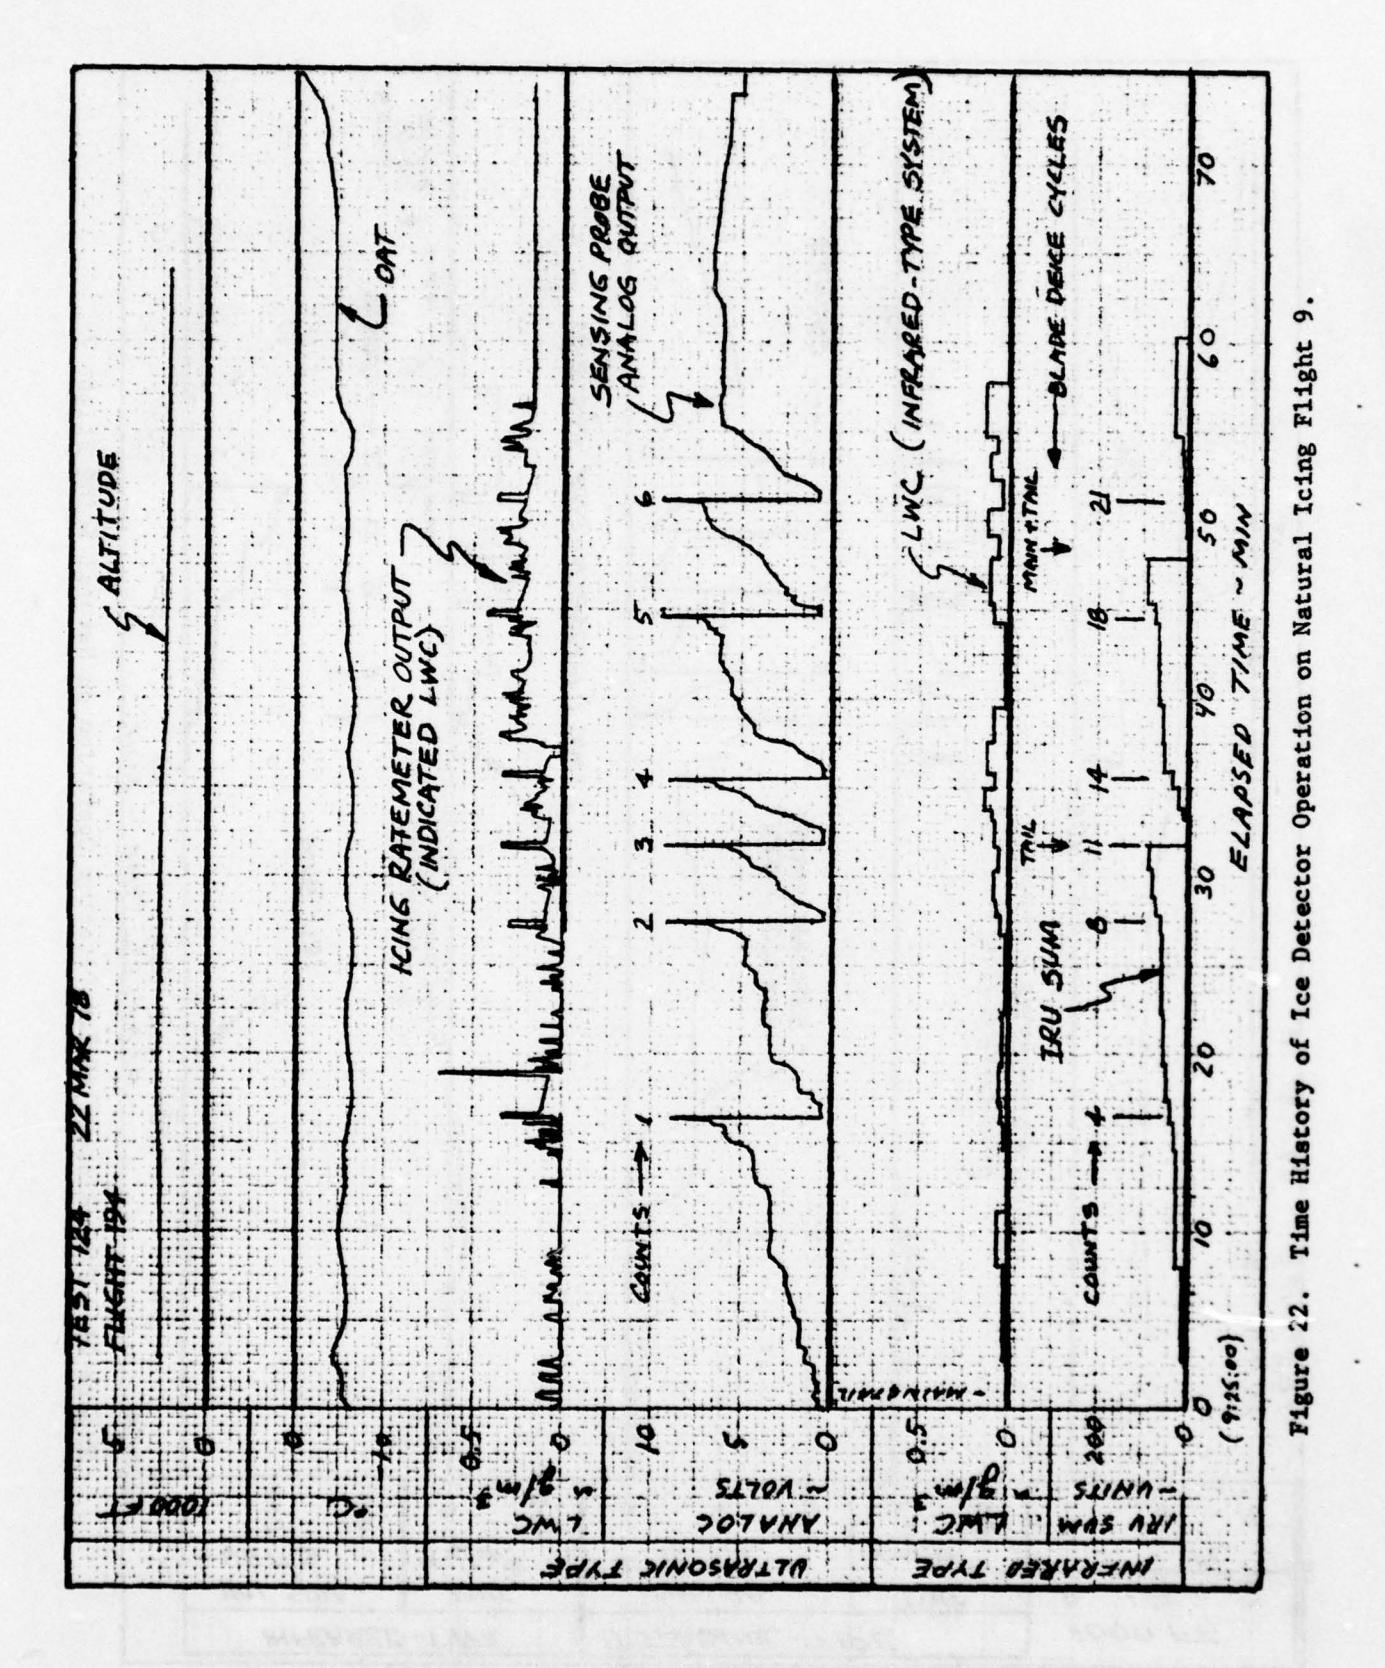
Typical indications of both systems are shown in Figures 21 and 22 during flight in intermittent natural icing. Generally good agreement is shown between the two systems. Operation of the IRU can be seen from the bottom parameter on each figure which is the IRU sum or the integrated rate units.

The zero shift, mentioned previously, did not appear on Flight 190 (Figure 21) but does show after time 38 minutes on Figure 22. Note that the ultrasonic-type LWC does not return to zero and the LWC indication is more than twice that of the infrared type after the zero shift. This can also be noted on Figure 6 after time 18 minutes. In addition, the spikes on the analog voltage trace at the ice detector probe deice point were not characteristic of last year's data (See Figures 17 through 21 of Reference 4). During the period of the zero shift, the ratio of the number of ice detector cycle counts for the ultrasonic to the infrared decreased also. Presumably these problems will be corrected in the production version of the new aspirated-probe configuration of this detector.

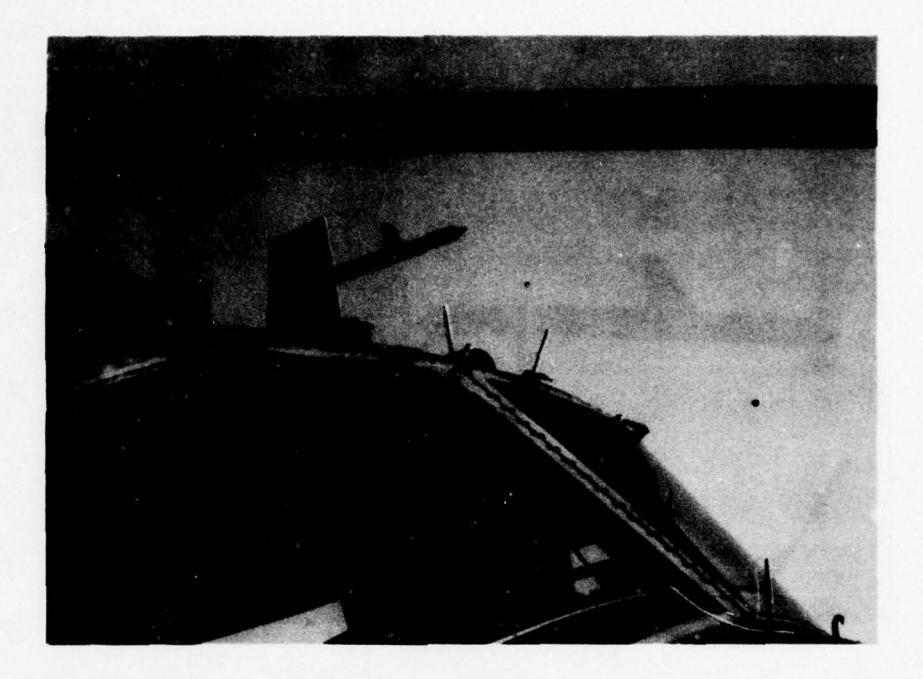
Figure 23 also shows something of interest relative to the battery compartment vent tube icing problem that was indicated from HISS tanker icing tests in 1975 and reported in Reference 1. Inspection of the ice catch on the icing mast located at the base of the windshield center near the battery vent, showed very little, if any, ice accretion on the post near its base up to the height of the battery vent. This indicates that the smaller size droplets in a natural icing environment do not impinge on the battery vent tube but pass over it as opposed to the larger droplet size of the HISS cloud. Therefore, it appears that in natural icing it is unlikely that the vent will ice up and clog; additional experience in icing is necessary to confirm this.

Figure 23. Three of the Stick-Like Masts Used in the Ice Detector Location Survey.

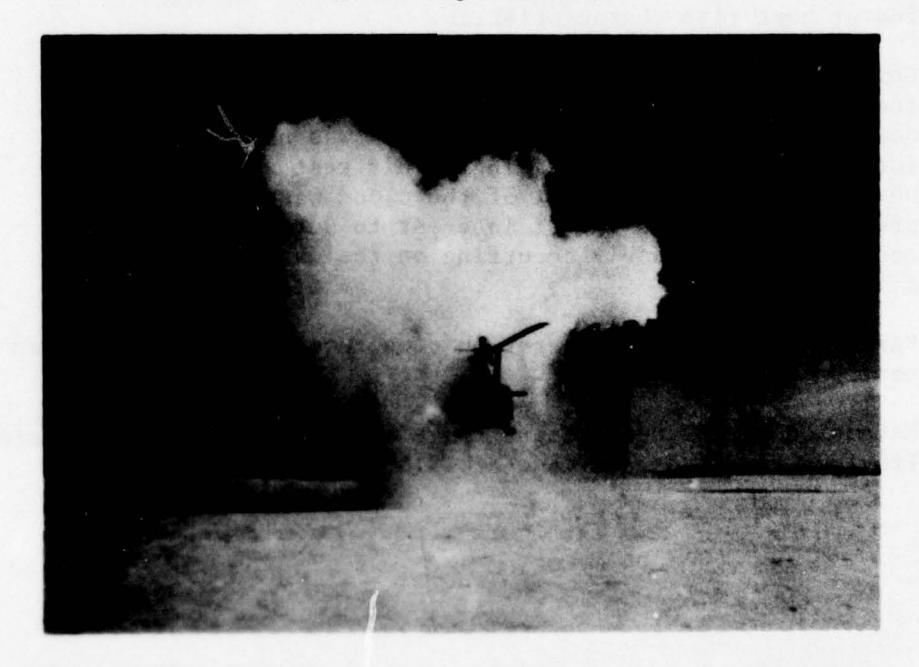
Figure 28. Rear View of Test Aircraft in the Spray Rig on Bright Clear Day With 0.7 g/m<sup>3</sup> LWC and -7°C OAT.

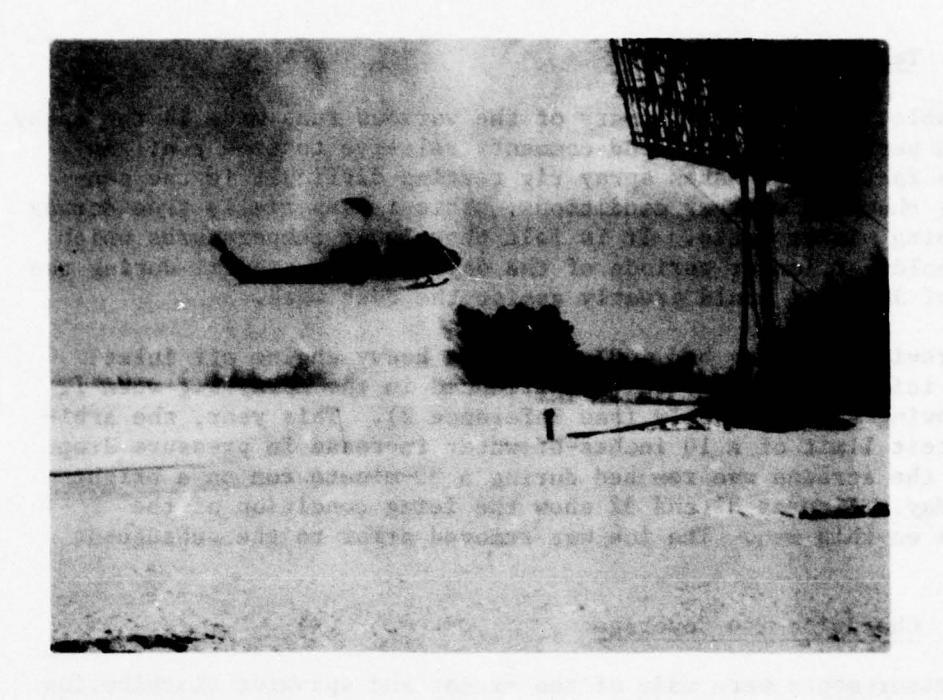
Figure 29. Spray Rig Operations With a 10-mph West Wind (cloud is  $0.7 \text{ g/m}^3$  at  $-6.5^{\circ}\text{C}$  OAT).

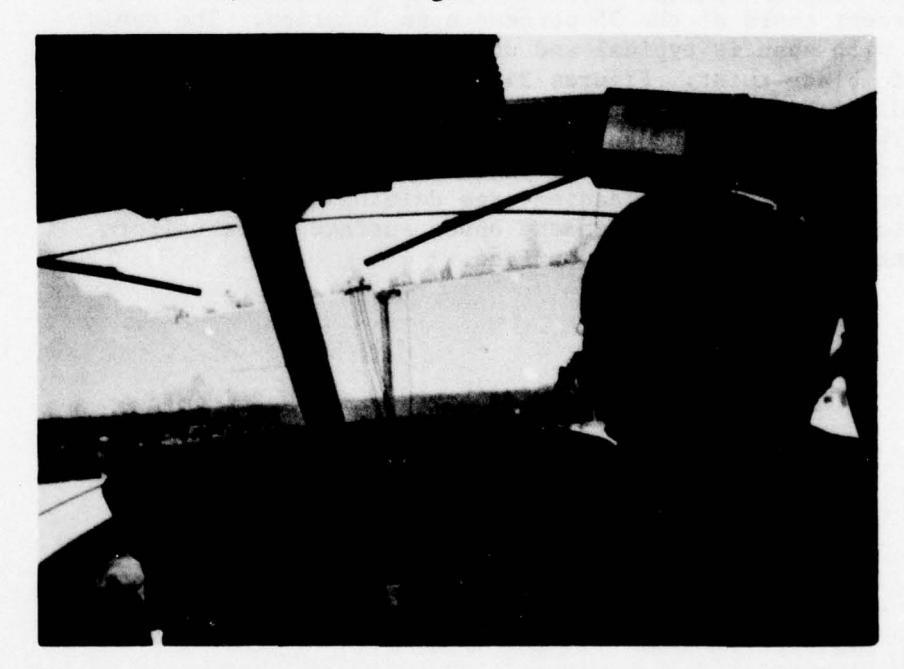
Figure 30. View From the Cockpit During a Spray Rig Test Prior to Cloud Pulldown (20-mph wind and 0.55 g/m<sup>3</sup> at  $-11^{\circ}$ C).
