USARTL-TR-78-48

ICING TESTS OF A UH-IH HELICOPTER WITH AN ELECTROTHERMAL ICE PROTECTION SYSTEM UNDER SIMULATED AND NATURAL ICING CONDITIONS

R. H. Cotton LOCKHEED-CALIFORNIA CO. P.O. Box 551 Burbank, Calif. 91520

April 1979

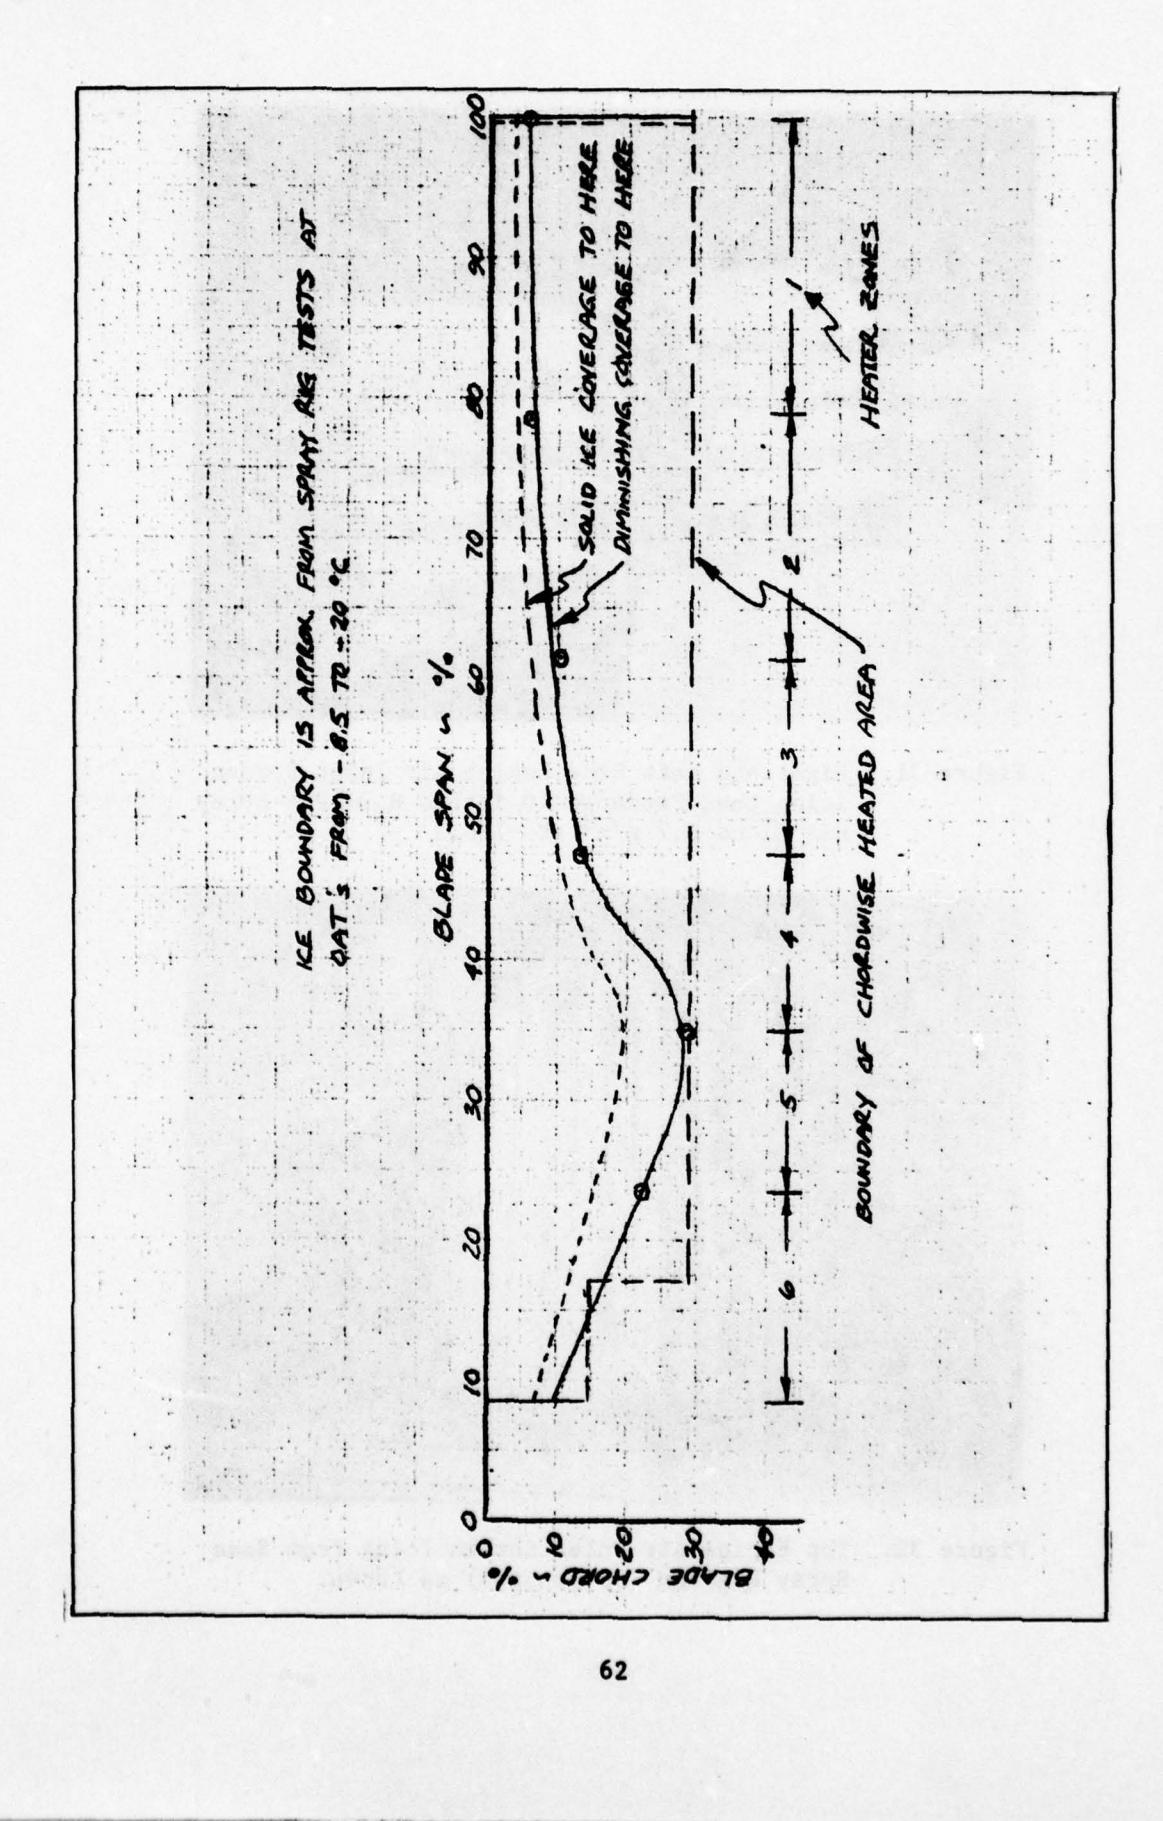
Measurements were made of the extent and spanwise distribution of main rotor blade chordwise ice coverage. Figure 33 shows the quantitative results for the lower surface. The pattern shown is typical for the spray rig and shows a maximum chordwise coverage of 29 percent chord at the 35-percent span location. The rapid decrease with span is typical and undoubtedly related at least in part to blade twist. Figures 34 and 35 are photographs of a typical distribution and texture on the lower surface of the blade. The upper surface usually has a fairly uniform one-half to three-quarters of an inch coverage which would be approximately 3-1/2 percent chord. The leading-edge deicing heater coverage extends to 12 percent chord on the upper surface and a uniform 29 percent chord on the lower surface. TABLE 3. SPRAY RIG TESTING SUMMARY (Sheet 1 of 2)

Figure 33. Chordwise Extent of Ice on Main Rotor Blade Lower Surface.

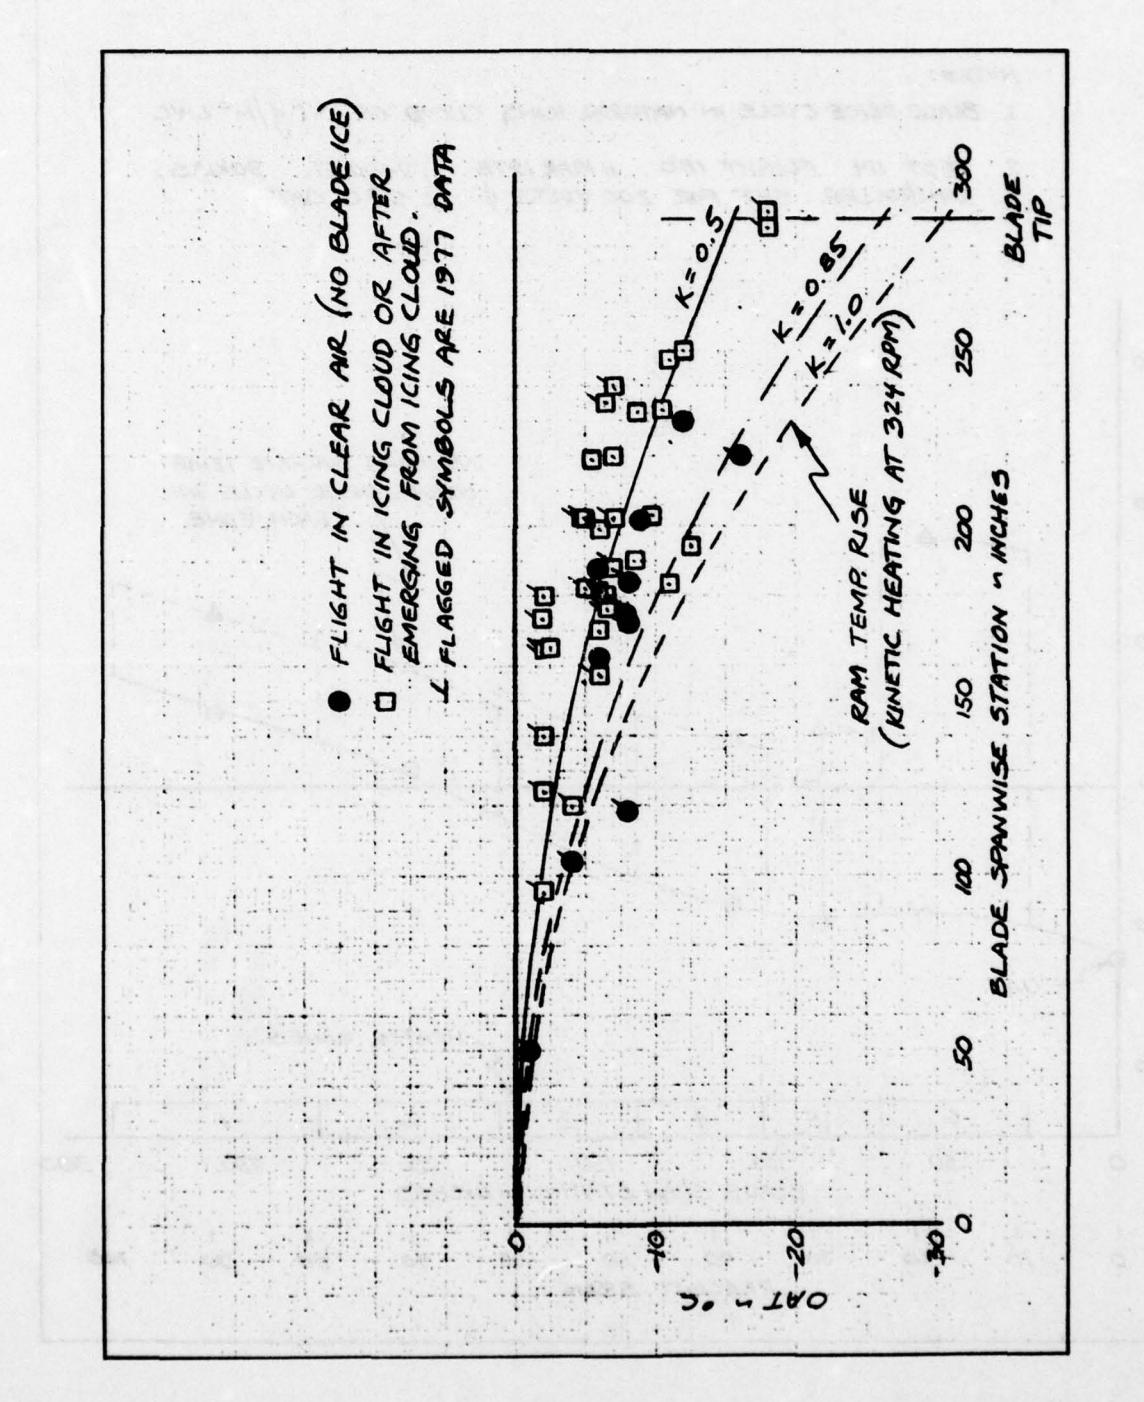
Figure 39 is a plot from data like that shown in Figure 38 of the spanwise station that the blade temperature variation crosses 0°C versus outside air temperature. This plot is an indication of the spanwise extent of blade icing for any air temperature. It also is an indication of the amount of kinetic heating or "net kinetic heating" of the blade. Considerable scatter is apparent in the data, indicative of the difficulty mentioned previously in defining spanwise temperature distributions that are considered representative of specific operating conditions. Because of the inconsistencies that have been noted in examining the available test data, the only differentiation

Figure 39. Blade Station for 0°C Skin Temperature versus OAT.

It appears from Figure 39 that to determine the heater-on time required to deice (raise the surface temperature to  $0^{\circ}$ C), the assumption that 50 percent net kinetic heating is realized is still a valid one.

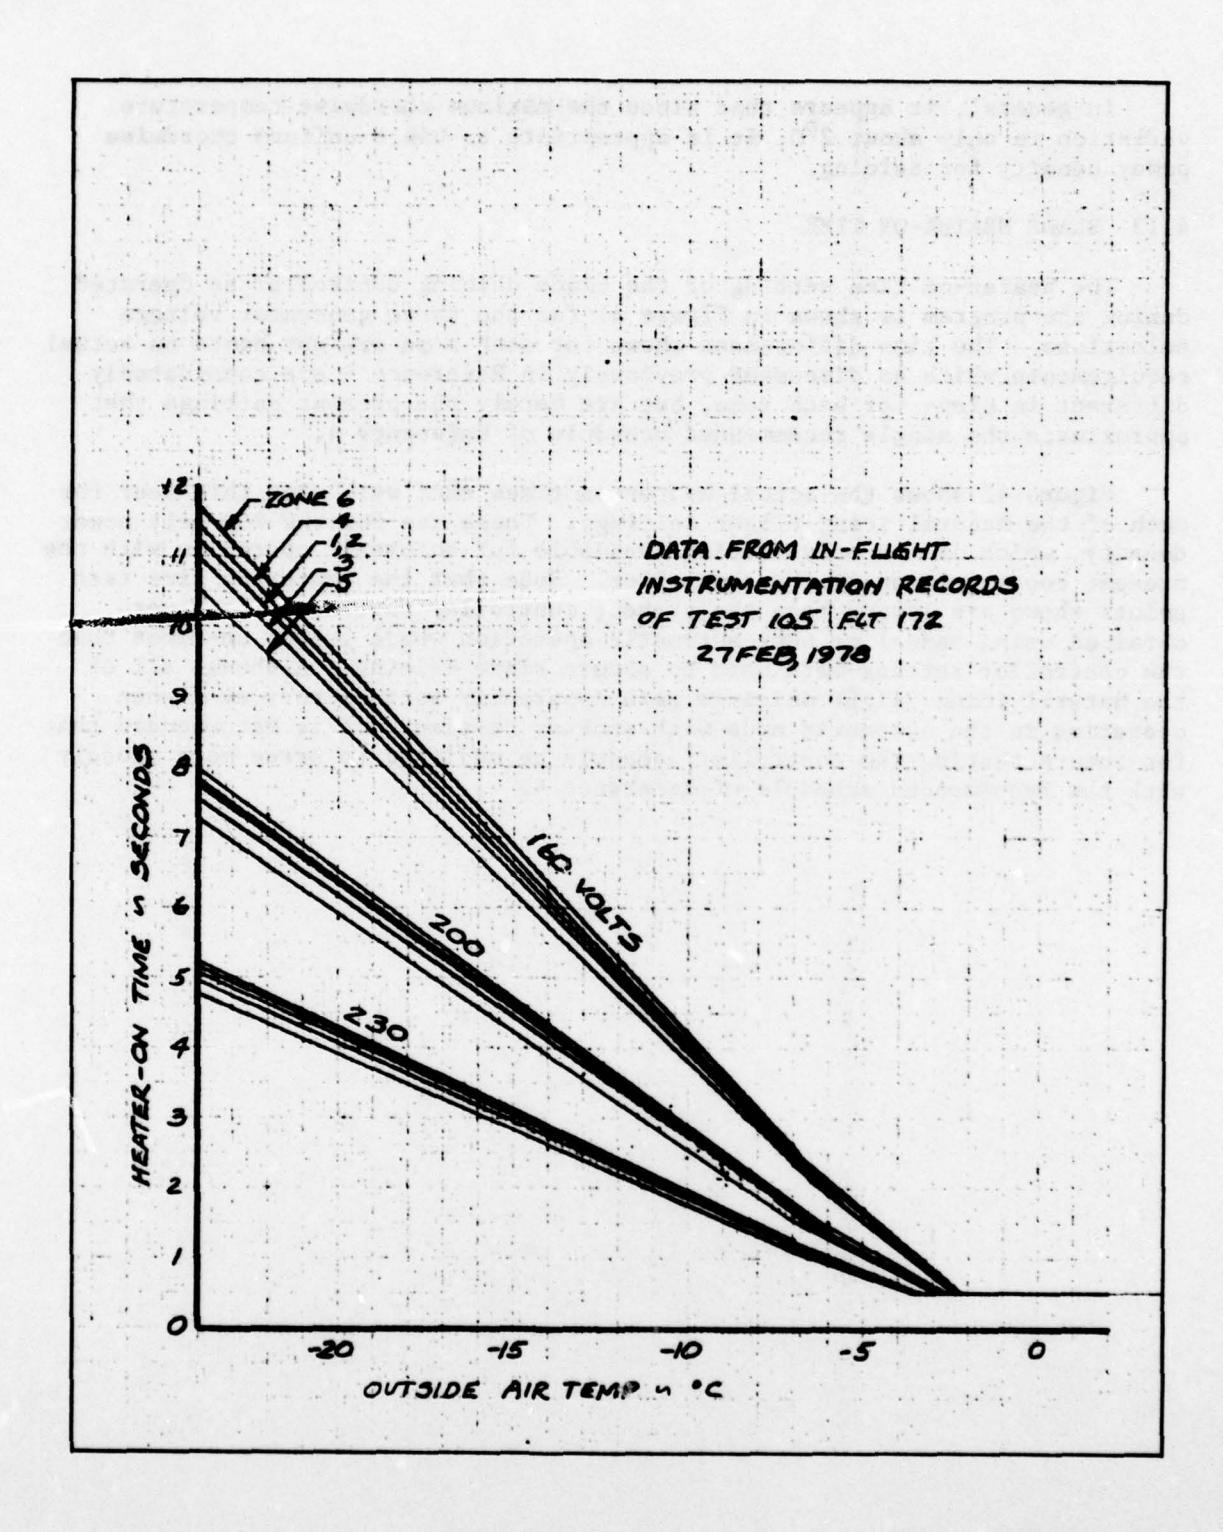
The heater-on time setting of the blade deicing controller as operated during the program is shown in Figure 41 for the three generator voltage selections. The time differences shown for each zone are not based on actual requirements, which as discussed previously in Reference 4 are considerably different in slope for each zone, but are merely the present settings that approximate the single recommended schedule of Reference 4.

Figure 41. Present Scheduling by Controller of Main Blade Heater-On Time.

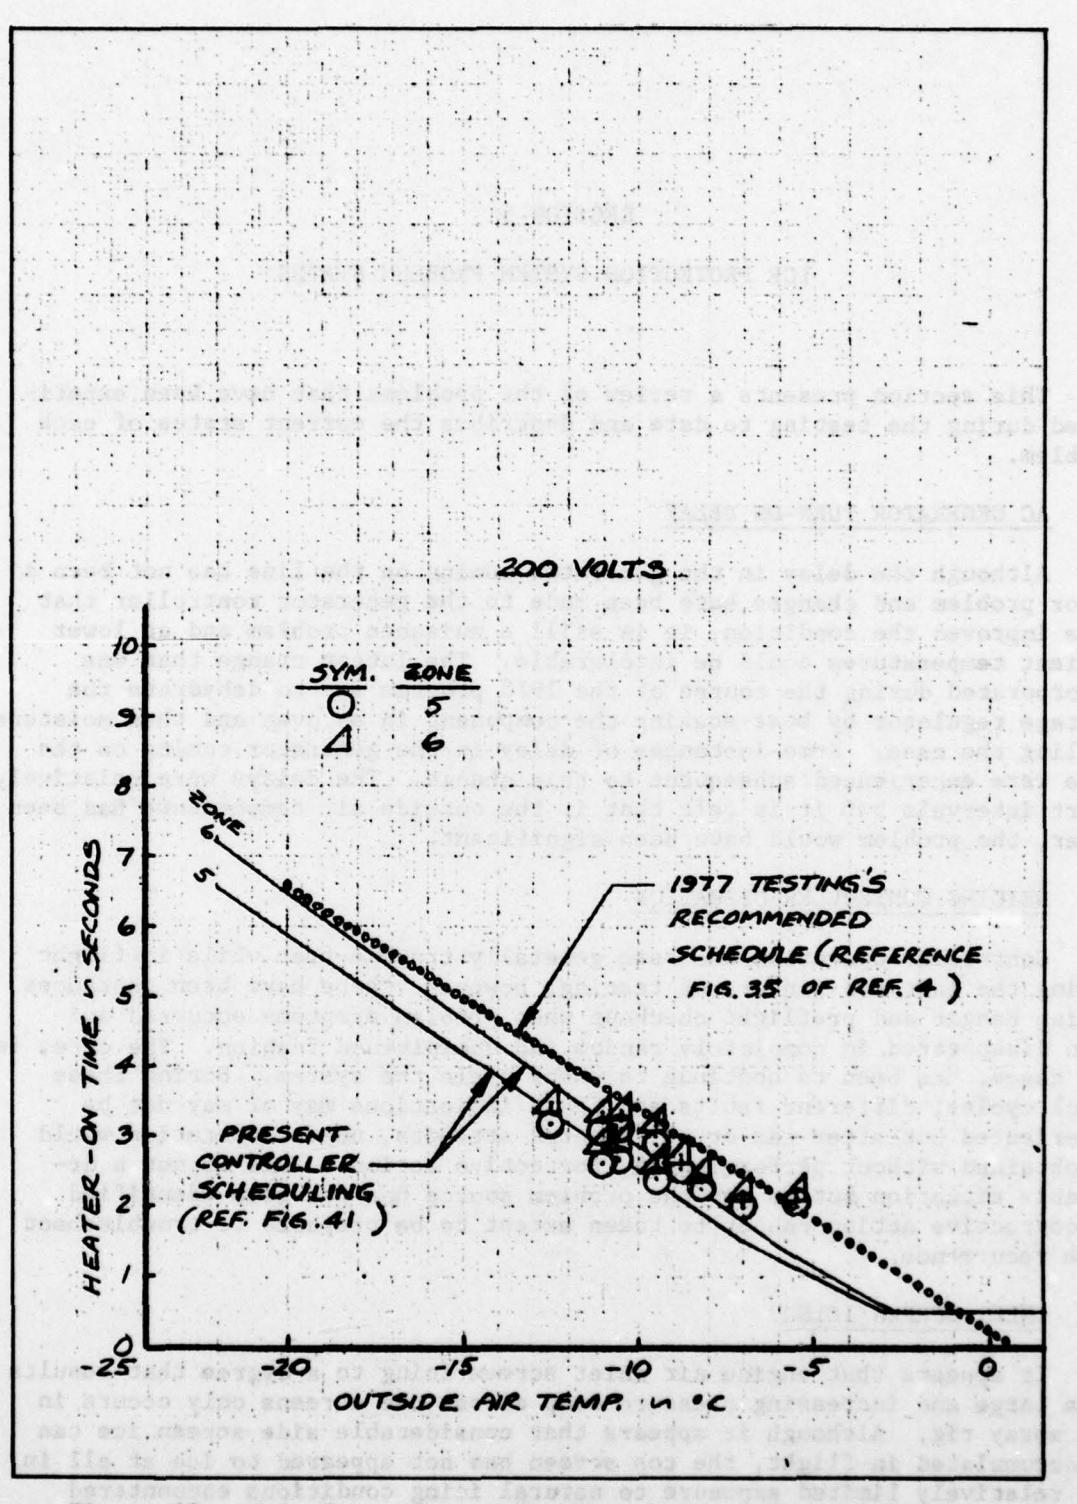
Figure 42 shows the actual heater-on times that were used this year for each of the natural icing flight deicings. These are for the 200-volt power density, which is the only setting available for automatic operation with the present configuration of the controller. Note that the heater-on time test points shown are longer than the present controller setting. These were obtained using manual or semi-automatic operation where longer on-times than the controller setting were used to assure blade deicing. Although all of the natural icing flight deicings were apparently satisfactory even when operating in the automatic mode with shorter on-times, it is recommended that for future testing the controller schedule be modified to agree more closely with the recommended schedule of Reference 4.

Figure 42. Main Rotor Heater-On Times Used on Natural Icing Flights During 1978 Testing.
