ATLANTIC COAST BASIN
QUIGLEY CREEK
MONMOUTH COUNTY
NEW JERSEY

SHADOW LAKE DAM

NJ 00090

PHASE 1 INSPECTION REPORT NATIONAL DAM SAFETY PROGRAM

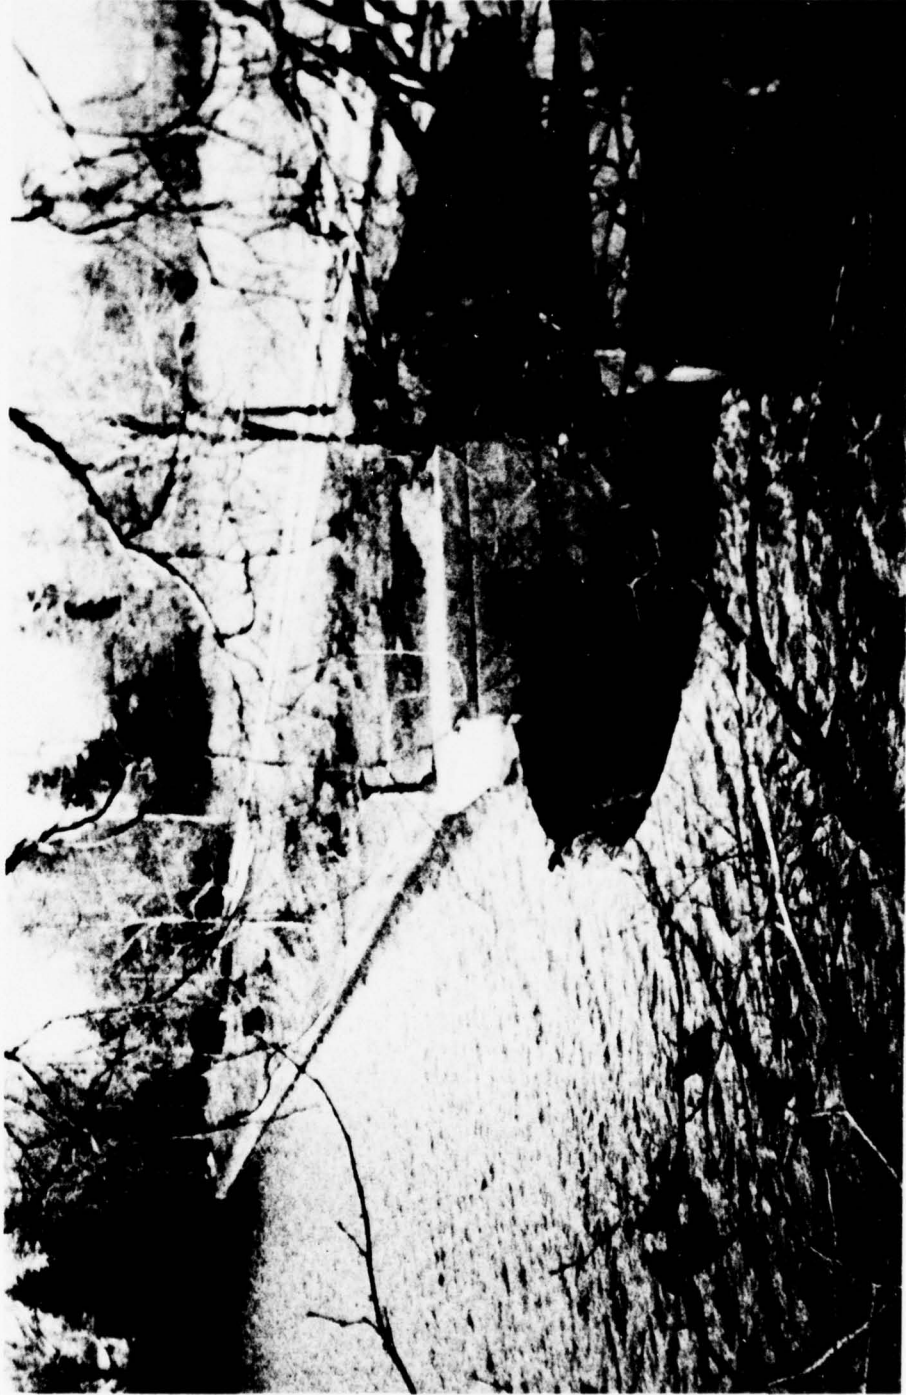
OVERVIEW OF SHADOW LAKE DAM

Shadow Lake Dam is assessed to be in an overall good condition and is recommended to be downgraded from a high hazard to a significant hazard category. Overtopping of the dam would not substantially increase the danger of loss of life or property damage as the downstream flood plain is uninhabited. No detrimental findings were uncovered to render a hazardous assessment. Remedial actions recommended to be undertaken in the future are 1) regrade and protect the downstream embankment areas at the spillway wingwalls, 2) protect these areas with slope paving and, 3) regrade, level and reseed the main dam embankment.

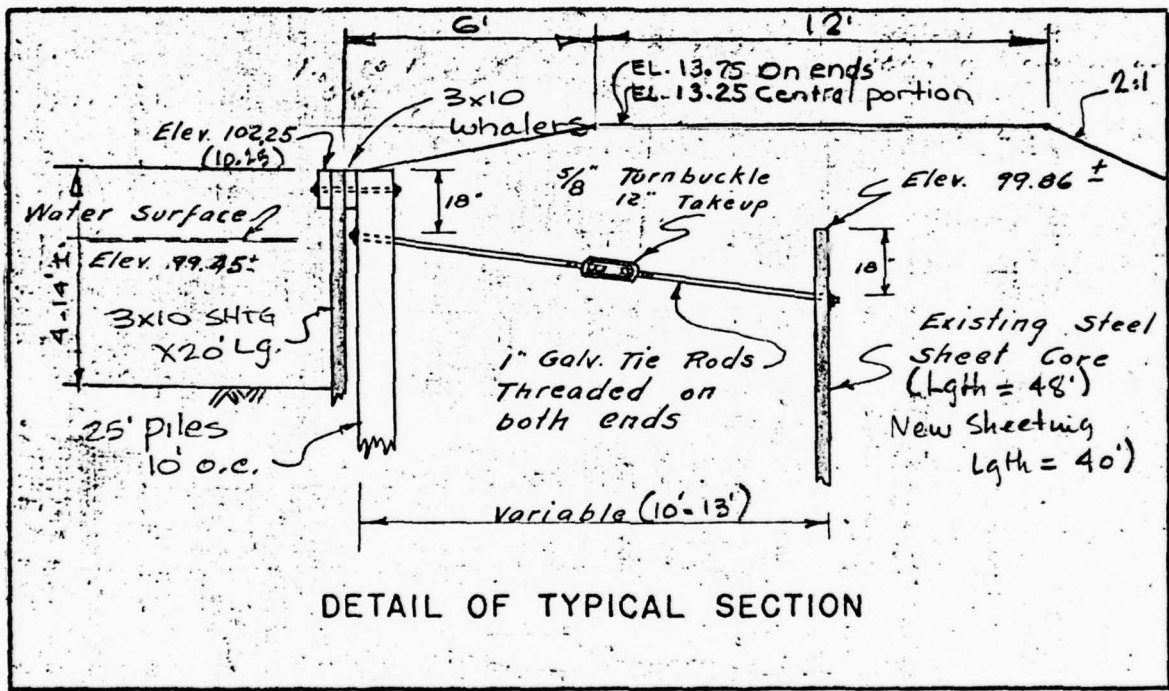
Figure 3

Based on the review of the design information available and the visual inspections, Shadow Lake Dam is deemed to be in a sound structural condition as long as it is not overtopped by extremely high hydraulic heads. The inspection team was mainly concerned with the foundation aspects of the steel sheeting core wall (see Figure 3). The breaching and failure of the dam in 1938 destroyed over 100 feet of the existing sheeting in a zone beginning 130 feet north of the main spillway. This was replaced with new sheeting but the zones adjacent to the break utilized the older sheeting, which was tilted downstream 1 to 3 feet at the top cut-off. Practically all of the dam embankment below the sheetline was completely scoured out to depths between 15 and 25 feet below the present crest. The juncture between the new and old work was drawn together with bolts with come-a-longs and the older sheeting was so out-of-plumb that it could not be interlocked with the new sections and had to be welded together. Following this, the new timber bulkhead was installed on the upstream face.
