National Dam Inspection Program.
Upper Donohoe Dam (now Referred to as)
Twin Lakes Number 2 Dam, NDS I.D.
PA-001478), Ohio River Basin, Little
Cragtree Creek, Westmoreland County,
Pennsylvania. Phase I Inspection
Report.

PHASE I REPORT
NATIONAL DAM INSPECTION PROGRAM

Upper Donohoe Dam: NDS I.D. No. PA-00478

Owner: Westmoreland County
State Located: Pennsylvania (PennDER I.D. No. 65-55)
County Located: Westmoreland
Stream: Little Crabtree Creek
Inspection Date: 13 December 1978
Inspection Team: GAI Consultants, Inc.
570 Beatty Road
Monroeville, Pennsylvania 15146

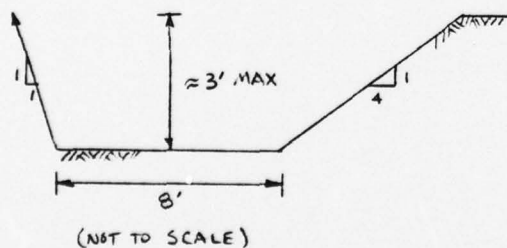
- ALTHOUGH THE HYDROLOGIC/HYDRAULIC EVALUATION OF THIS FACILITY WILL BE PERFORMED ASSUMING THAT THE SPILLWAY CHUTE CHANNEL IS IN IDEAL CONDITION (SEE SECTION 5.3), SOME ESTIMATE OF THE ACTUAL PRESENT SPILLWAY SYSTEM CONSEQUENCES AND CAPACITY SHOULD BE MADE.
- DUE TO THE PRESENCE OF THE BREACH IN THE LEFT CHUTE CHANNEL WALL (CAUSED BY THE PLACEMENT OF A TEMPORARY EARTH AND ROCK ROAD ACROSS THE CHUTE CHANNEL @ ABOUT 35 FT DS FROM THE SPILLWAY CREST), SOME SPILLWAY DISCHARGE WILL FLOW TOWARD THE TOE WHEN THE CHANNEL DEPTH EXCEEDS ABOUT 1.5 FT OR SO.
- THE ACTUAL PRESENT CRITICAL FLOW CONTROL SECTION IS LOCATED ABOUT 70 FT DS FROM THE SPILLWAY (SEE SKETCH ON SHEET 6). THE APPROXIMATE CROSS-SECTION DIMENSIONS ARE GIVEN IN THE SKETCH BELOW. ASSUMING UNIFORM FLOW ABOVE THIS SECTION (REF 7, PG. 5), THE

MAXIMUM DEPTH OF FLOW UPSTREAM FROM THE SECTION WILL BE ≈ 2.7 FT (CORRESPONDING TO THE MAXIMUM SPILLWAY DEPTH PRIOR TO OVERTOPPING W/ THE CRITICAL CONTROL ON THE CREST). ALSO, IGNORING THE POSSIBLE FLOW THROUGH THE LEFT CHUTE CHANNEL WALL BREACH, THE SPILLWAY CAPACITY CAN BE FOUND

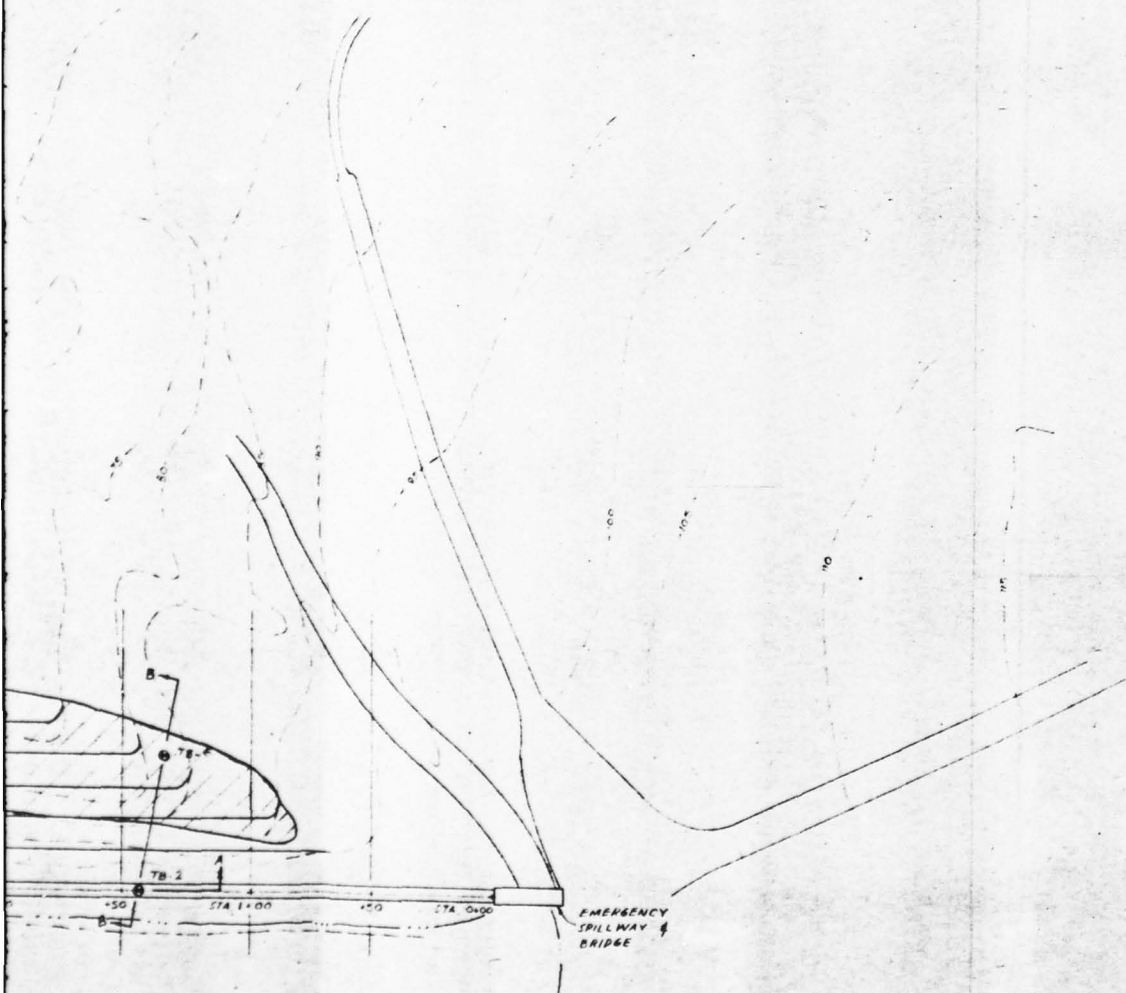
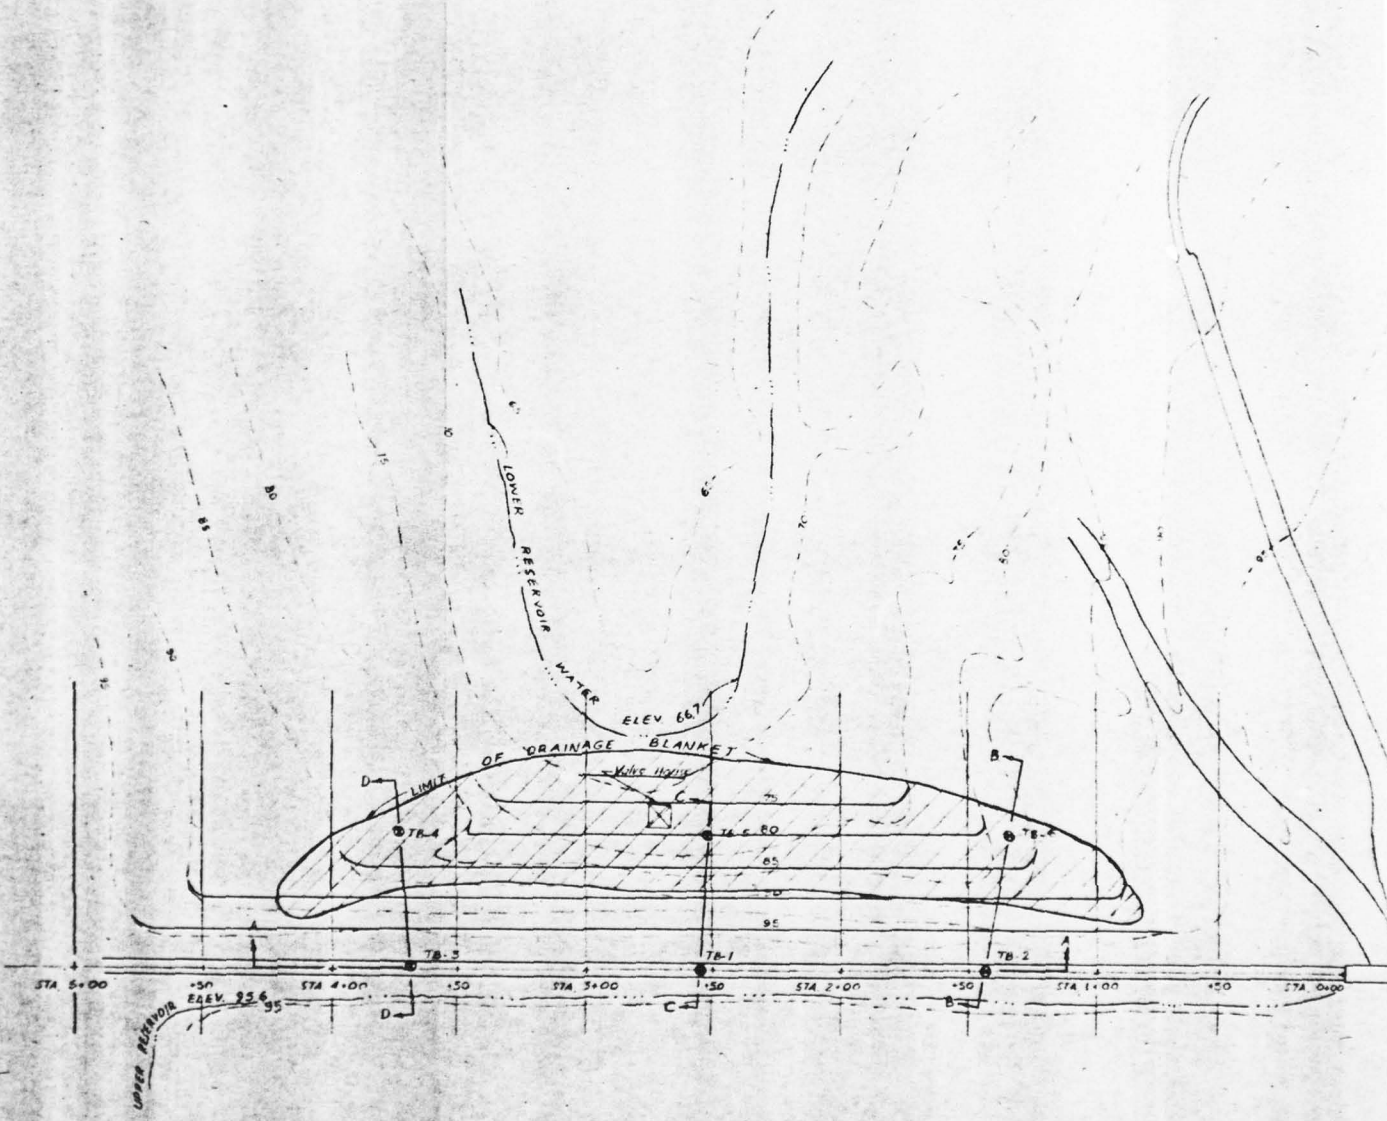
FIGURE 3

2. Embankment. In 1978, six test borings were drilled along the downstream side of the embankment by the owner's consultant for the purpose of assessing the existing conditions within the embankment and to develop design parameters for the proposed rehabilitation (see Figure 3). Three of the test borings were drilled through the embankment and all six borings penetrated at least 25 feet into the underlying bedrock to determine the type, depth, and engineering properties of these materials. Shelby tube and bag samples were secured for subsequent direct shear and permeability tests and for laboratory compaction, permeability and classification tests, respectively. Soil and rock field permeability tests were performed in four of the test borings. Typical embankment cross-sections depicting existing conditions within the embankment are presented on Figure 4, Appendix F. The methods and results of the testing are presented in the consultants report.

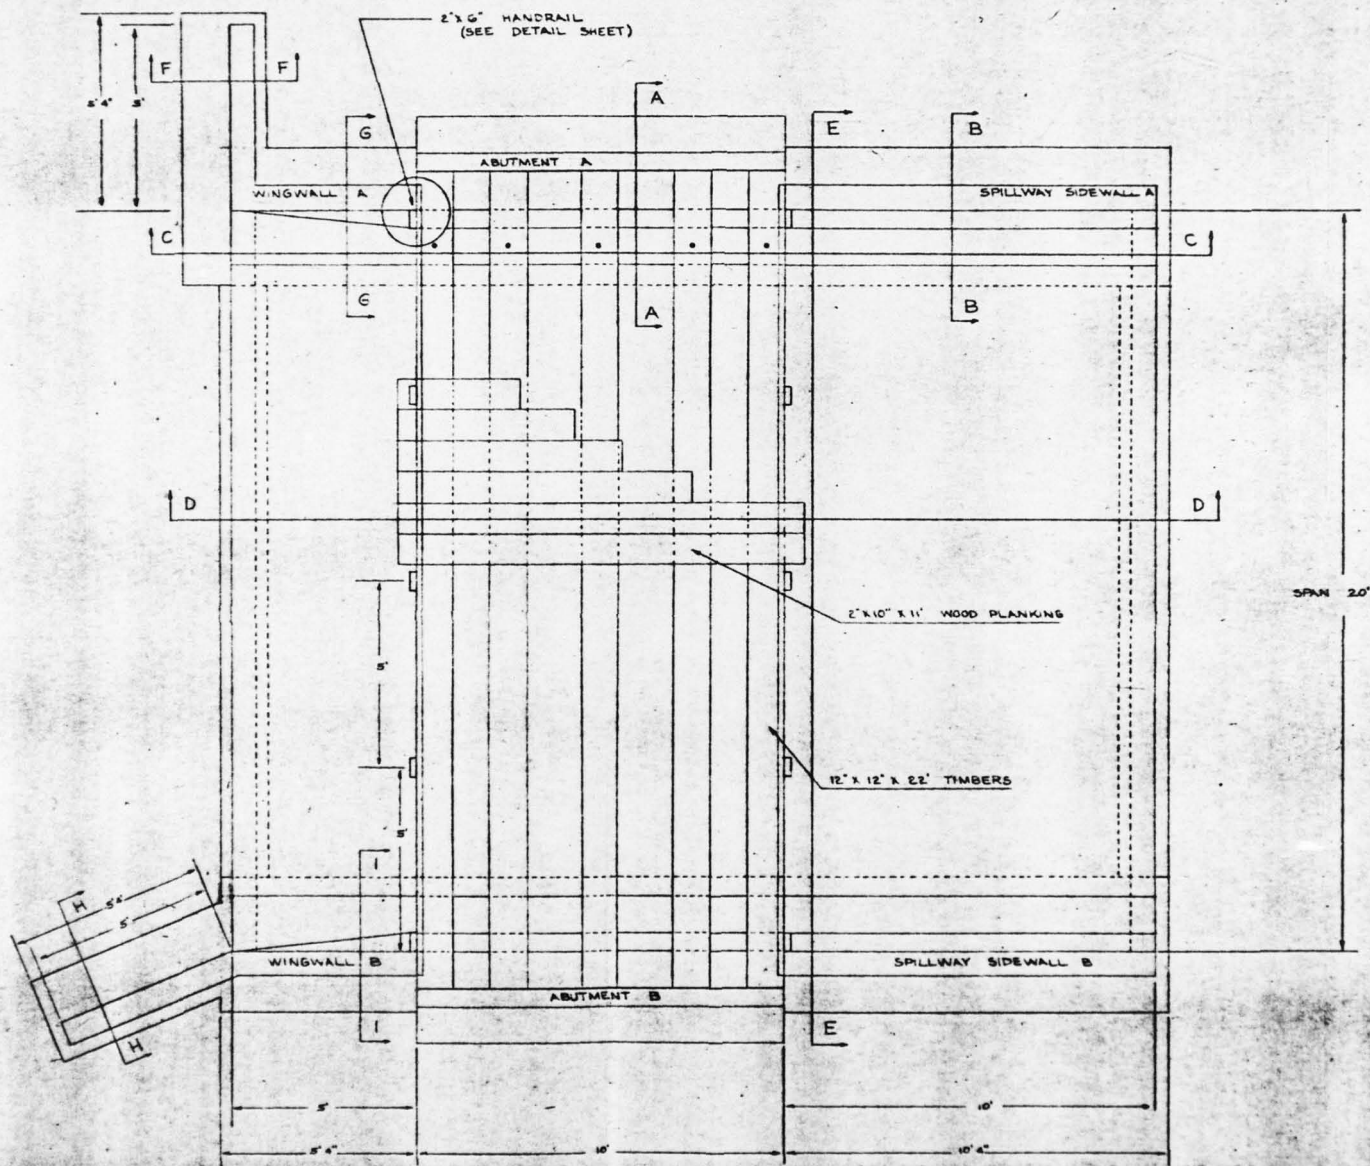
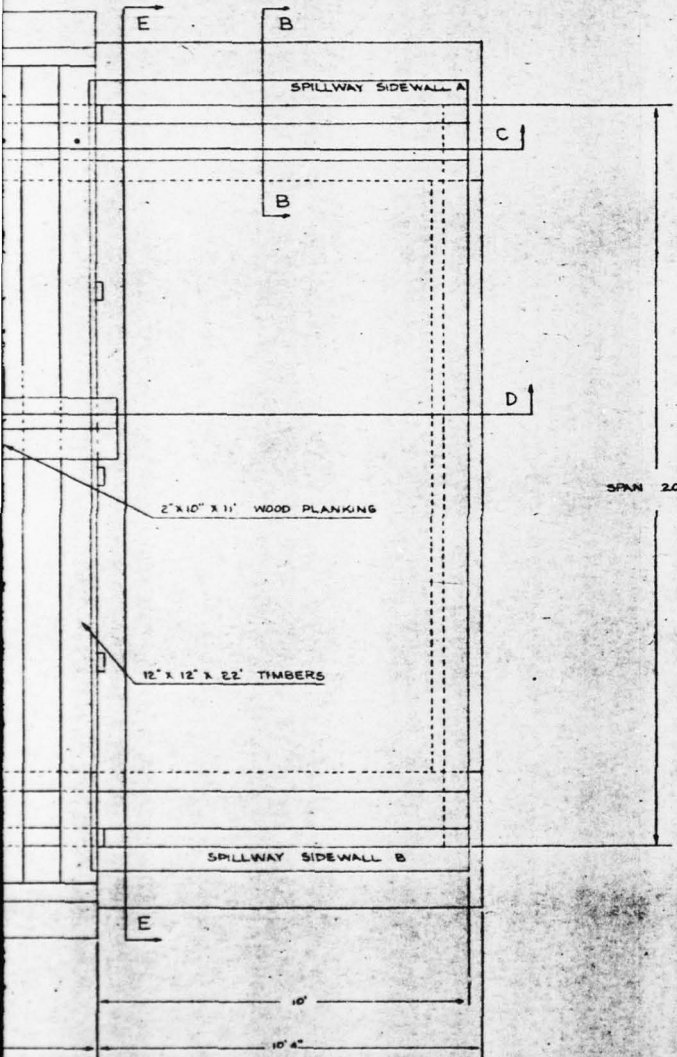
FIGURE 5

c) Spillway. The spillway consists of a recently constructed reinforced concrete chute and an unlined discharge channel (see Figures 5 and 6). At the control section, the concrete channel is approximately 20 feet wide and 36 feet long. Discharge from the spillway enters a channel cut in natural ground and flows into the reservoir of Twin Lakes No. 1 Dam approximately 250 feet downstream of the Upper Donohoe Dam.
