6AI CONSULTANTS INC MONROEVILLE PA
NATIONAL DAM INSPECTION PROGRAM. TWIN LAKES NUMBER 1 DAM (NDS1.--ETC(U)
APR 79

PHASE I INSPECTION REPORT
NATIONAL DAM INSPECTION PROGRAM

PHASE I REPORT
NATIONAL DAM INSPECTION PROGRAM

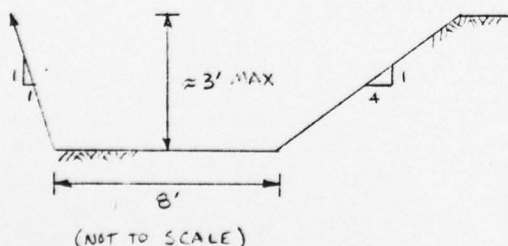
- ALTHOUGH THE HYDROLOGIC/HYDRAULIC EVALUATION OF THIS FACILITY WILL BE PERFORMED ASSUMING THAT THE SPILLWAY CHUTE CHANNEL IS IN IDEAL CONDITION (SEE SECTION 5.3), SOME ESTIMATE OF THE ACTUAL PRESENT SPILLWAY SYSTEM CONSEQUENCES AND CAPACITY SHOULD BE MADE.
- DUE TO THE PRESENCE OF THE BREACH IN THE LEFT CHUTE CHANNEL WALL (CAUSED BY THE PLACEMENT OF A TEMPORARY EARTH AND ROCK ROAD ACROSS THE CHUTE CHANNEL @ ABOUT 35 FT DS FROM THE SPILLWAY CREST), SOME SPILLWAY DISCHARGE WILL FLOW TOWARD THE TBE WHEN THE CHANNEL DEPTH EXCEEDS ABOUT 1.5 FT OR SO.
- THE ACTUAL PRESENT CRITICAL FLOW CONTROL SECTION IS LOCATED ABOUT 70 FT DS FROM THE SPILLWAY (SEE SKETCH ON SHEET 6). THE APPROXIMATE CROSS-SECTION DIMENSIONS ARE GIVEN IN THE SKETCH BELOW. ASSUMING UNIFORM FLOW ABOVE THIS SECTION (REF 7, PG. 5), THE

MAXIMUM DEPTH OF FLOW UPSTREAM FROM THE SECTION WILL BE ≈ 2.7 FT (CORRESPONDING TO THE MAXIMUM SPILLWAY DEPTH PRIOR TO OVERTOPPING W/ THE CRITICAL CONTROL ON THE CREST). ALSO, IGNORING THE POSSIBLE FLOW THROUGH THE LEFT CHUTE CHANNEL WALL BREACH THE SPILLWAY CAPACITY CAN BE FOUND

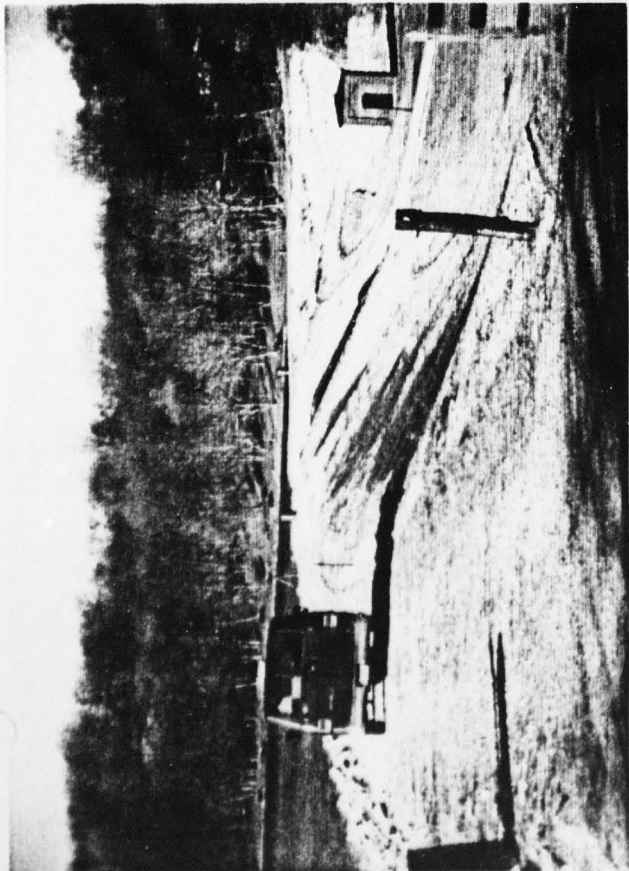
b. Embankment. The visual inspection suggests the embankment to be in good condition. Minor seepage, however, was observed along the downstream toe, particularly to the right of the spillway section (see Photograph 3). Despite the localized saturated areas, no signs of sloughing, erosion, or free flowing water were observed on or immediately below the embankment. A slag-gravel roadbed protects the crest against damage from occasional vehicular use. The downstream slope is covered with grass that requires little maintenance other than occasional mowing (see Photograph 1). The riprap is durable and well graded and provides adequate slope protection.

PHOTOGRAPH 1 View looking west along the crest and downstream slope of the embankment.
