RYERSON STATION STATE PARK DAM

NDI I.D. NO: PA-193

**PHASE I INSPECTION REPORT
NATIONAL DAM INSPECTION PROGRAM**

D'APPOLONIA CONSULTING ENGINEERS
10 DUFF ROAD
PITTSBURGH, PA. 15235
MARCH 1979

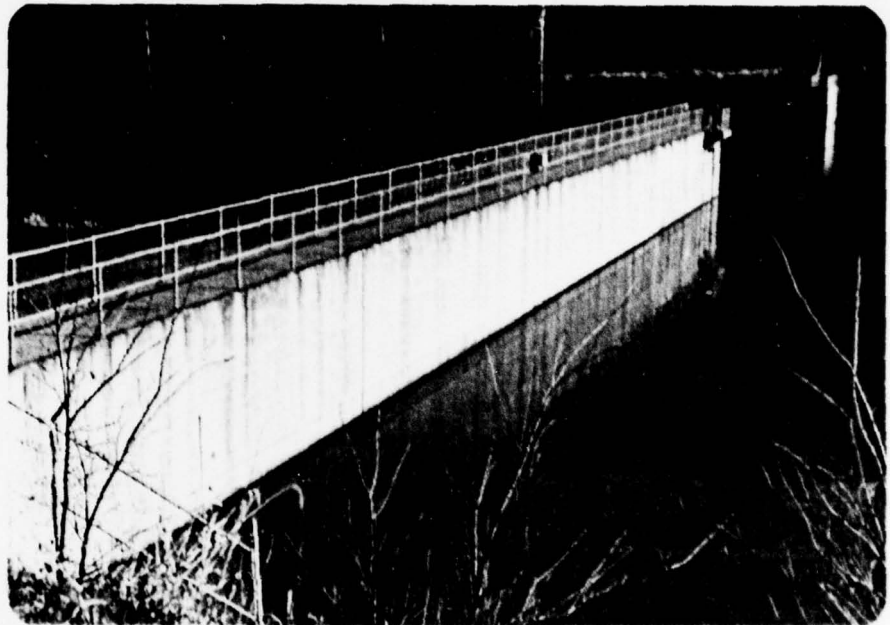
Upstream Face

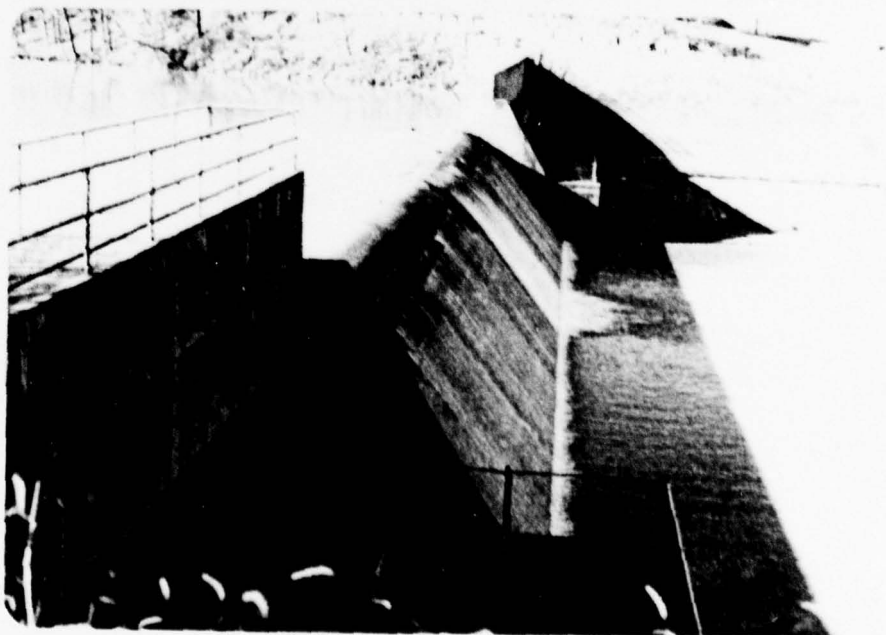
Downstream Face

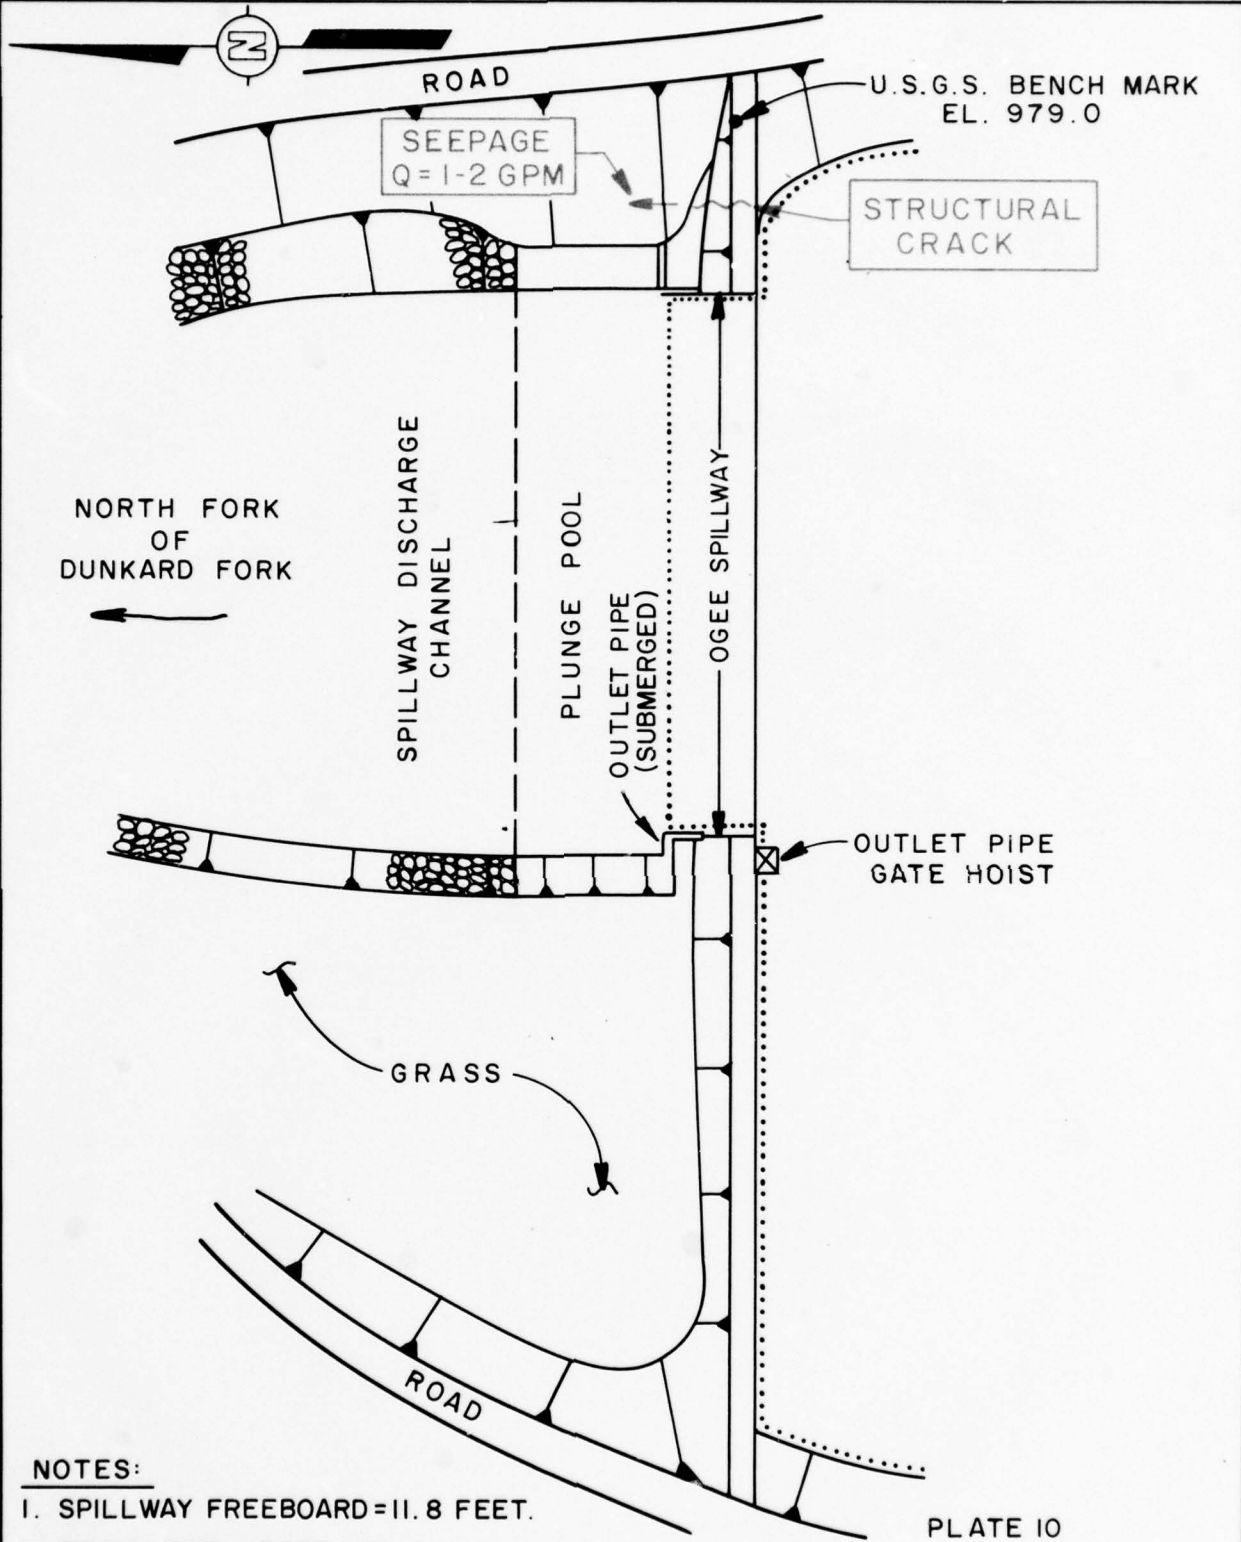
2

- NOTES:**
1. SPILLWAY FREEBOARD=11.8 FEET.
 2. POOL LEVEL DATE OF INSPECTION: 1 INCH OVER SPILLWAY CREST.

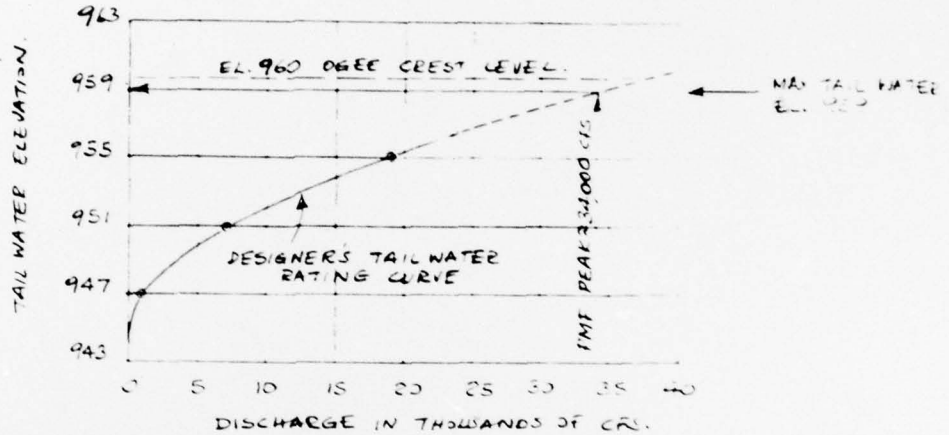
TAILWATER RATING CURVE
(REDRAWN FROM PLATE 2)

a) 34,000 cfs $H_c = 977.51 - 960.00 = 17.5'$
 $H_d = 977.51 - 959.00 = 18.5'$

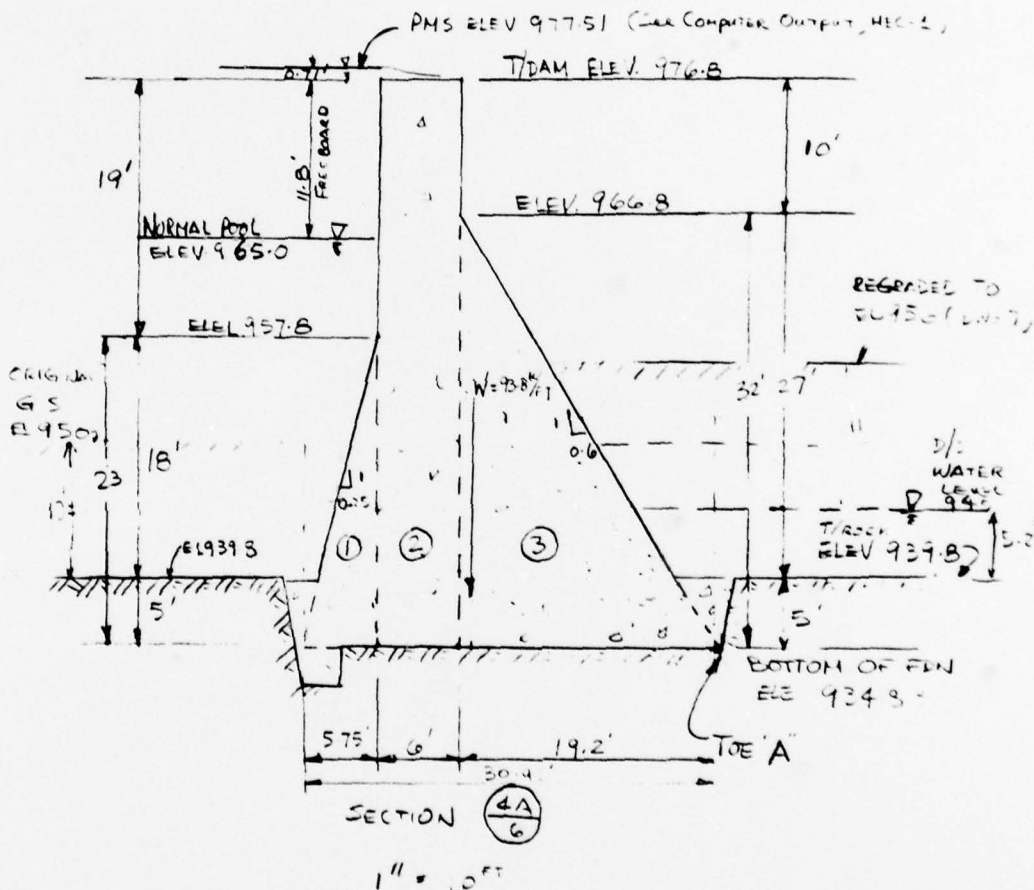
Ⓐ DAM SECTION $\frac{4A}{6}$

ITEMS	WEIGHT, k.p. k.p.	ARM to pt 'A' FT	Moment @ Pt 'A' k-ft
①	$\frac{1}{2}(5.75)(22)(0.15) = 9.92^k$	$19.2 + 6 + \frac{5.75}{3} = 27.12'$	268.96
②	$(6)(42)(0.15) = 37.80^k$	$19.2 + \frac{6}{2} = 22.20'$	839.16
③	$\frac{1}{2}(19.2)(32)(0.15) = 46.08^k$	$19.2 \times \frac{2}{3} = 12.80$	589.82
	$\Sigma V = 93.8^k$		$\Sigma M_a = 1698$

DAM IS STABLE UNDER PMS CONDITION WITH FACTOR SAFETY
OF 1.4 & 9 AGAINST OVERTURNING & SLIDING, RESPECTIVELY

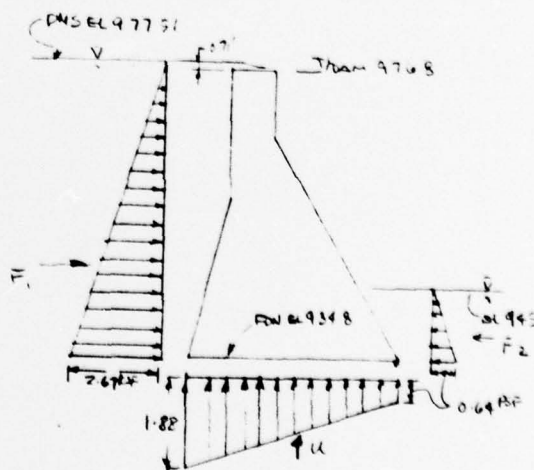
uplift & water pressures

AT HEEL $p = (977.51 - 934.8)(0.0624) = 267$ ksf
 AT TOE $p = (945 - 934.8)(0.0624) = 0.64$ ksf
 AT HEEL uplift $p' = (965 - 934.8)(0.0624) = 1.88$

ITEM	ARM	M _a k-ft
$F_1 = (\frac{1}{2})(267)(42.71) = 569$	$\times \frac{42.71}{3} = 14.24$	810.3
$F_2 = (\frac{1}{2})(0.64)(10.2) = -3.3$	$\times \frac{10.2}{2} = 3.4$	-11.0
$\Sigma F_x = 536.7^k$		
$U_1 = (\frac{1}{2})(1.88)(30.95) = 19.3^k$	$\times \frac{1}{3}(30.95) = 20.6$	398.5
$U_2 = (0.64)(30.95) = 19.7$	$\times \frac{30.95}{2} = 15.5$	304.8
$\Sigma F_y = 39^k$		$M_a = 1513.6 - 11 = 1502.6$
