CABIN CREEK DAM

NDS ID NO. PA-00336

RED LION MUNICIPAL AUTHORITY
PHASE I INSPECTION REPORT
NATIONAL DAM INSPECTION PROGRAM

PHASE I INSPECTION REPORT

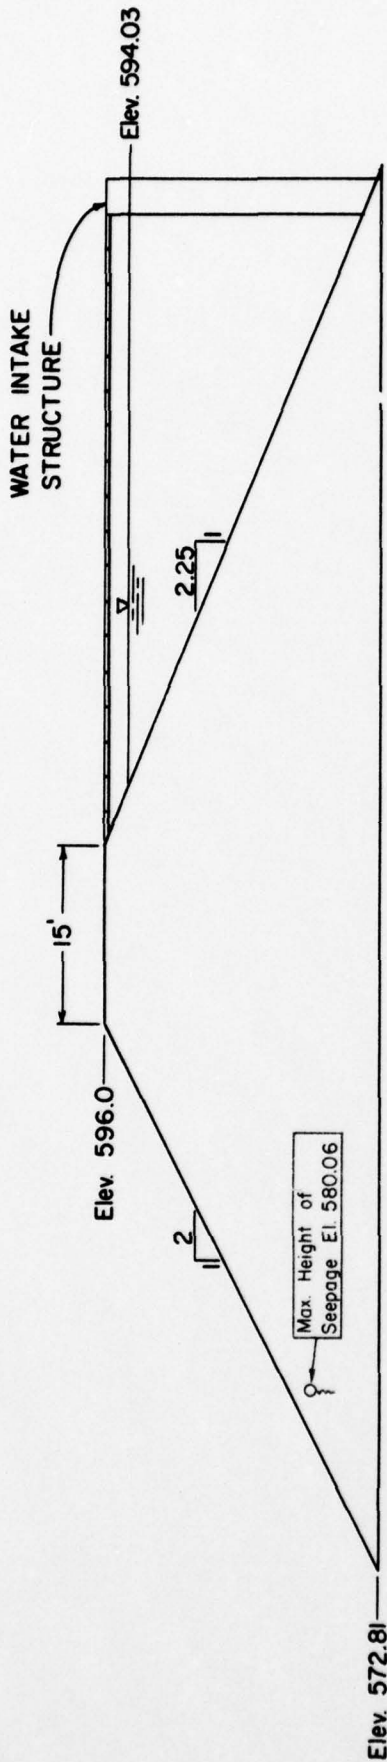
MAXIMUM SECTION

b. Dam. The dam appears to conform closely to the construction drawings. From a brief survey conducted during the inspection it was determined that several low spots are present on the crest toward the left abutment. One area adjacent to the emergency spillway wingwall is approximately one (1) foot low. Several erosion gullies were noted on the downstream slope. These gullies may have resulted from the 1972 overtopping. Several seepage zones were noted on the downstream slope. The seepage zones were small (2' x 2') and minimal flow was noted. Two (2) wet areas (6' x 6') were noted at the toe of the embankment. Approximately seven (7) large trees are growing at the toe of the embankment. See drawing on pages 7 and 8 for location of seepage and wet areas.
